Waddell Creek CZU Post-fire Surveys 2020-2023

Jerry J. Smith, frogs_and_fish@yahoo.com

10 September 2023

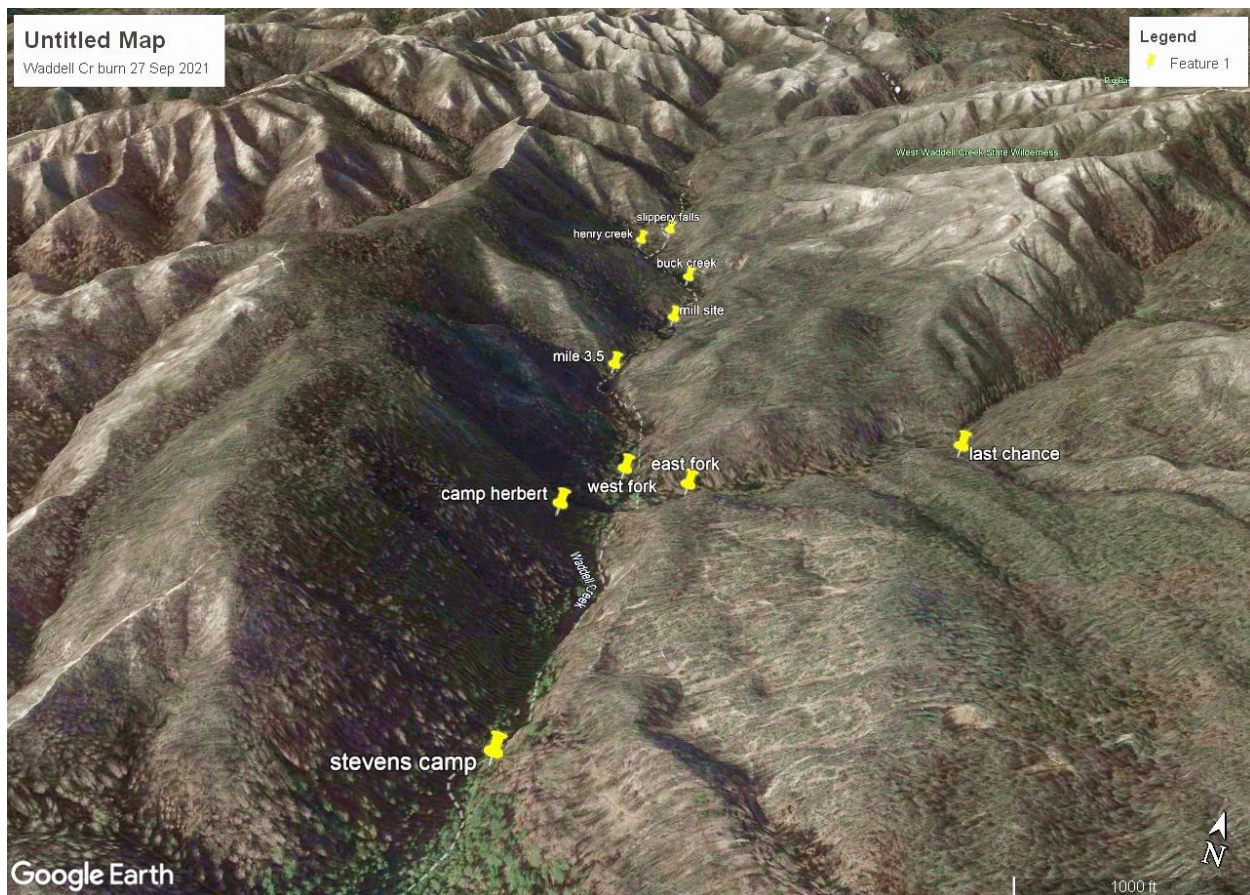
elimination of deeper pools with fines and small mudstone gravel between the forks and mile 2.7 (Figure 3). On the west fork between miles 3.4 and 3.5 there was significant stream aggradation from steep west slope erosion. Elsewhere the stream channel of Waddell Creek, including at fish sampling sites used annually since 1992 (Smith 2020), was not significantly altered. Summer stream flow in 2021 was apparently increased compared to that expected in such a dry year, due to the loss of forest canopy soil water demands in the watershed from tree deaths and substantial reduction in leaf area of most surviving trees. The summer stream flow effect could persist for years.

Figure 3. Google Earth aerial photo from 27 September 2021 from downstream of Stevens Camp (mile 2.55) upstream to the upper watershed of the East and West forks of Waddell Creek. The riparian corridor, lowermost east slope, and the west slopes of Waddell and lower West Fork Waddell had partially intact forest canopy. Drought conditions (with the exception of limited January 2021 rain) resulted in establishment of only very limited vegetative ground cover in 2021 beneath burned standing and downed trees.

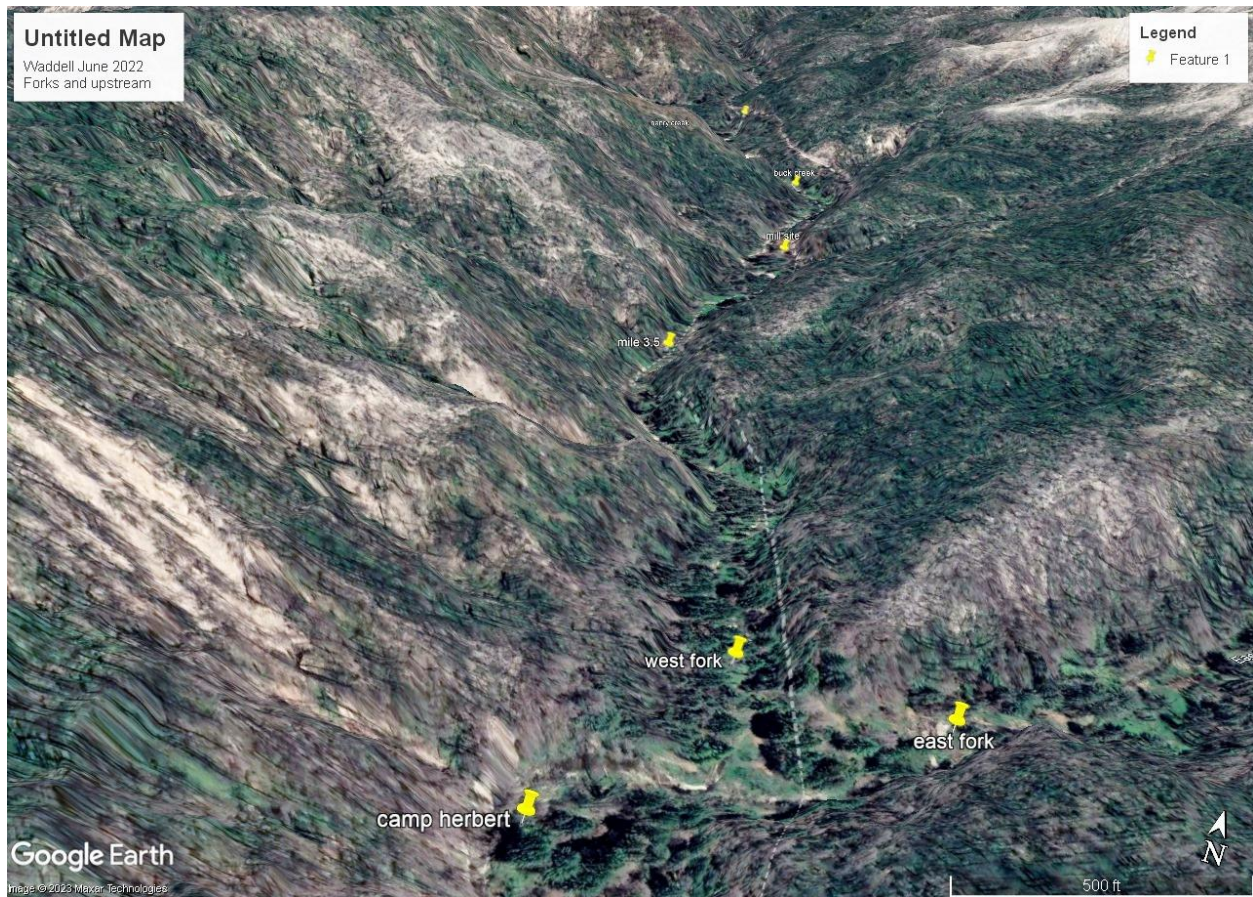
Figure 9. Google Earth aerial photo from 10 June 2022 from the confluence of the forks upstream. West slope Waddell Creek erosion filled almost all West Fork pools. The east slope above the West Fork of Waddell Creek did not apparently contribute to stream sedimentation. The north slope above the East Fork (lower right) also lost its forest. However, the north-facing slope suffered only a moderate burn. Pools on the lower East Fork were not substantially impacted in 2022 (or 2023).

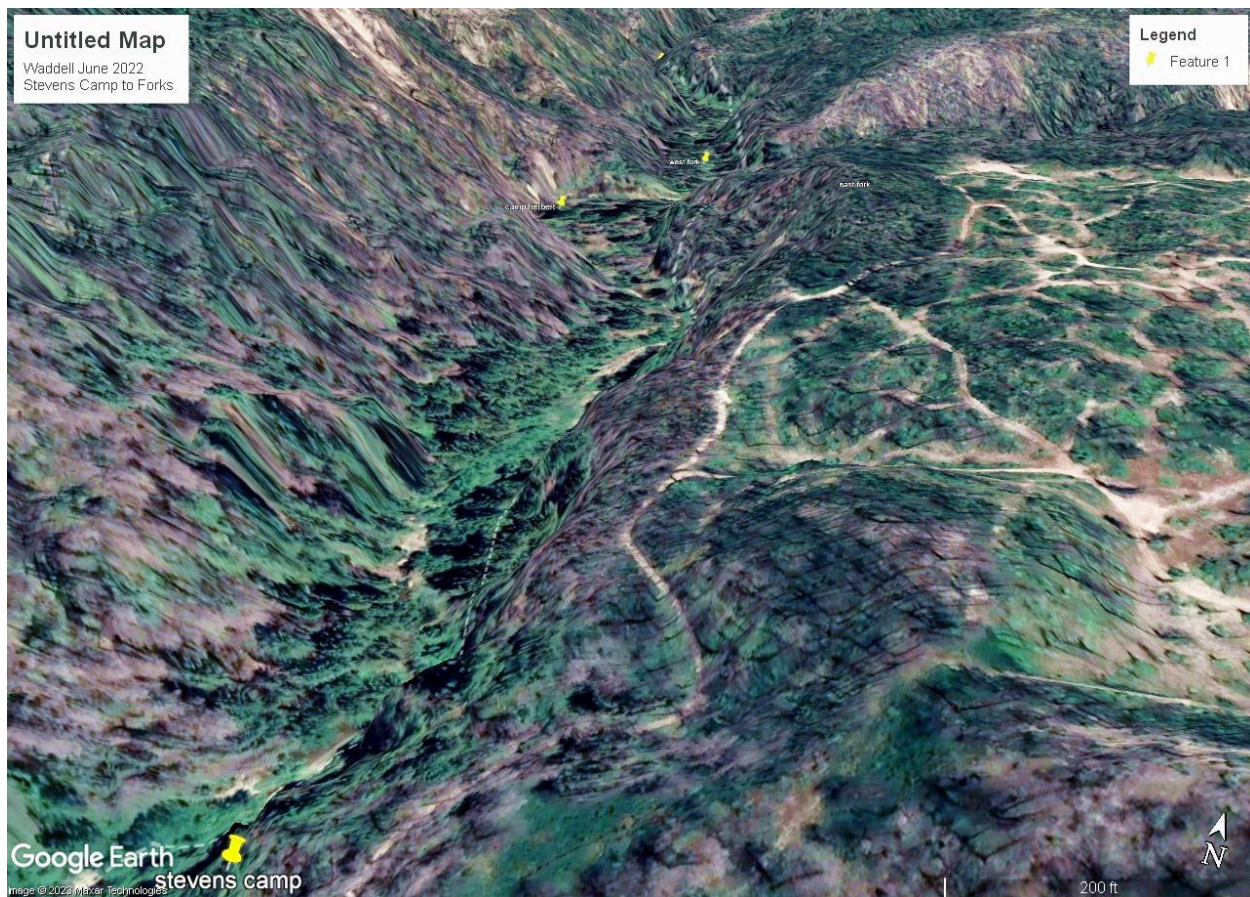
Figure 10. Google Earth aerial photo from 10 June 2022 between Stevens Camp (mile 2.55) and the East and West forks of Waddell Creek. In 2021 streambed sedimentation and pool filling extended from the forks downstream half way to Stevens Camp. In 2022, erosion from the west slopes of Waddell and West Waddell creeks extended streambed sedimentation downstream to at least mile 1.75 (Twin Redwoods Camp). The upper east slopes and hilltops between Stevens Camp and the East Fork (right in the photo) are private property that was salvage logged for redwood in 2021; the green is primarily blue blossom *Ceanothus*.

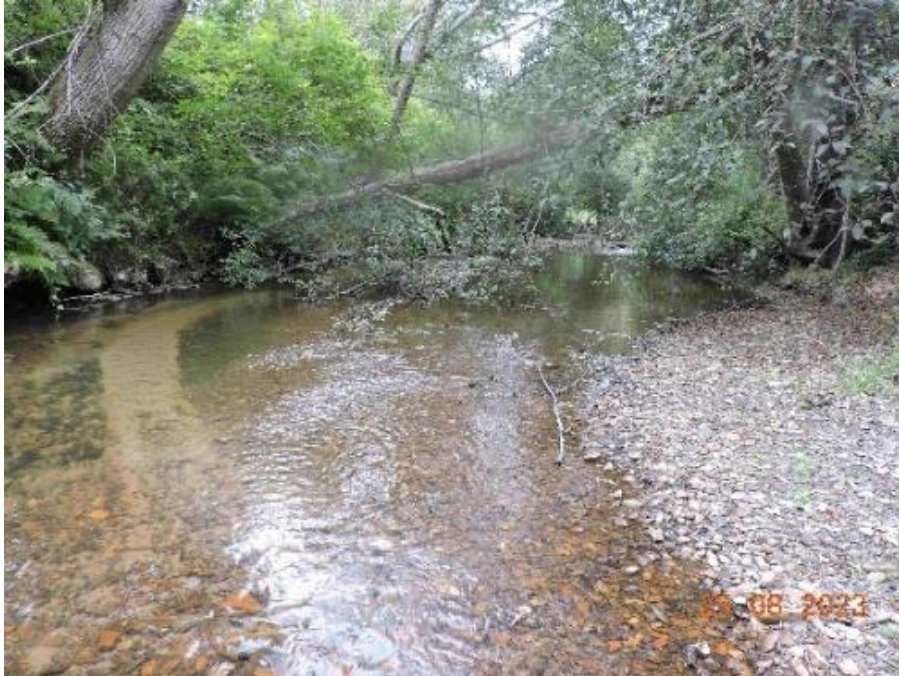
Photo 3. Mile 0.65, looking upstream. Narrow run habitat along the right bank was replaced by shallow sand and fine gravel glide habitat across most of the shallow, leveled channel.

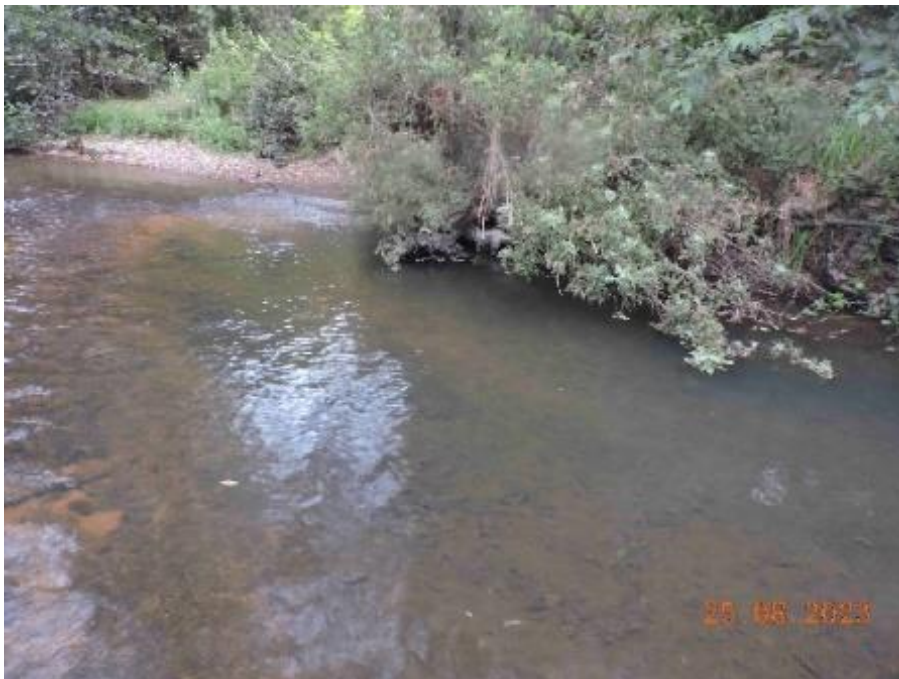
Photo 4. Mile 0.65, looking upstream. Local scour at a left bank root wad provides habitat in an otherwise broad, shallow channel.

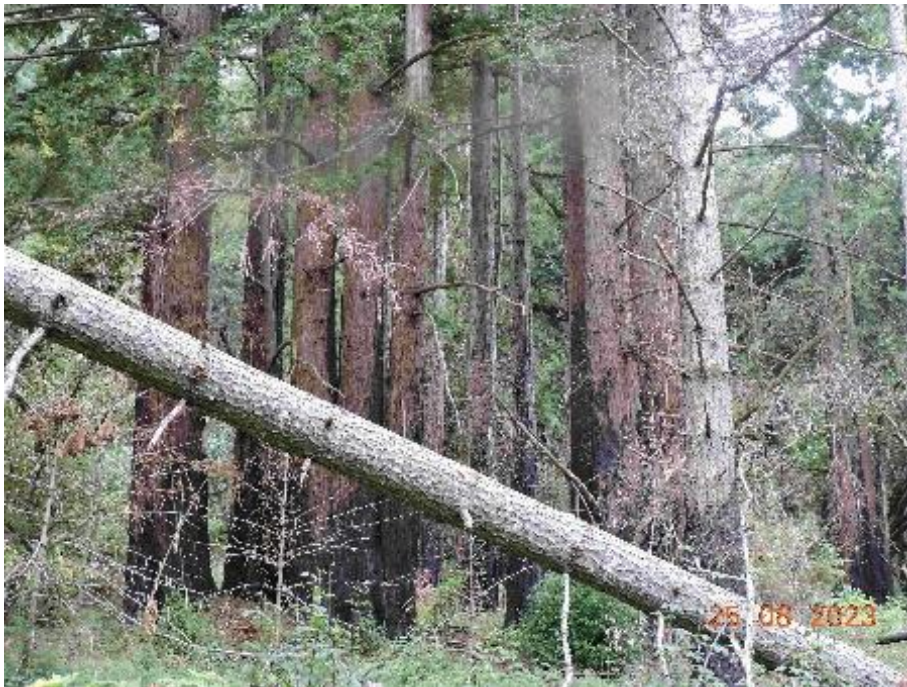
Photo 18. Mile 1.75+, across the road at base of the east slope. Fire scars are present on redwoods and some fallen Douglas firs.

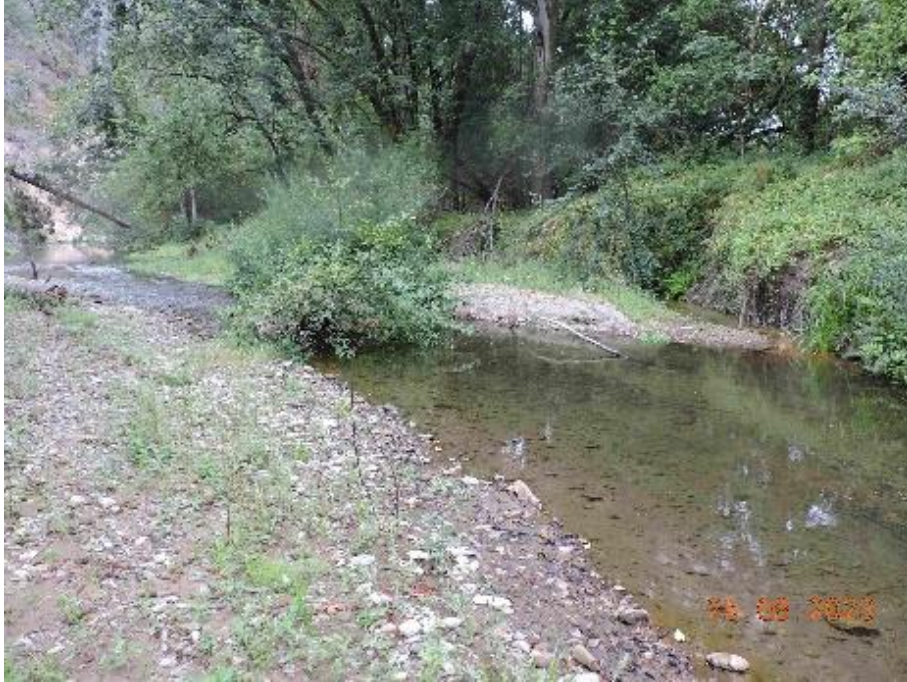
Photo 19. Mile 1.75+, looking upstream. Formerly deep pool with undercut bank and wood structure near the tail, was 60% filled in 2022, but with a deep remnant. In 2023, the pool was completely filled, with a sandbar along the upstream left bank.

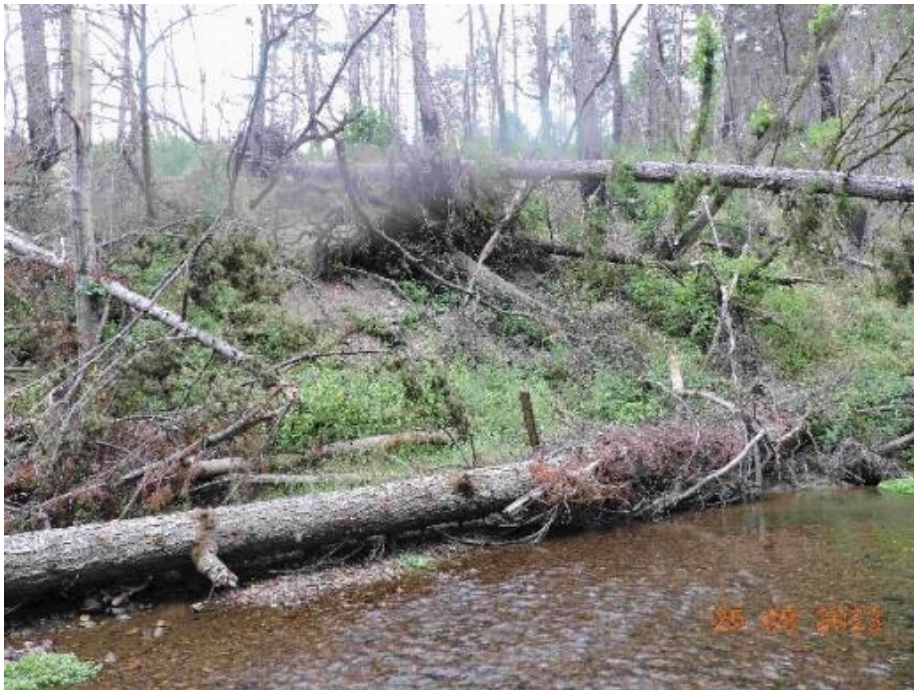
Photo 20. Mile 1.75+, looking at west (right) bank. Fire damaged alders and Douglas firs toppled by high flows and wind in 2023. Canopy shade was lost. Channel is wide and shallow.

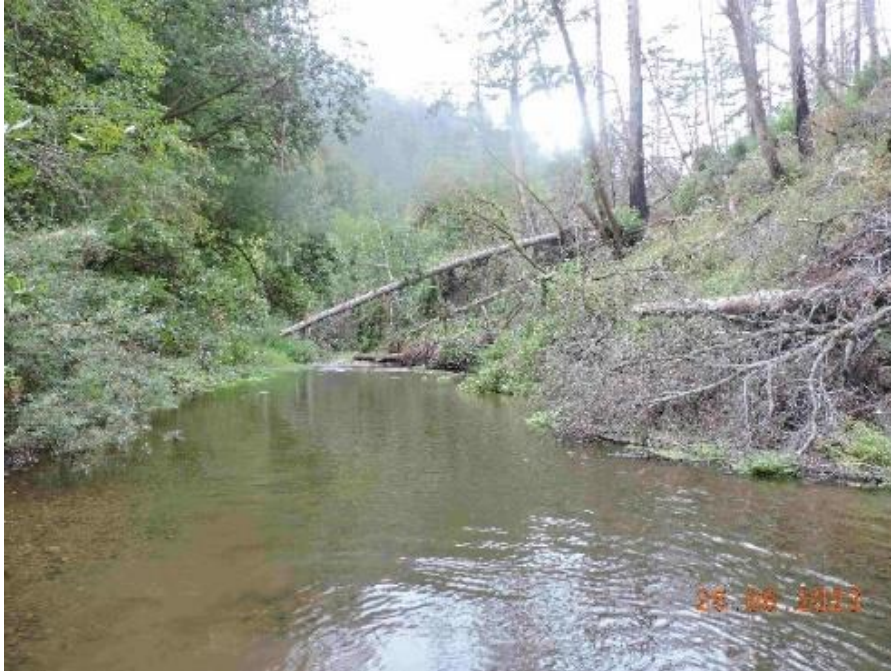
Photo 21. Mile 1.8, looking downstream. Wide, shallow, sunny channel. Standing and fallen Douglas firs on right bank.

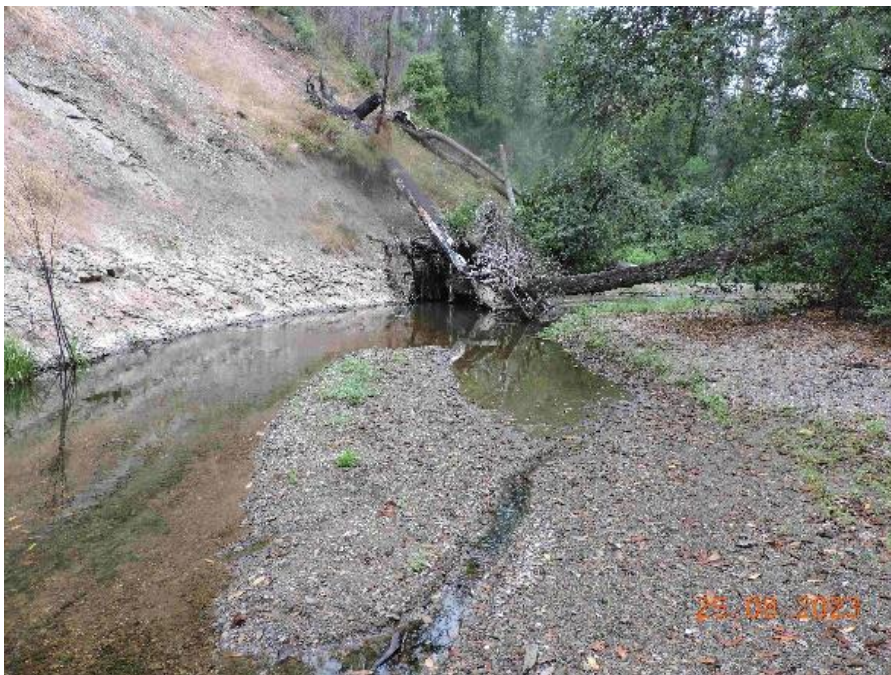
Photo 22. Mile 1.8, looking upstream. The downstream portion of the long, deep (swimming) pool was mostly filled by the right bank slope failure in 2022. In 2023 almost all of the pool was shallow, except immediately around in-channel wood at the channel bend.

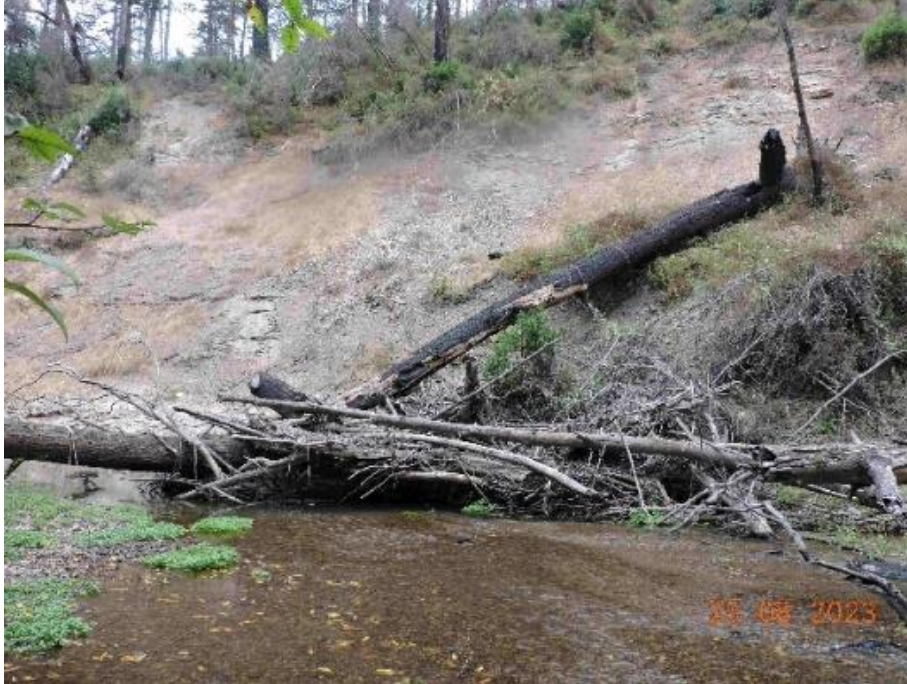
Photo 23. Mile 1.8, looking downstream. 2022 slope failure scarp and channel wood at the bend shown in photo 22.

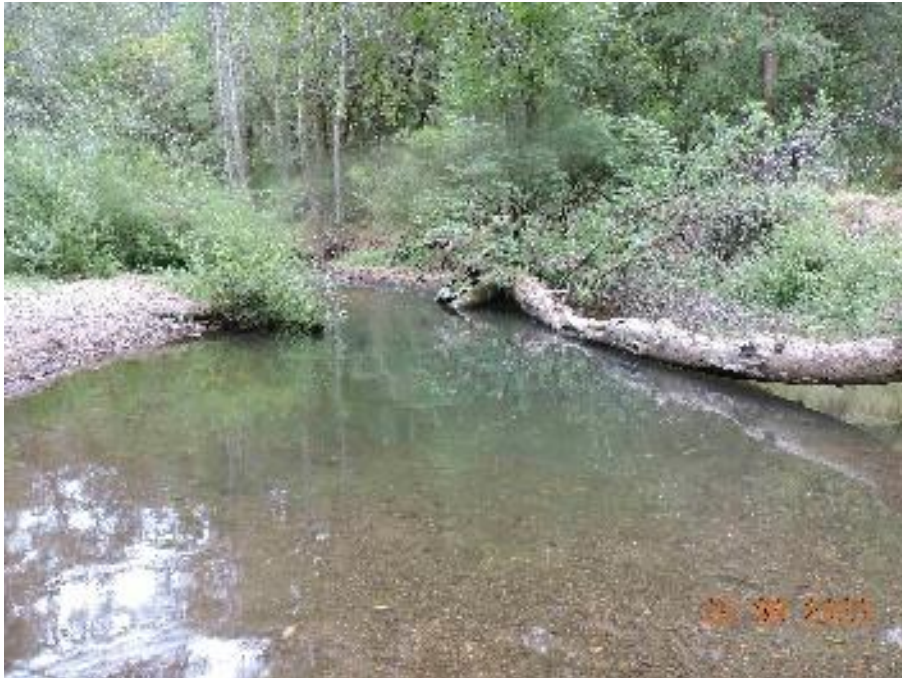
Photo 24. Mile 1.8, looking upstream. The fallen, but living, California bay along the left bank has supported a deep pool since 1998. In 2022 toppled alders from both banks provided scour at the pool through winter 2023. This is the only large, deep, and complex habitat remaining at the fish sampling site.

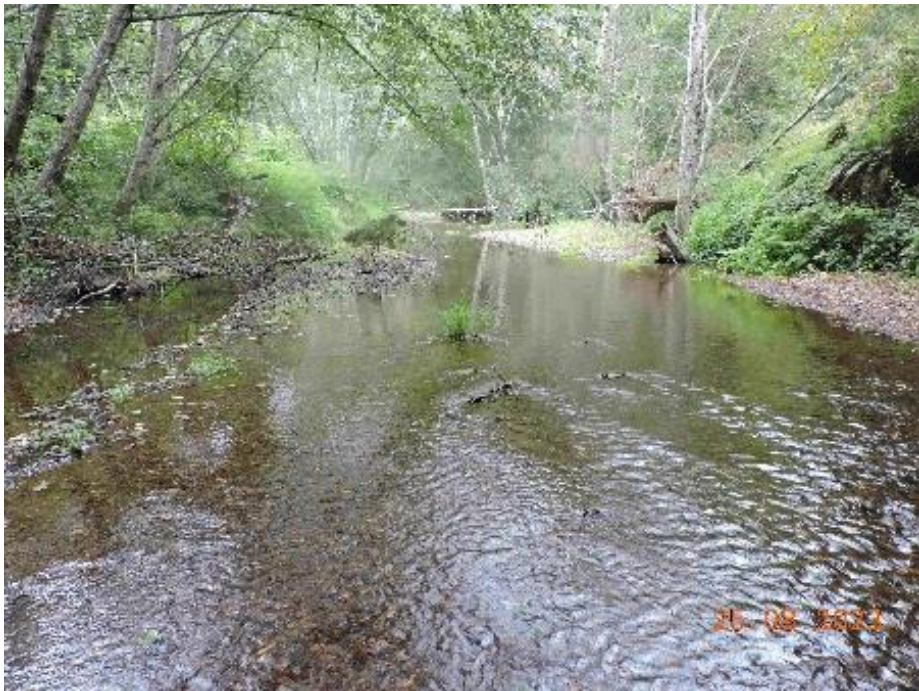
Photo 26. Mile 1.8, looking upstream. A series of pools and glides upstream of the pool in photos 24 and 25, are wide, simple, and shallow.

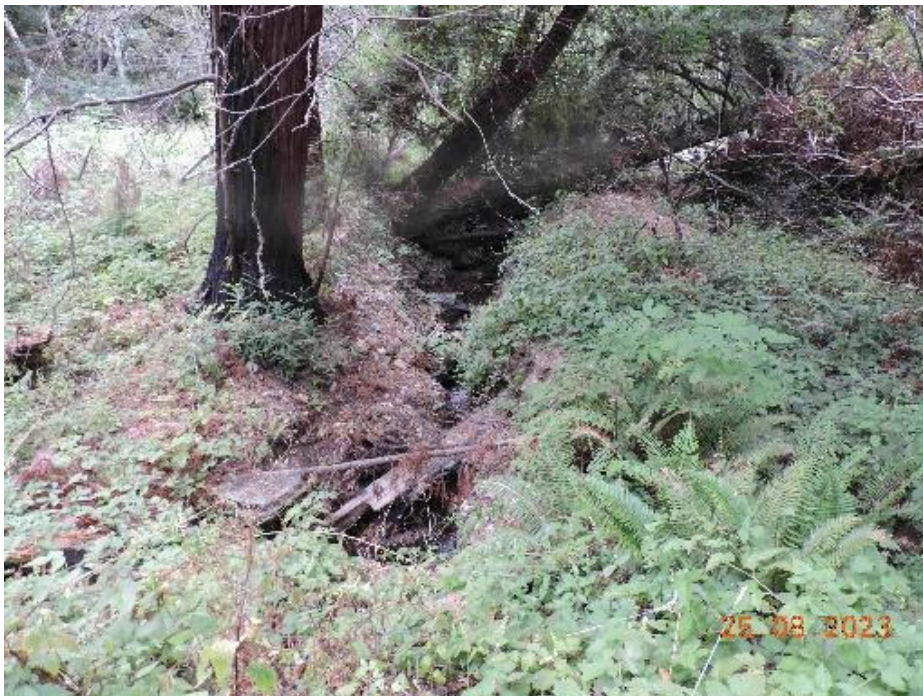
Photo 28. Mile 2.05. The Tramway Springs drainage channel downstream of the road was eroded deeper in 2023 and deposited sediment near Waddell Creek.

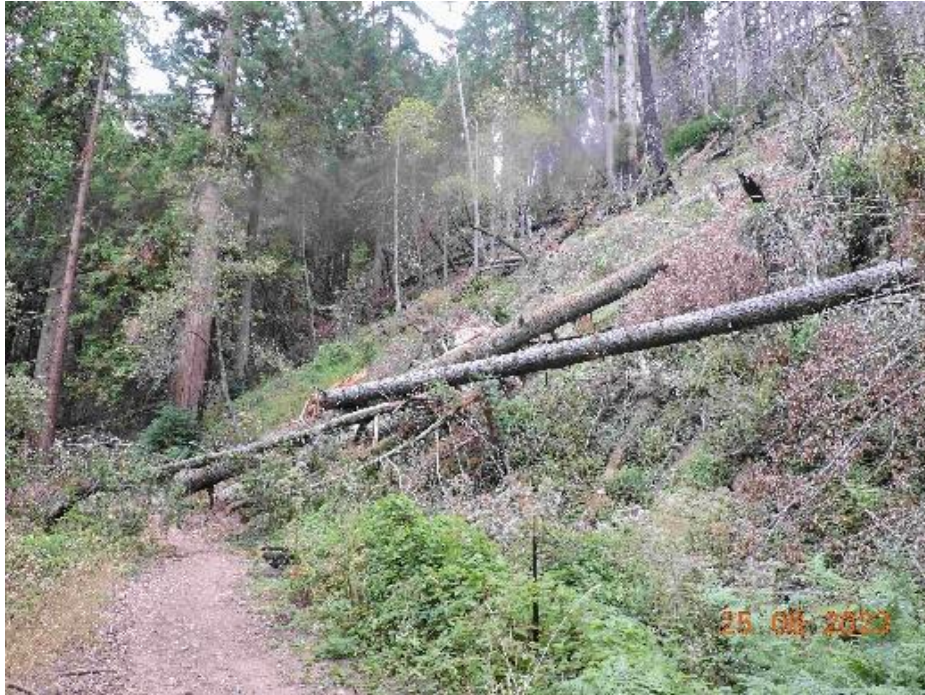
Photo 29. Mile 2.1, looking upstream. Burned Douglas firs fallen in 2023 across the road from the east slope.

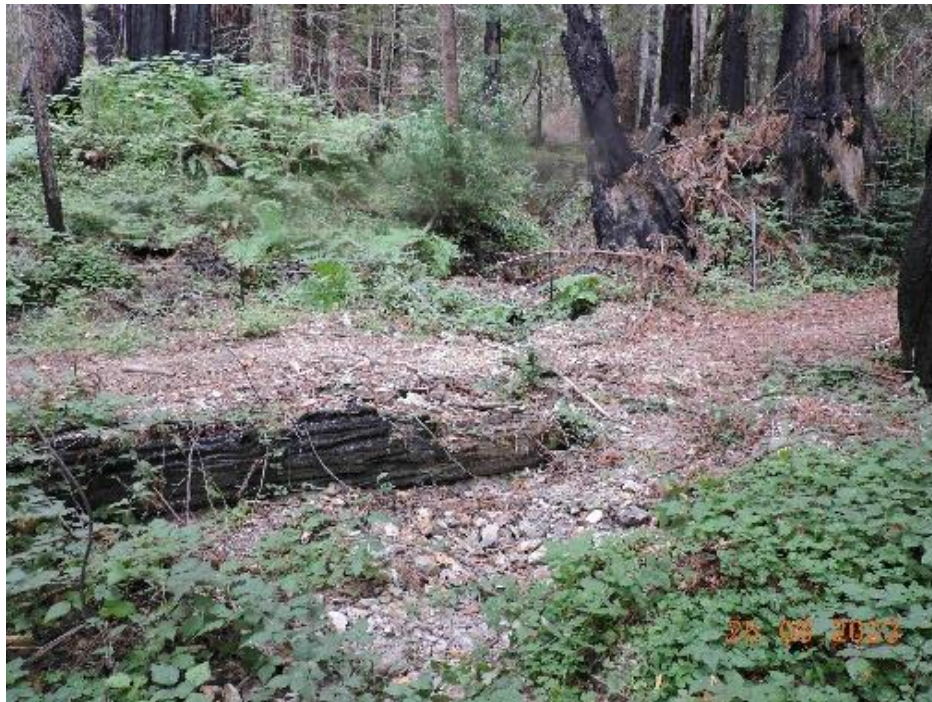
Photo 30. Mile 2.15, looking upslope across road. Seasonal drainage carried sediment and angular mudstone gravels across road and down to Waddell Creek in 2023.

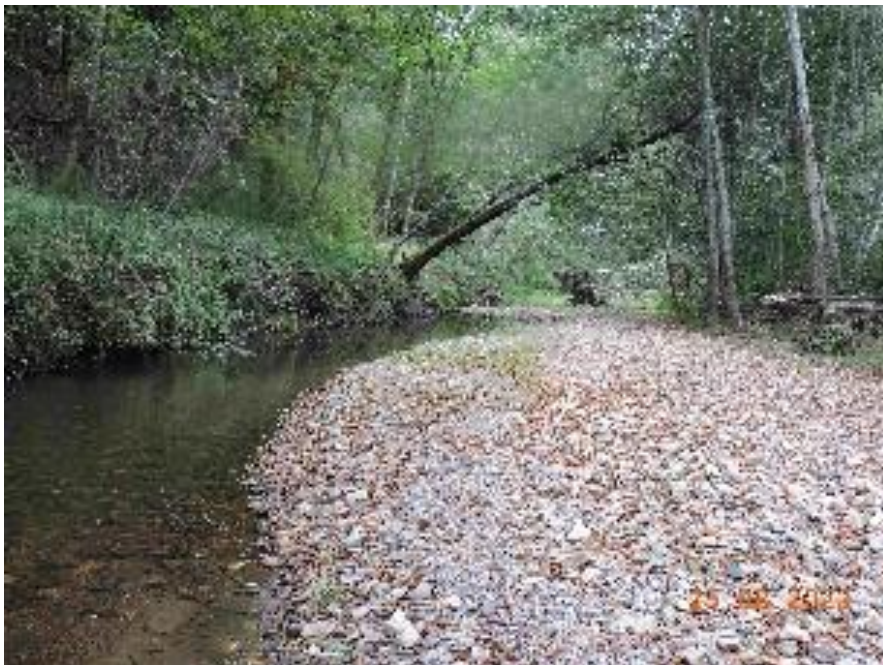
Photo 32. Mile 2.15+, looking downstream. The downstream portion of the lower fish sampling pool at the site was filled by fines and gravels in 2022 and 2023.

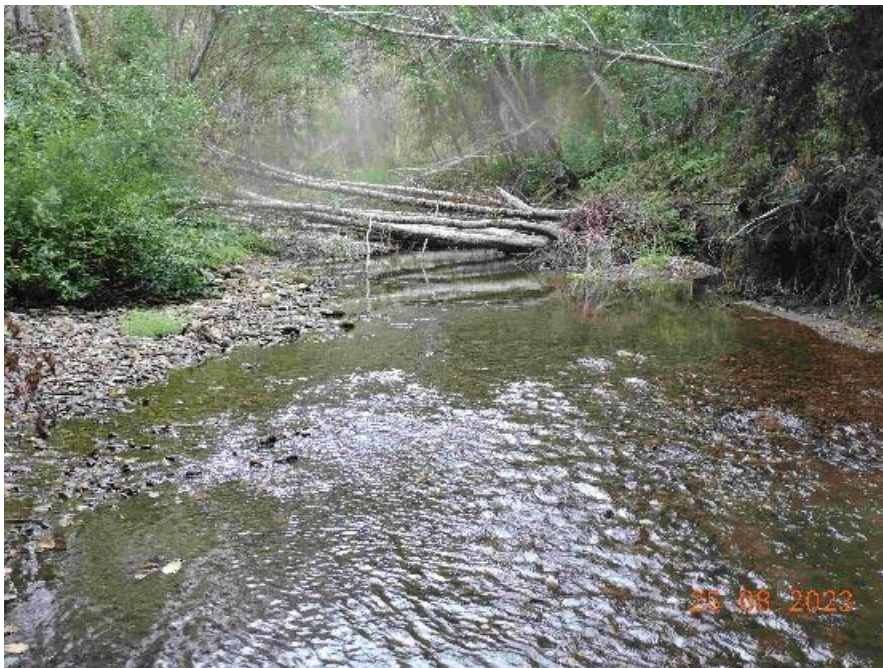
Photo 36. 2.15+, looking upstream. Another cluster of fallen alders spanned the wide, shallow channel, which replaced glide and shallow pool habitat in 2023.

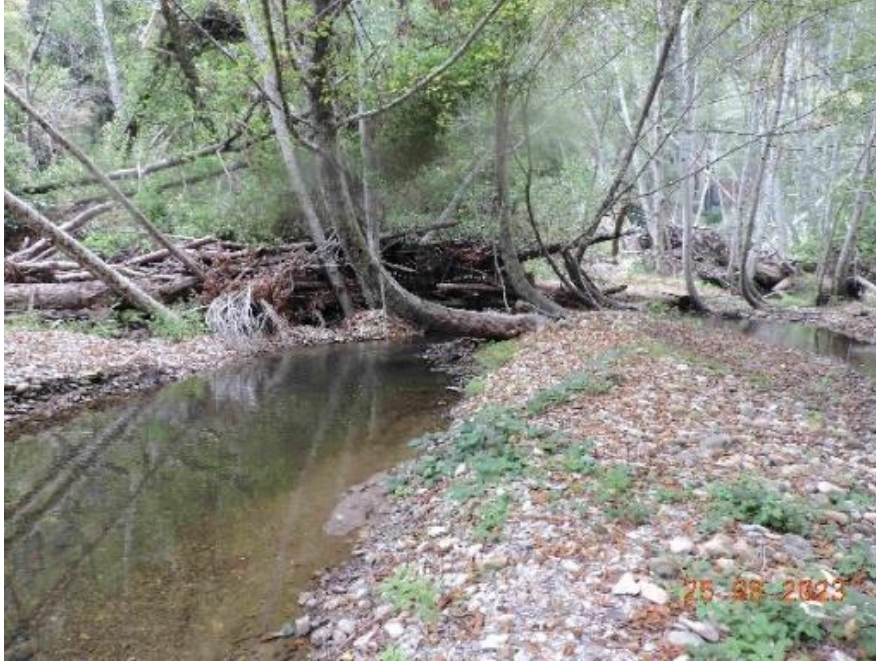
Photo 37. Mile 2.2, looking upstream. In 2023 the channel rearranged and split around stream-side alders. A shallow pool upstream was filled by fines and gravels.

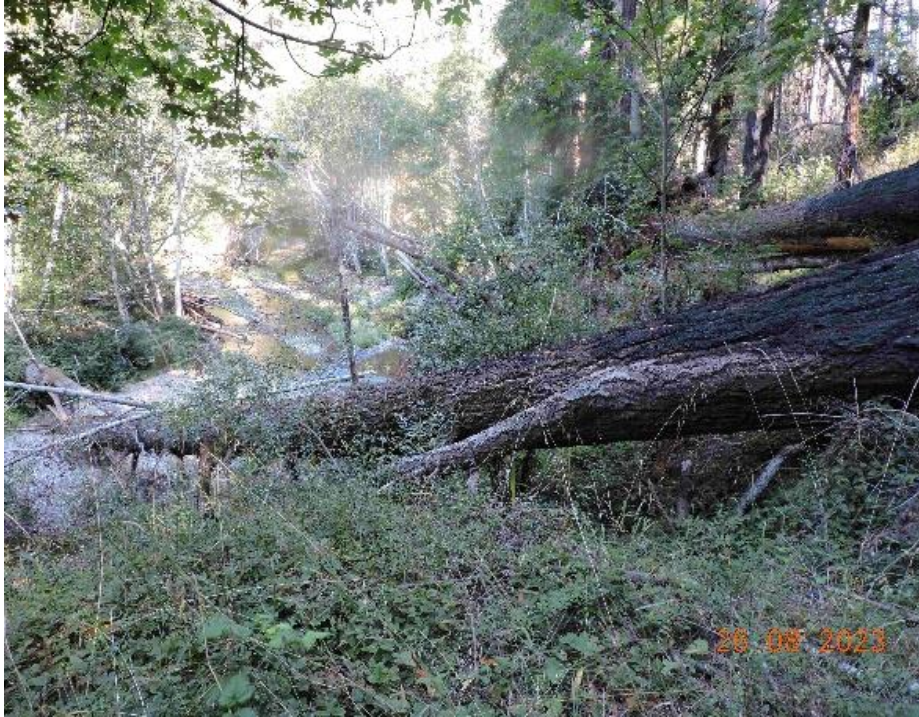
Photo 41. Mile 2.6+, looking upstream from right bank trail on high bank. Numerous large burned Douglas firs fell across the trail and into channel 2023.

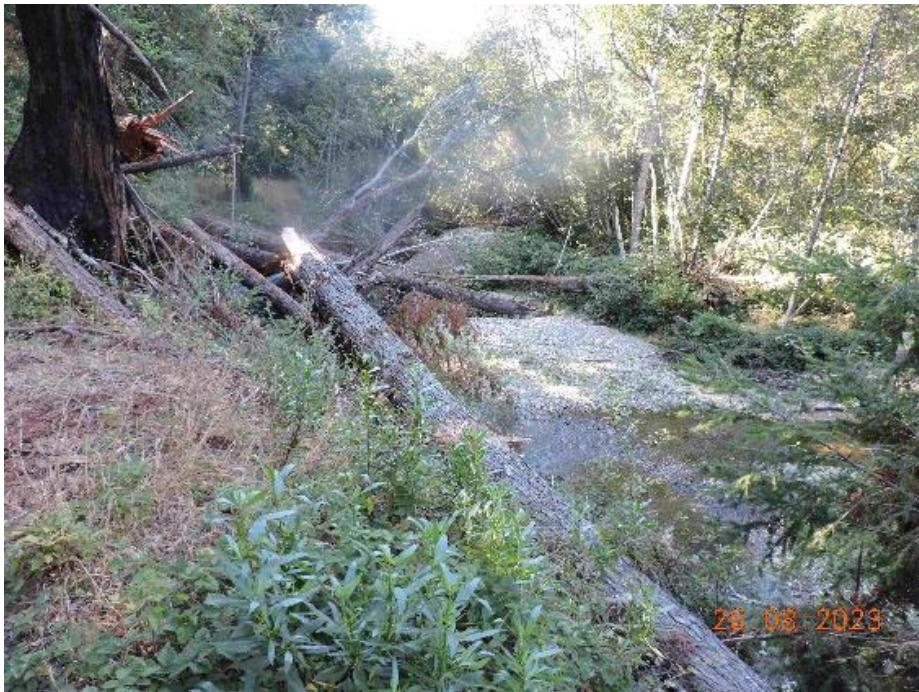
Photo 42. Mile 2.6+, looking downstream at fallen firs, sand/gravel bar, and filled middle portion of formerly large, deep pool.

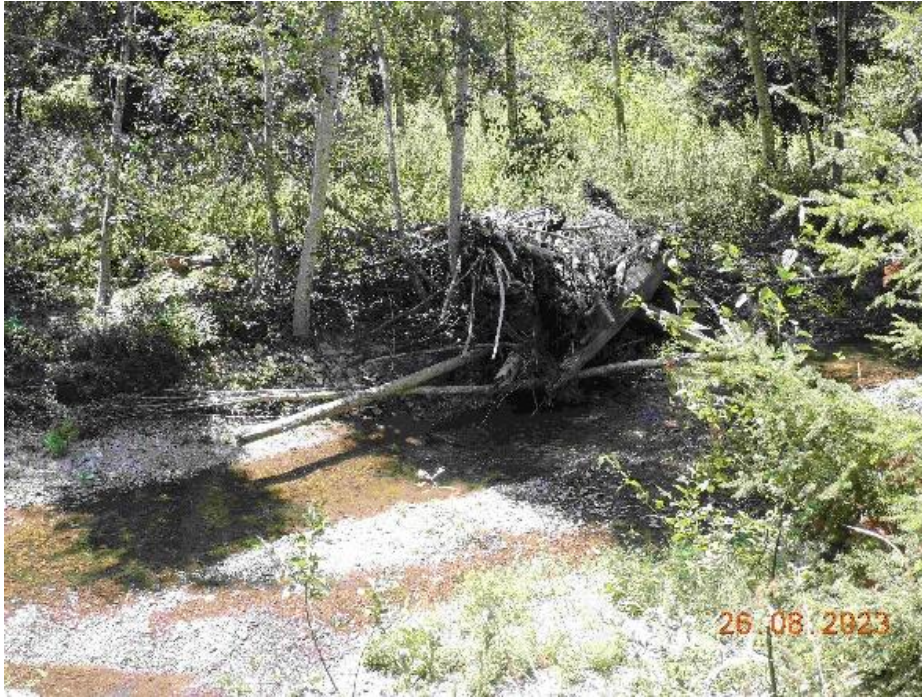
Photo 43. Mile 2.6+, looking across channel to filled pool and dead, transported alders caught on 10 ft high bank.

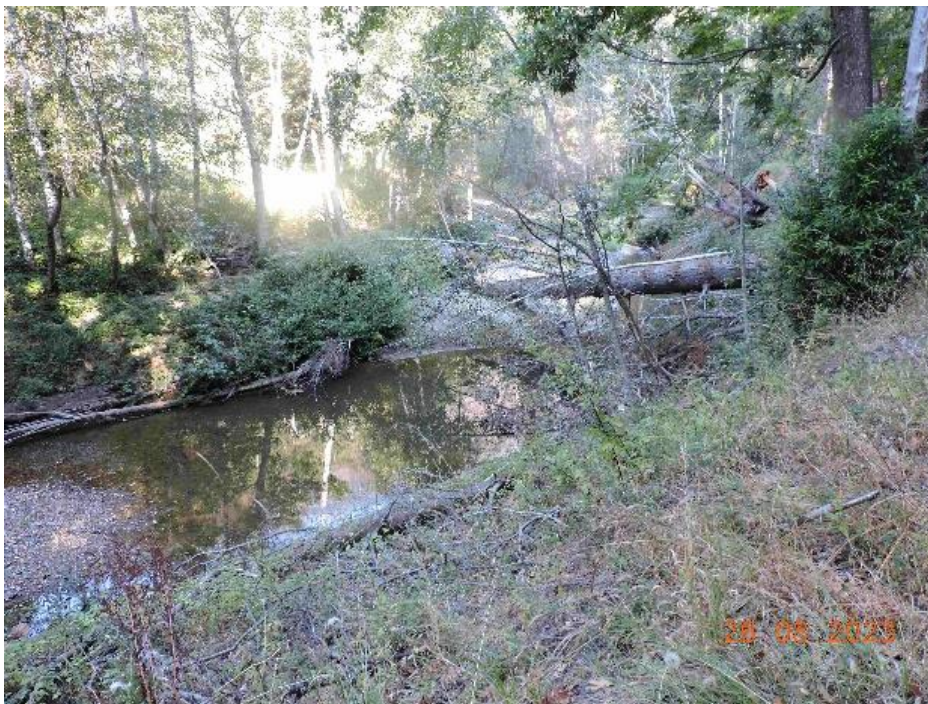
Photo 44. Mile 2.6+, looking upstream at shallow upstream remnant of the formerly deep pool.

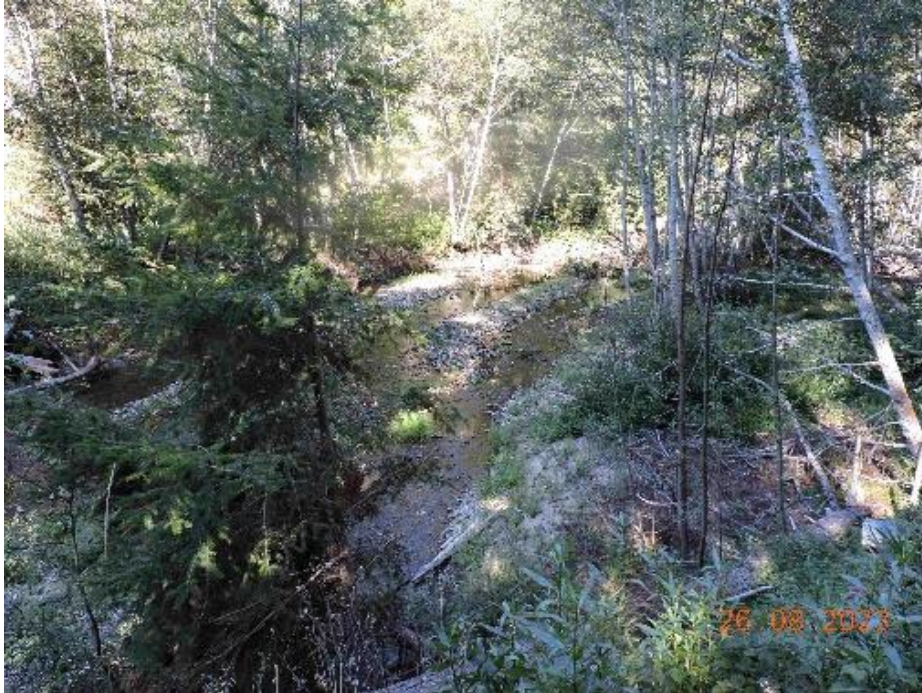
Photo 45. Mile 2.6+, looking upstream above sharp channel bend in photo 44. The shallow channel was widened and large wood and a deep pool were eliminated in 2023.

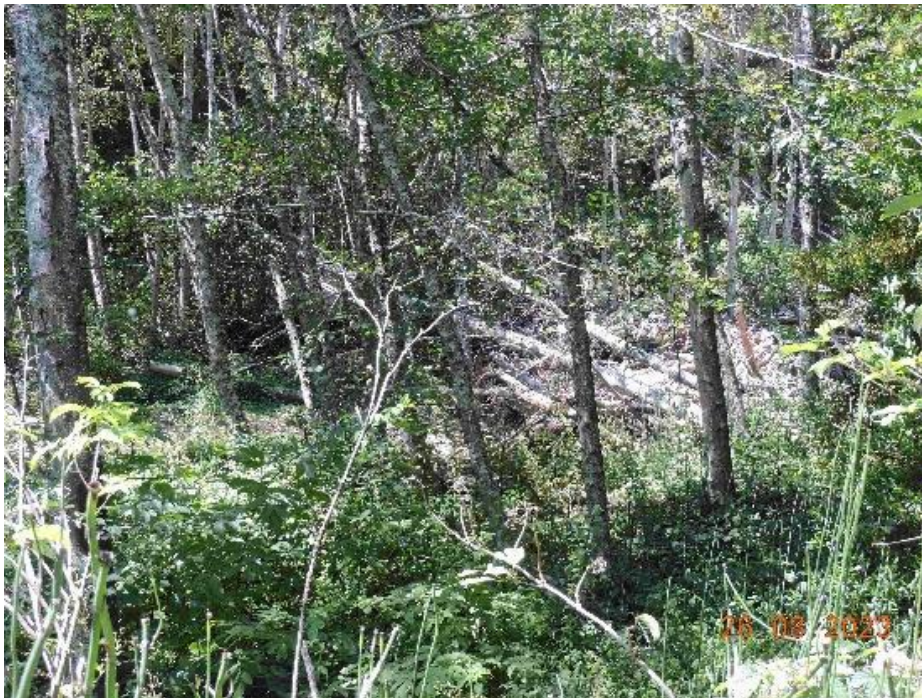
Photo 46. Mile 2.65, looking at floodplain upstream of bend. Flood flows deposited fallen alders 10 ft up on the floodplain in 2023.

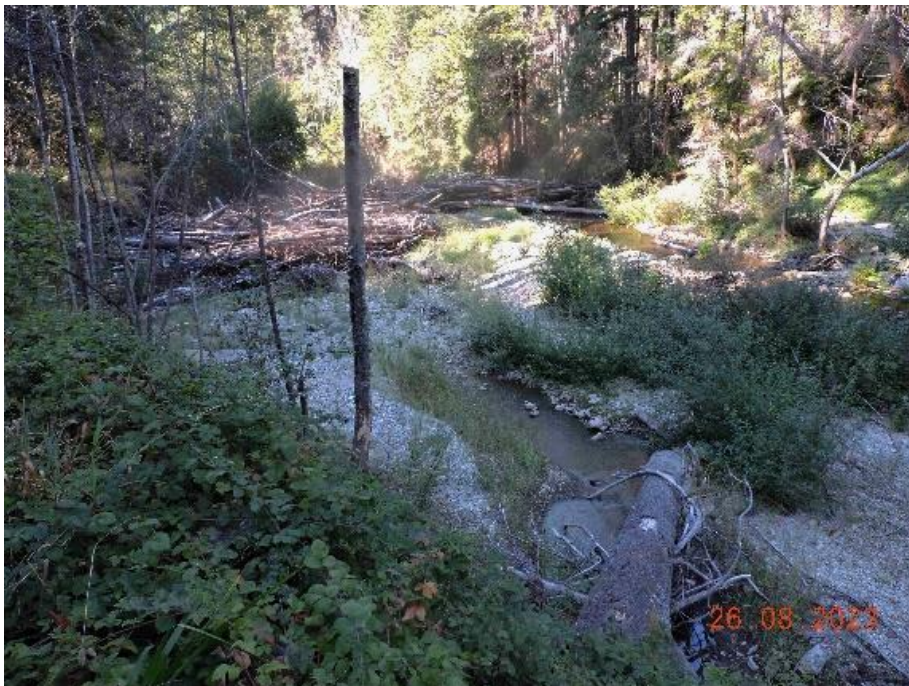
Photo 48. Mile 2.7, looking downstream (2023 repeat of photo 47). Channel scoured from bank to bank by high flows in 2023, with abundant downed alders forming a very large new jam across the channel downstream.

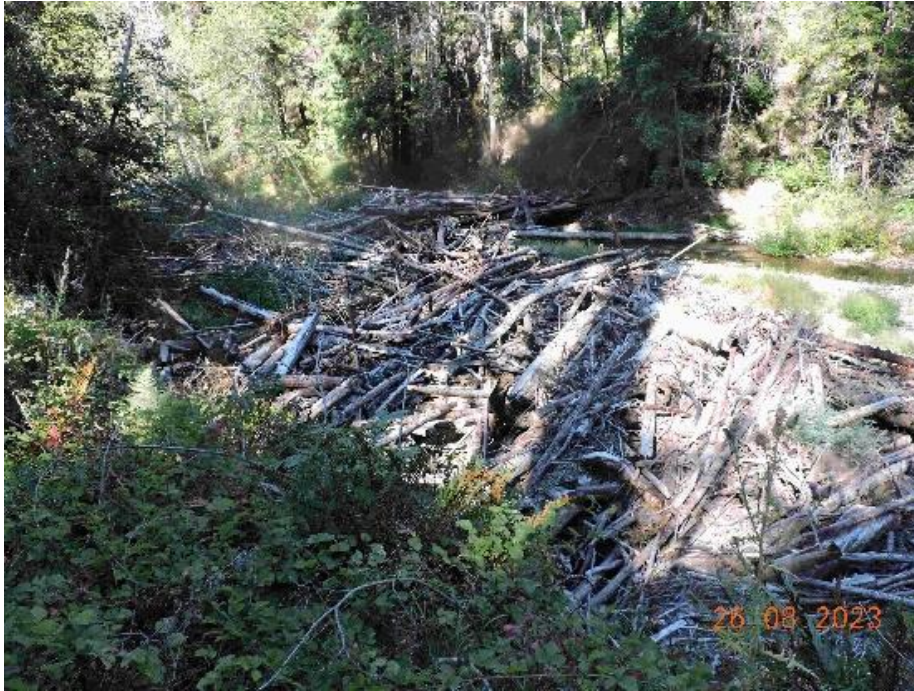
Photo 49. Mile 2.7, looking downstream at jam formed in 2023 from fallen alders, including from jam present in 2021 and 2022 at mile 2.85+, which washed out and downstream in 2023.

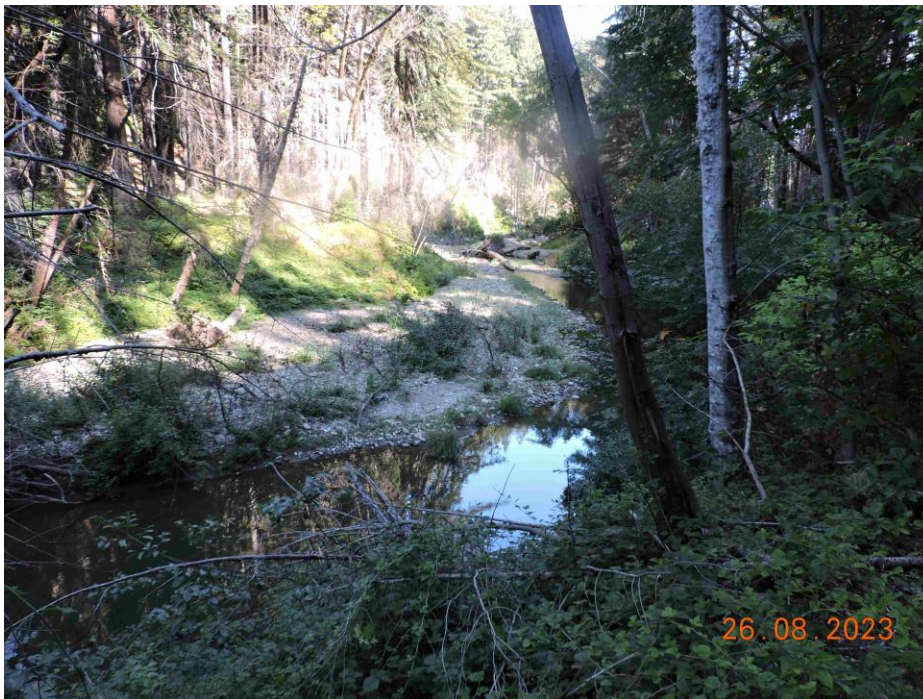
Photo 50. Mile 2.75, looking upstream. Bank alders lost, with a widened, shallow, gravel channel.

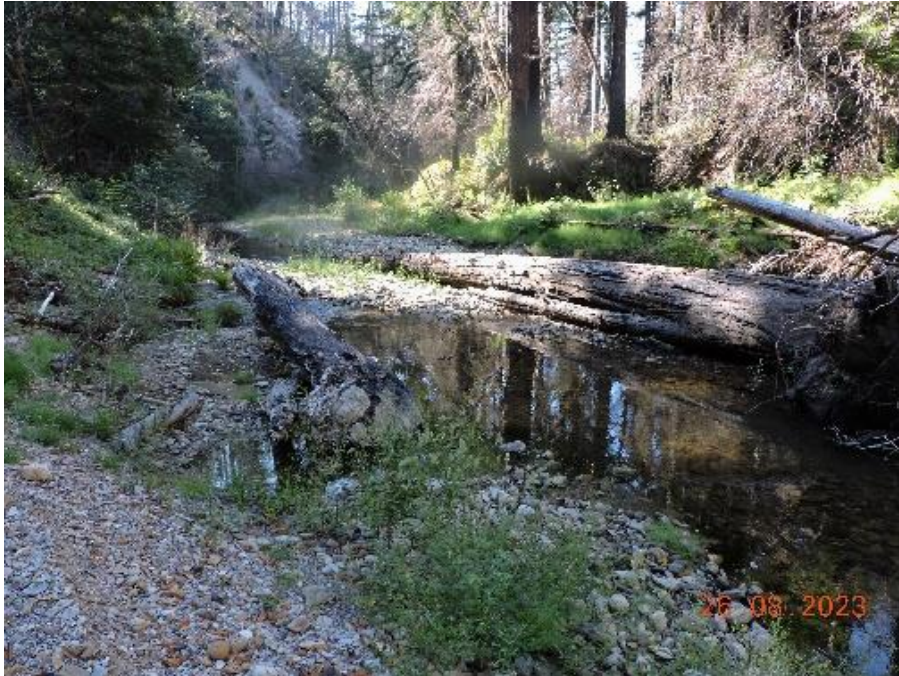
Photo 51. Mile 2.75+, looking downstream. Fire burned to stream banks. Most remaining bank alders were lost in 2023, with large fallen redwood washed to site by winter flows. Fine mudstone gravels were rinsed downstream and replaced by cobbles in the channel along the redwood in 2023.

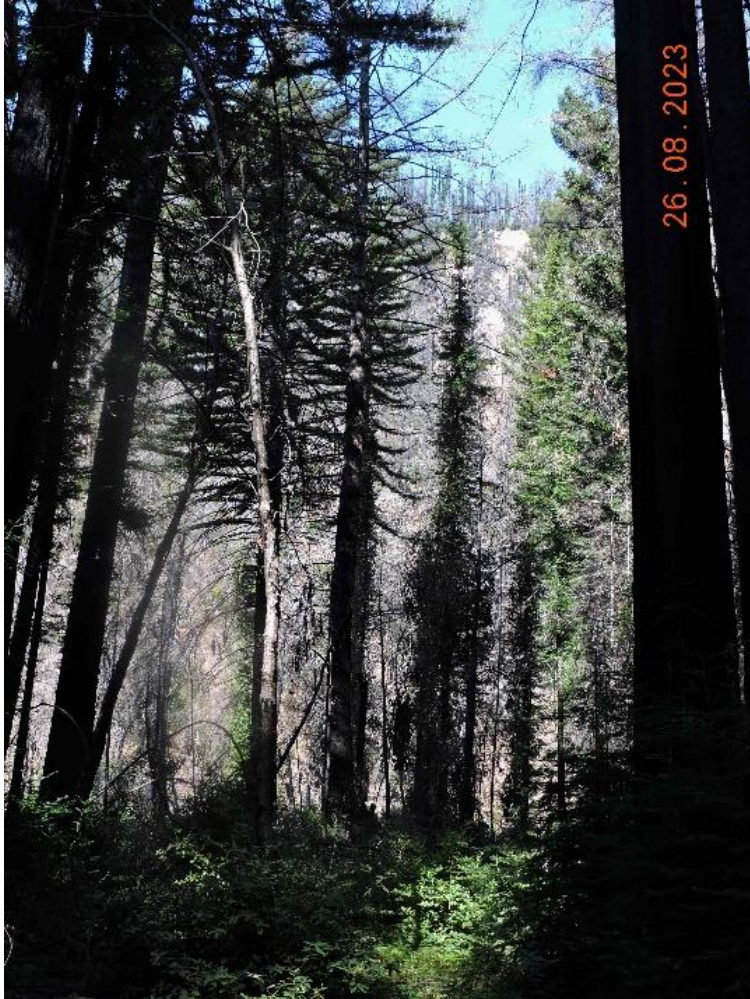
Photo 59. Mile 3.05+, at Camp Herbert, looking towards west slope. Douglas firs were killed, but redwoods survived with trunk and branch sprouts. The rim to stream steep slope with the debris flow in 2021 is in the background.

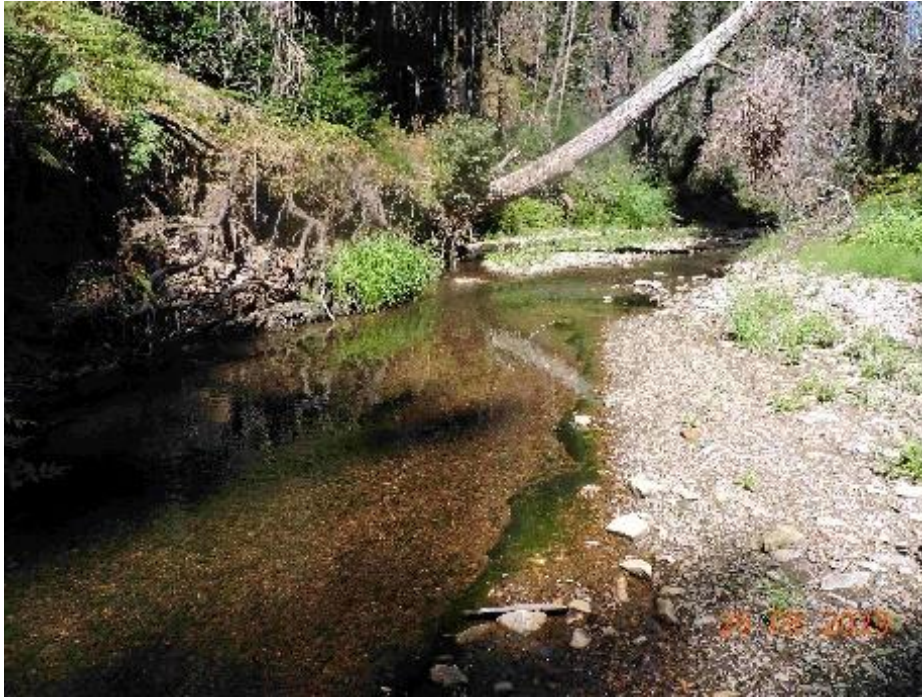
Photo 66. West Fork, mile 3.15, looking upstream. Deep pool with right bank alcove and backwater through 2021 (frequently too deep to sample effectively). Was filled in 2022, and was narrowed in 2023.
