Waddell Creek CZU Post-fire Surveys 2020-2023

Jerry J. Smith, frogs_and_fish@yahoo.com

10 September 2023

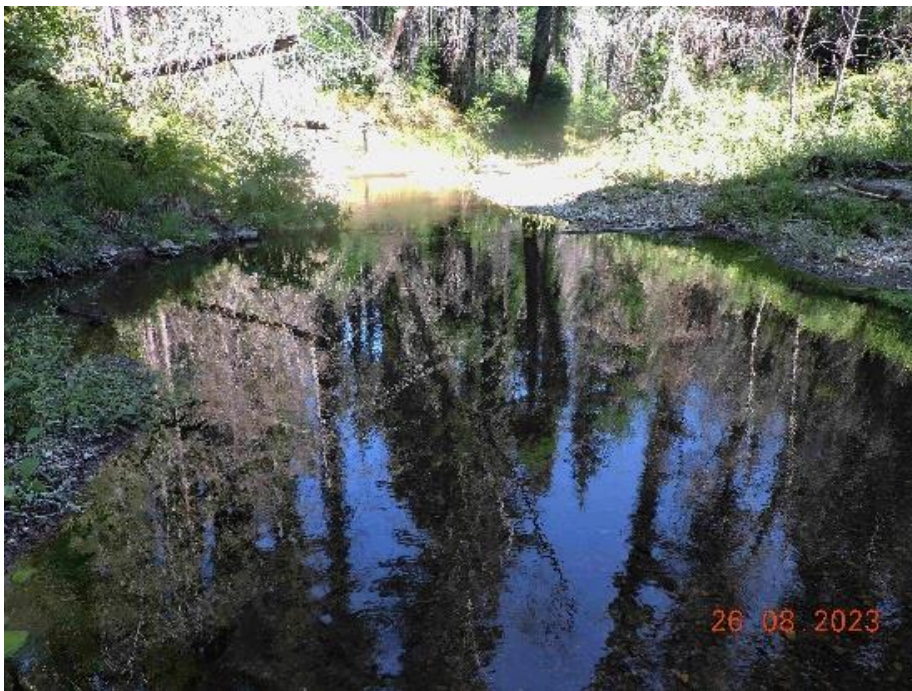
Photo 67. West Fork, mile 3.15, looking upstream. Third deep pool, with cross-channel log creating scour in 2005-2021, was filled with gravel in 2022 and 2023.

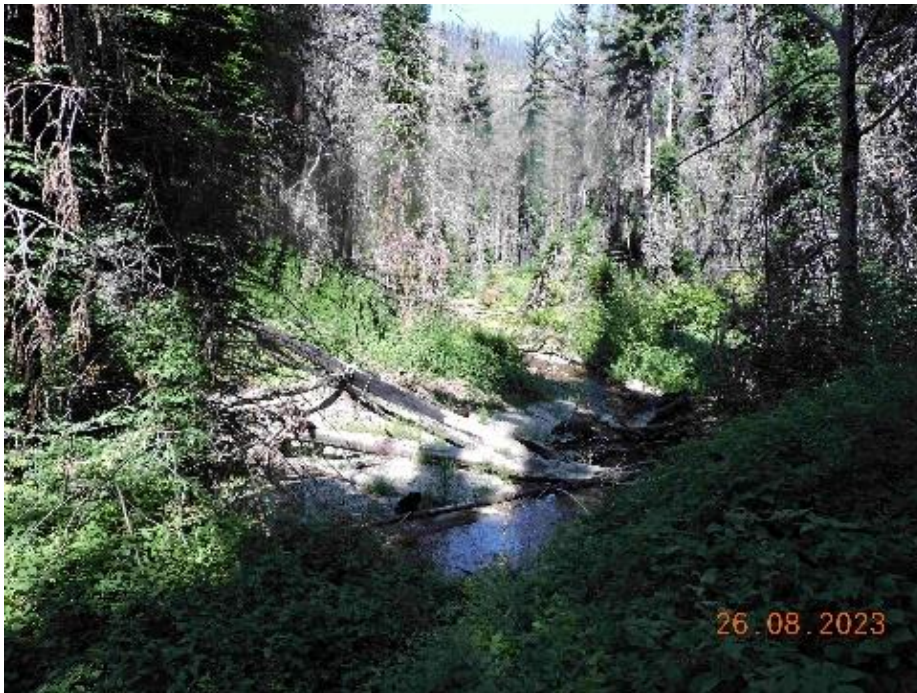
Photo 69. West Fork, mile 3.4. Dense streamside habitat at a 1998 very large logjam (a frequent partial fish barrier) that was substantially burned in 2020. Passable in rearranged aggraded channel in 2022 and 2023.

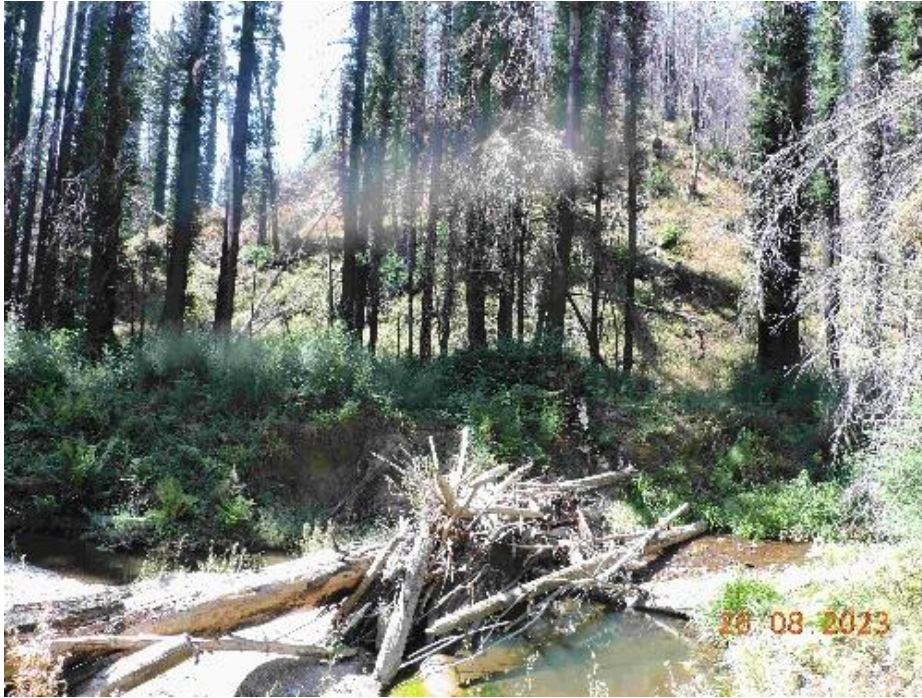
Photo 70. West Fork, mile 3.45, looking across channel to west slope. In 2022 a fallen tree had accumulated substantial wood and in 2023 the remnants produced a small backwater pool in the aggraded channel. Some ground cover vegetation finally began to develop on the west slope in 2023.

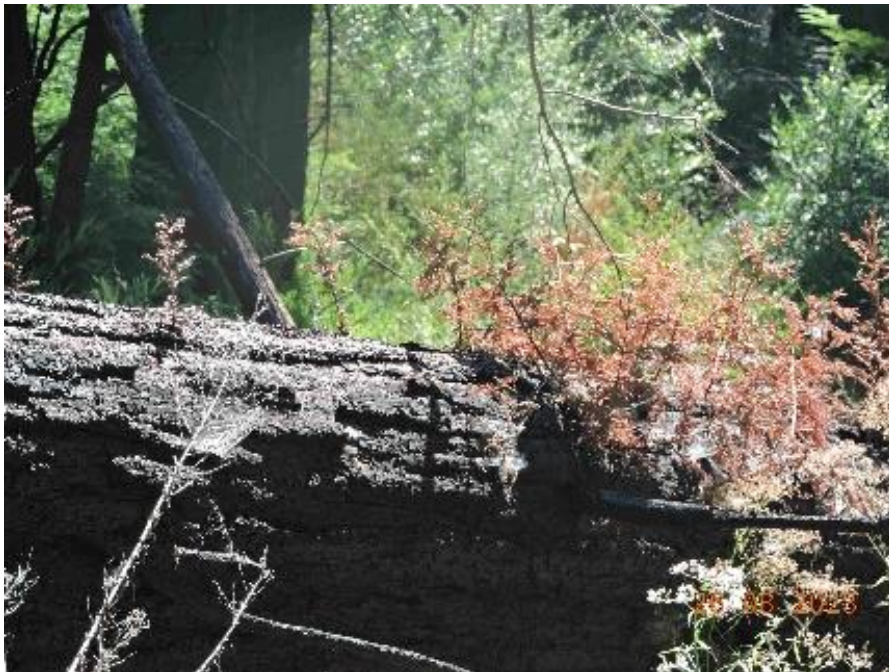
Photo 73. West Fork, mile 3.5. In a trailside wetland, 5 large burned redwoods had fallen in 2021, but had epicormic trunk sprouts on the prone trunks in 2022. The trunk sprouts were dead in 2023, but basal sprouts were alive.

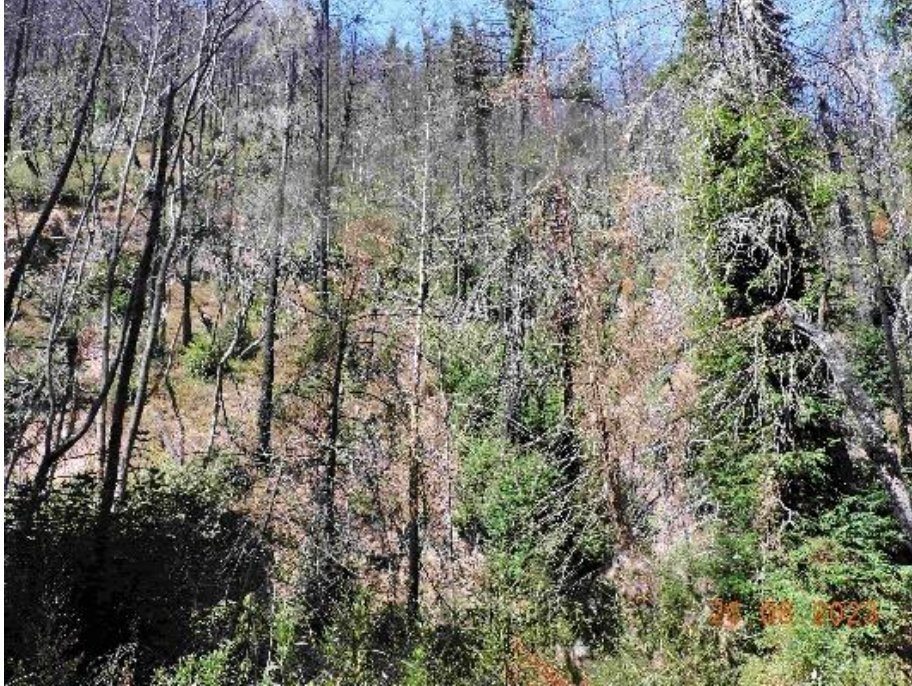
Photo 74. West Fork, mile 3.55. Steep west slope with heavy tree mortality and limited ground cover to protect against erosion.

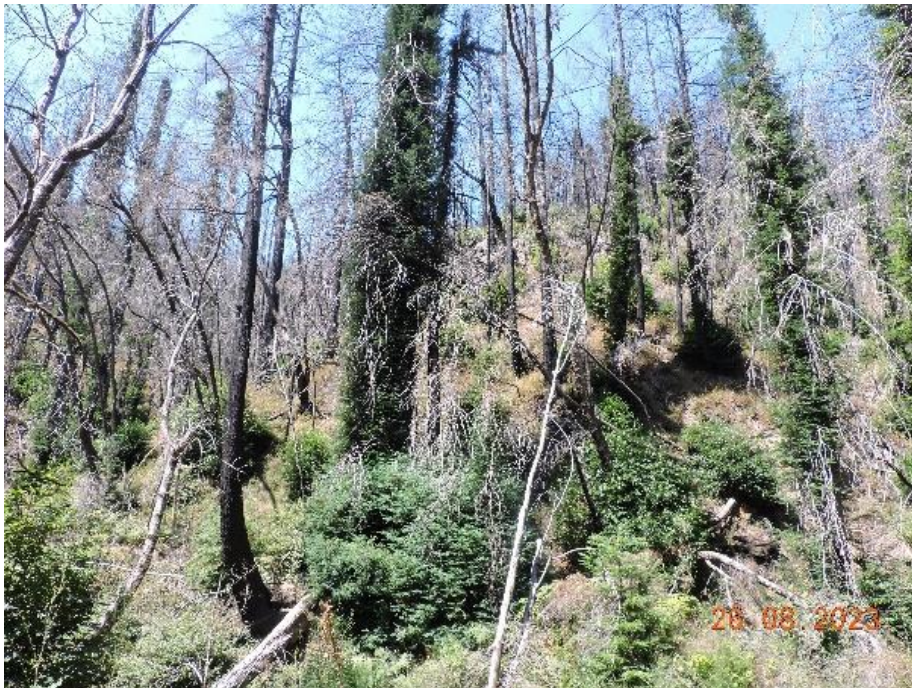
Photo 75. West Fork, mile 3.55. Steep west slope with surviving redwoods and ground cover near the stream, but dead trees and sparse ground cover upslope.

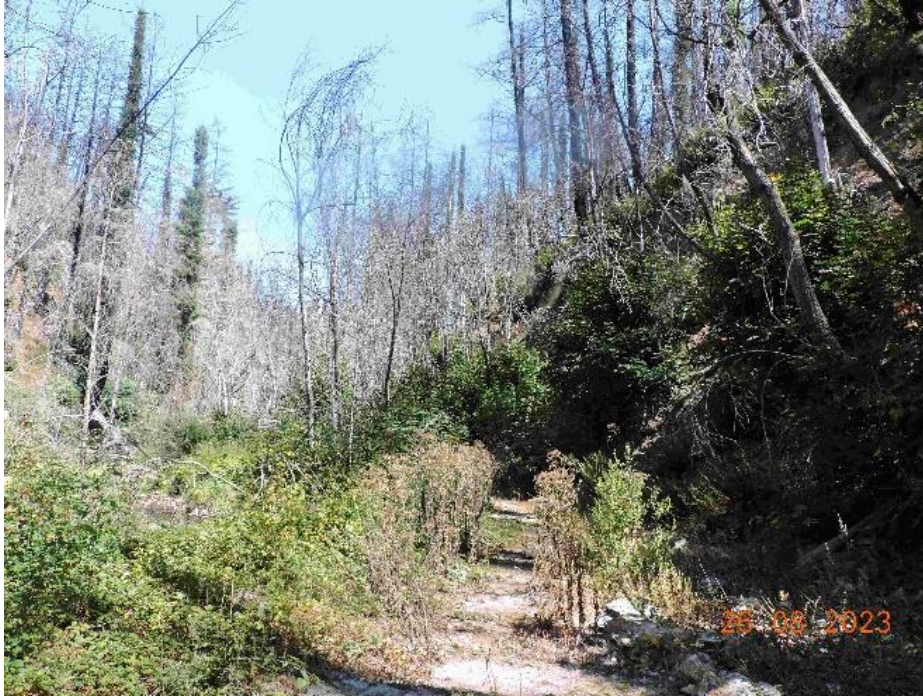
Photo 76. West Fork, mile 3.55+. Bedrock near the stream and in the channel. All alders killed by fire, but streamside maples with basal sprouts to 10+ ft high in 2023.

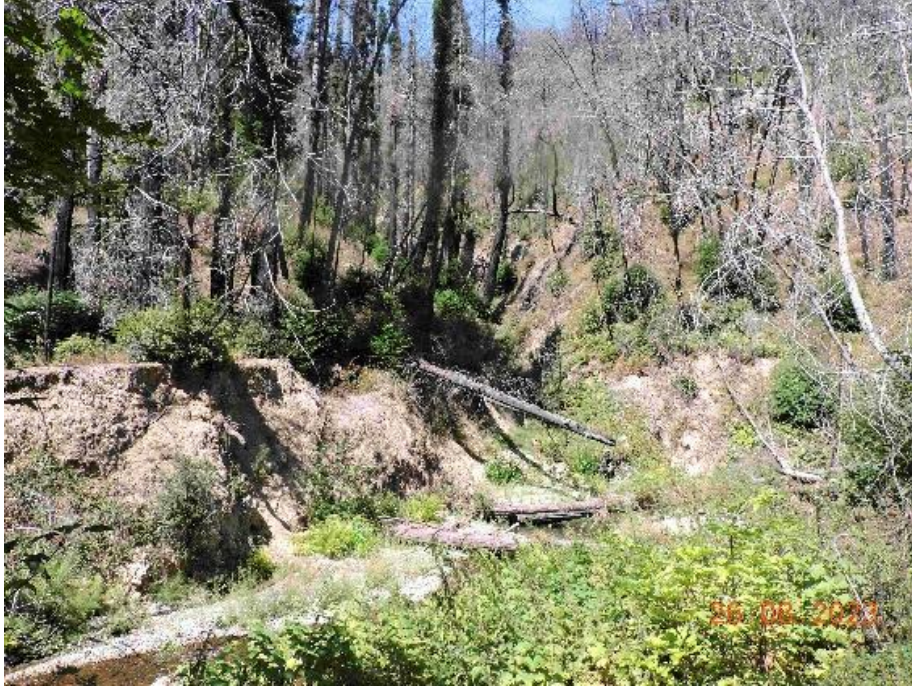
Photo 78. West Fork, mile 3.6-. Looking across to west slope. Eroding gully with remnants of sediment and log delta spilling into stream. Much of the wood from 2022 was washed away in 2023. Terrace to the left of gully is likely a remnant of an old debris flow.

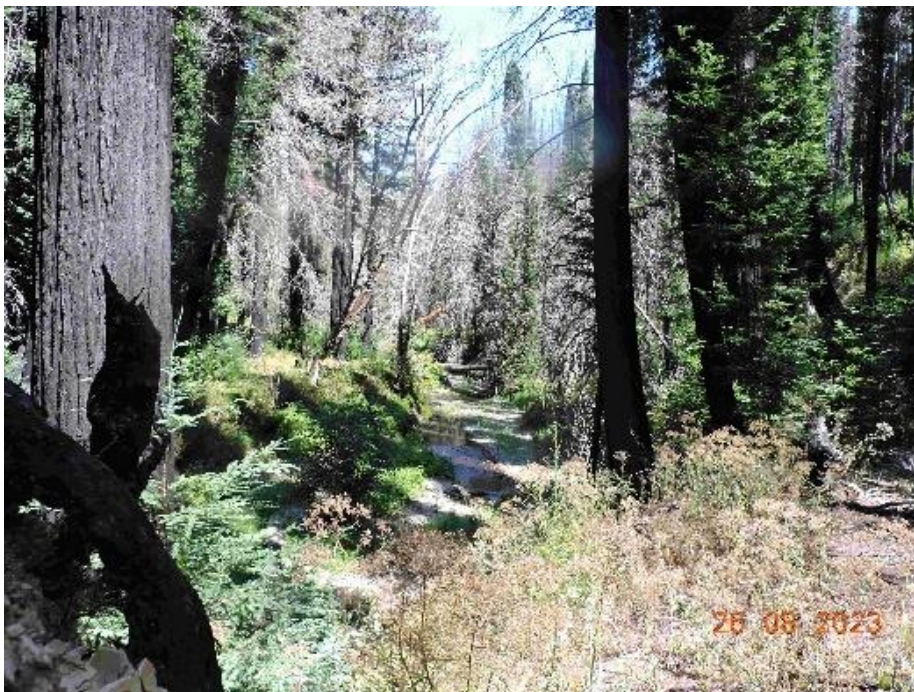
Photo 81. West Fork, mile 3.6+, looking upstream. Terrace trees mostly intact, but severely aggraded stream channel.

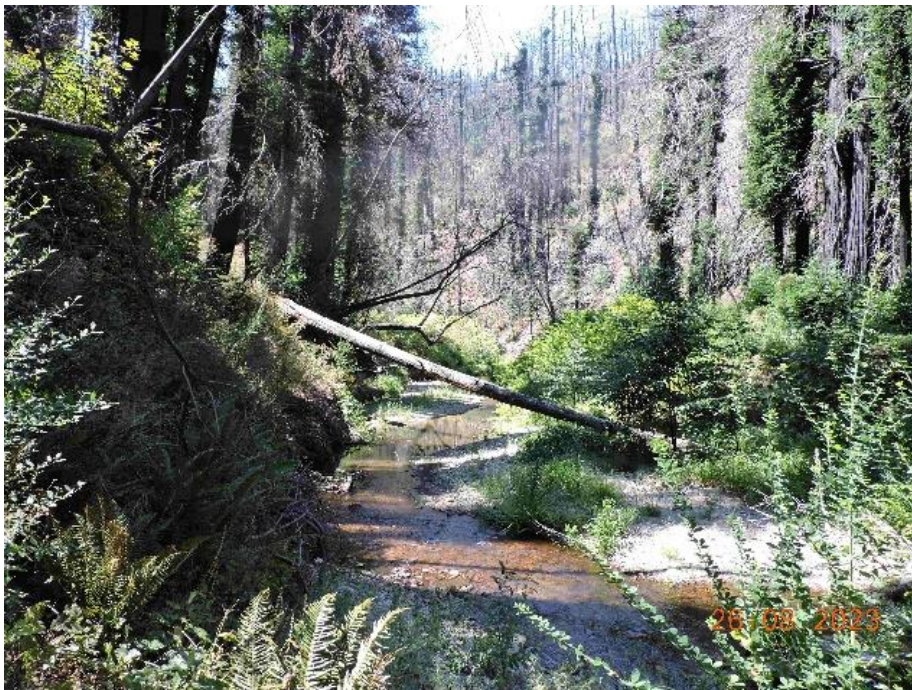
Photo 83. West Fork, mile 3.6++, looking downstream. Uppermost fish sampling pool was long (130 ft) and 3+ ft deep through 2021. In winters of 2021-2022 and 2022-2023 it was completely filled with fines and gravels, and channel wood was lost.

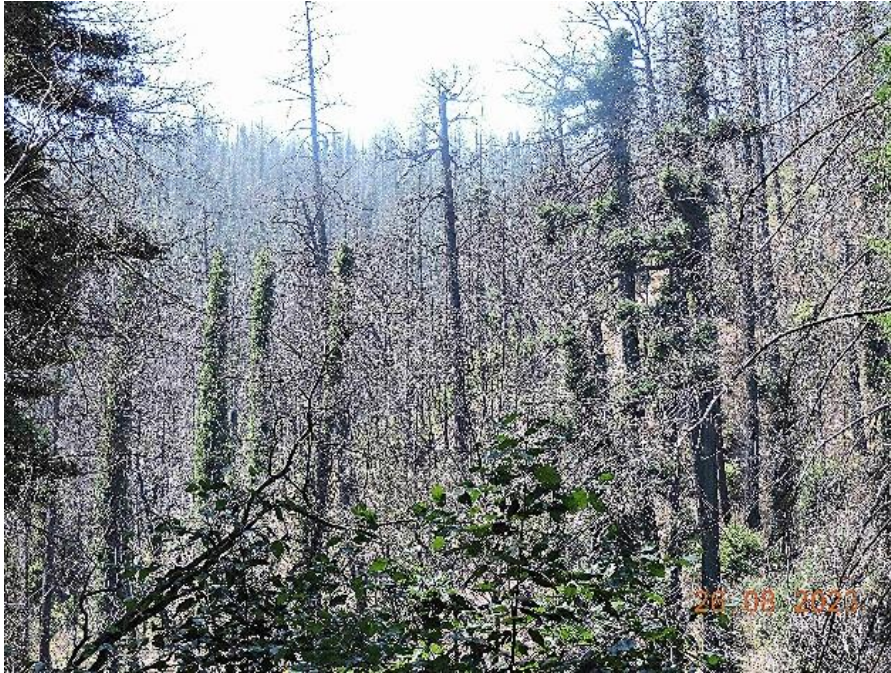
Photo 84. West Fork, mile 3.6++, looking downstream. Telephoto shot of the severely damaged west slope from the same photo location as photo 83.

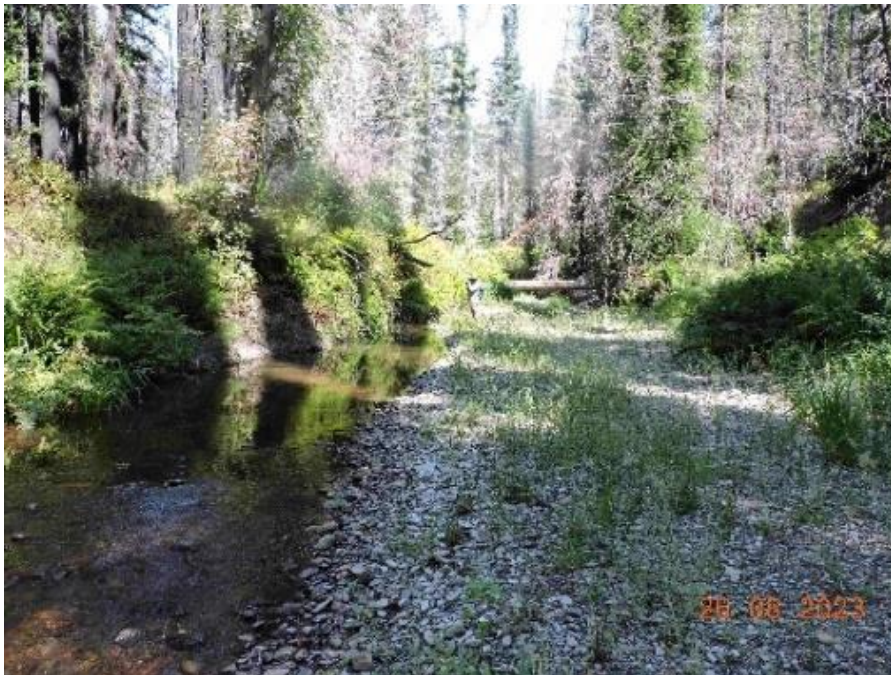
Photo 85. West Fork, mile 3.6++, looking upstream. This large pool immediately upstream of the pool in photo 83 was previously too deep to electrofish. In 2022 it was 95% filled with fines and gravels, except for a small scour pocket at the upstream end. In 2023, even the pocket was filled. A new, large, fallen Douglas fir spans the upstream portion in 2023.

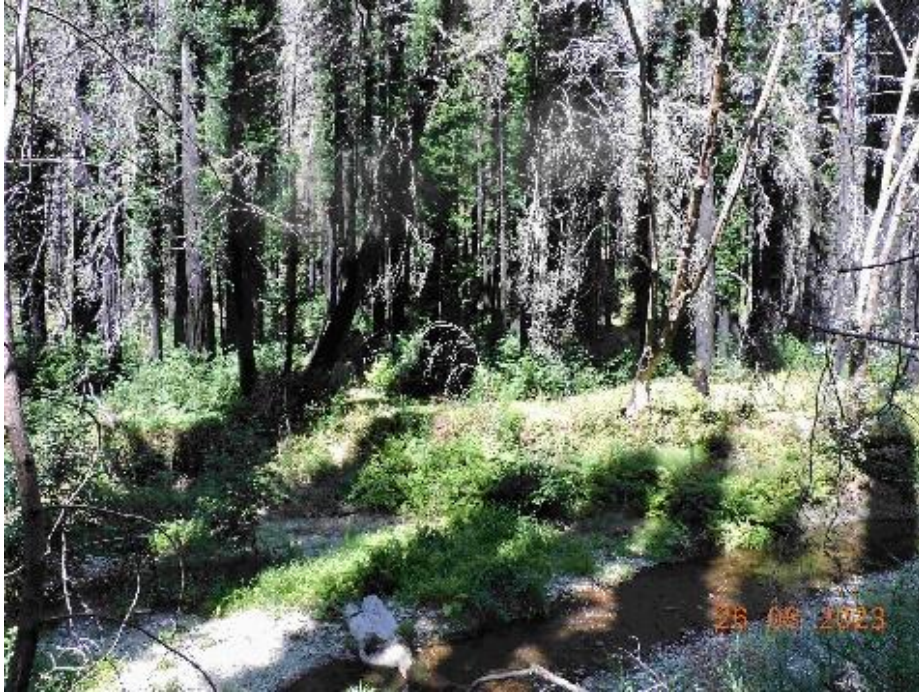
Photo 86. West Fork, mile 3.6++, looking across the channel to the right bank terrace. Large trees are recovering on the terrace, but the forest is backed by a steep, eroding, west slope with few live trees.

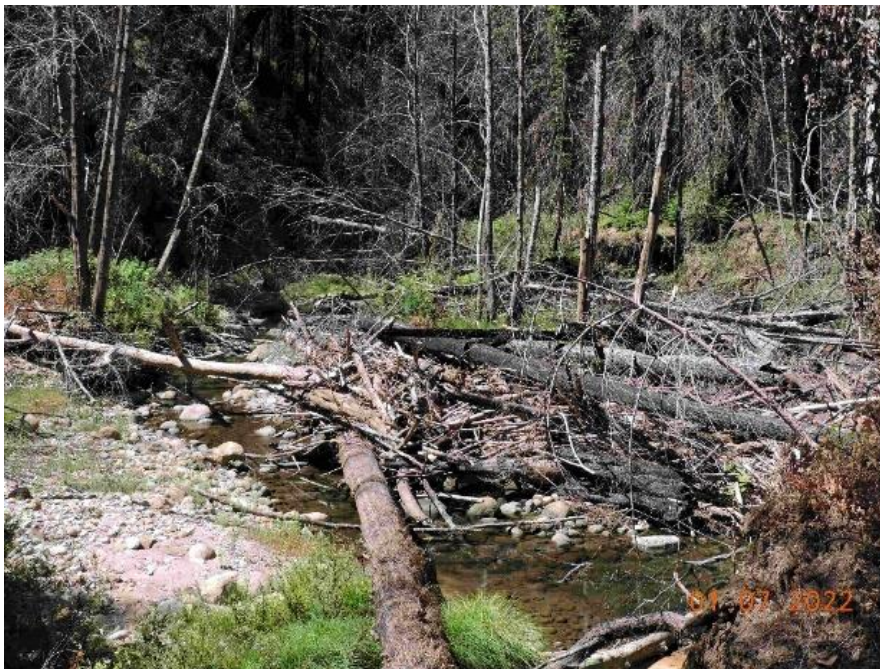
Photo 92. East Fork, mile 0.1+, looking downstream. July 2022 photo of the same area shown in photo 91. Alders and redwoods burned and/or fallen from the eroded bank in the bend had forced channel to the left and away from the 1998 storm pools and large downed redwood near right bank.

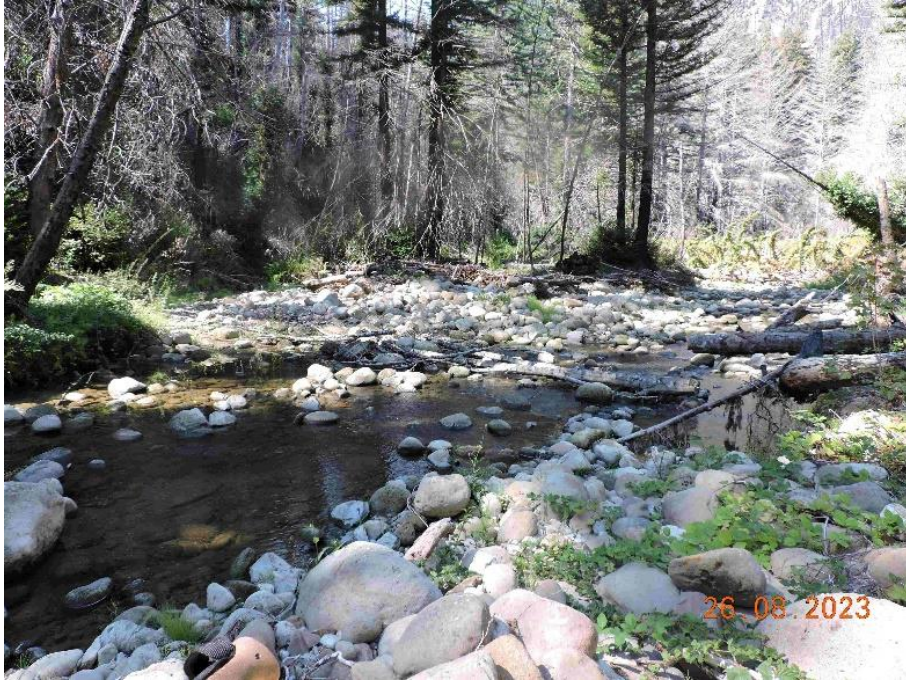
Photo 93. East Fork, mile 0.1+, looking downstream to the big bend shown in photos 90-92. A secondary left bank flood channel directly entered the pool in photo 89 and cleared the material deposited in 2022.

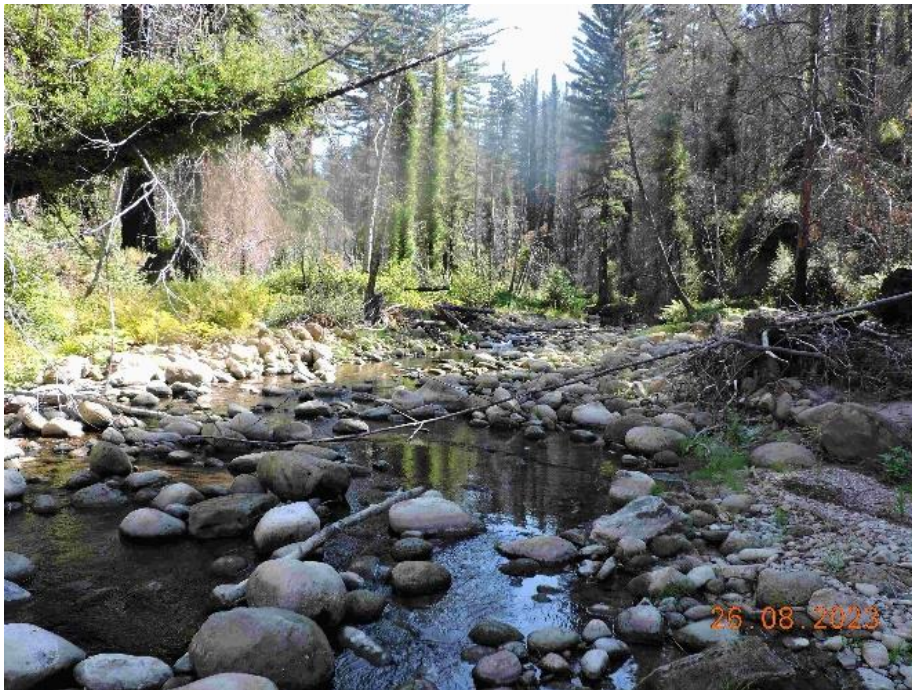
Photo 94. East Fork, mile 0.15, looking upstream. Alders were killed by fire and removed by high flows in 2022. Terrace and lower slope redwoods recovering with trunk and branch epicormic sprouts.

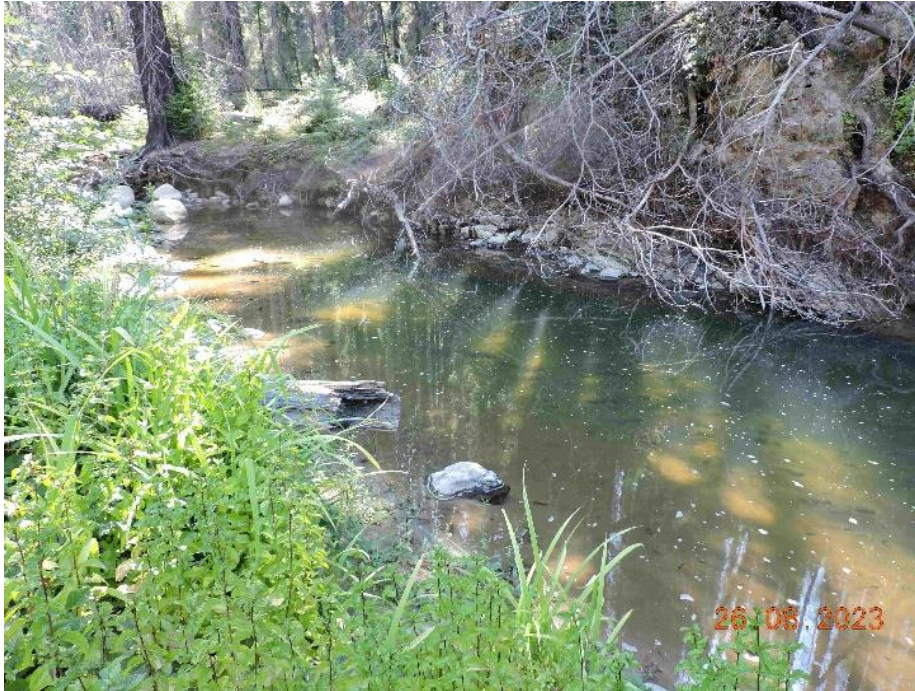
Photo 95. East Fork, mile 0.2, looking upstream. This persistent, deep pool (3+ ft) had only some filling with fine sediment in 2022 and 2023.
