# DISTRIBUTION AND ABUNDANCE OF JUVENILE COHO AND STEELHEAD IN GAZOS, WADDELL AND SCOTT CREEKS IN 2007-2022

Jerry J. Smith, frogs\_and\_fish@yahoo.com  
Department of Biological Sciences (Emeritus)  
San Jose State University, San Jose, CA 95192  
30 November 2022

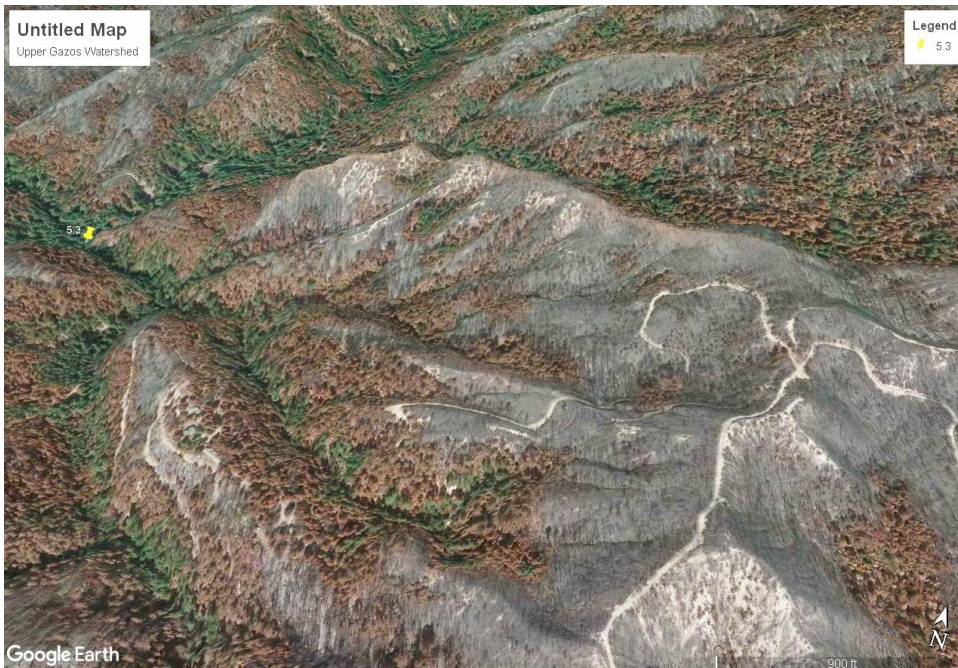
Figure 3. The intensively burned portion of the Gazos Creek watershed upstream of mile 5.5 (upstream of anadromy). Even standing burned trees are scarce in half of the upper watershed.

**The burns in the upper watershed (upstream of anadromy) and most of the upper slopes in Gazos were severe (Figures 2 and 3). The fire did not impact the stream-side riparian habitat or lower slopes downstream of mile 2.1 (near the Cloverdale Road junction) (Smith 2020). Farther upstream, the fire burned to or near the stream, but loss of streamside trees and canopy was relatively light (Smith 2021b and 2022a). However, Old Woman's Creek, which enters from the south at about mile 2.0 suffered a more severe burn. The mild winter in 2020-2021 did not produce debris flows or extensive erosion, but fine sediment was added to the stream bed (Smith 2021b). The large storms in October and December 2021 brought the damage the watershed was spared in winter 2020-2021. Extensive upstream and upslope erosion resulted in fines and gravel filling or eliminating most pools on Gazos Creek (Smith 2022a). Downstream of the direct fire impacts to Gazos Creek, sediment from Old Woman's Creek mostly filled the pools in the lower 2.0 miles of the stream.**

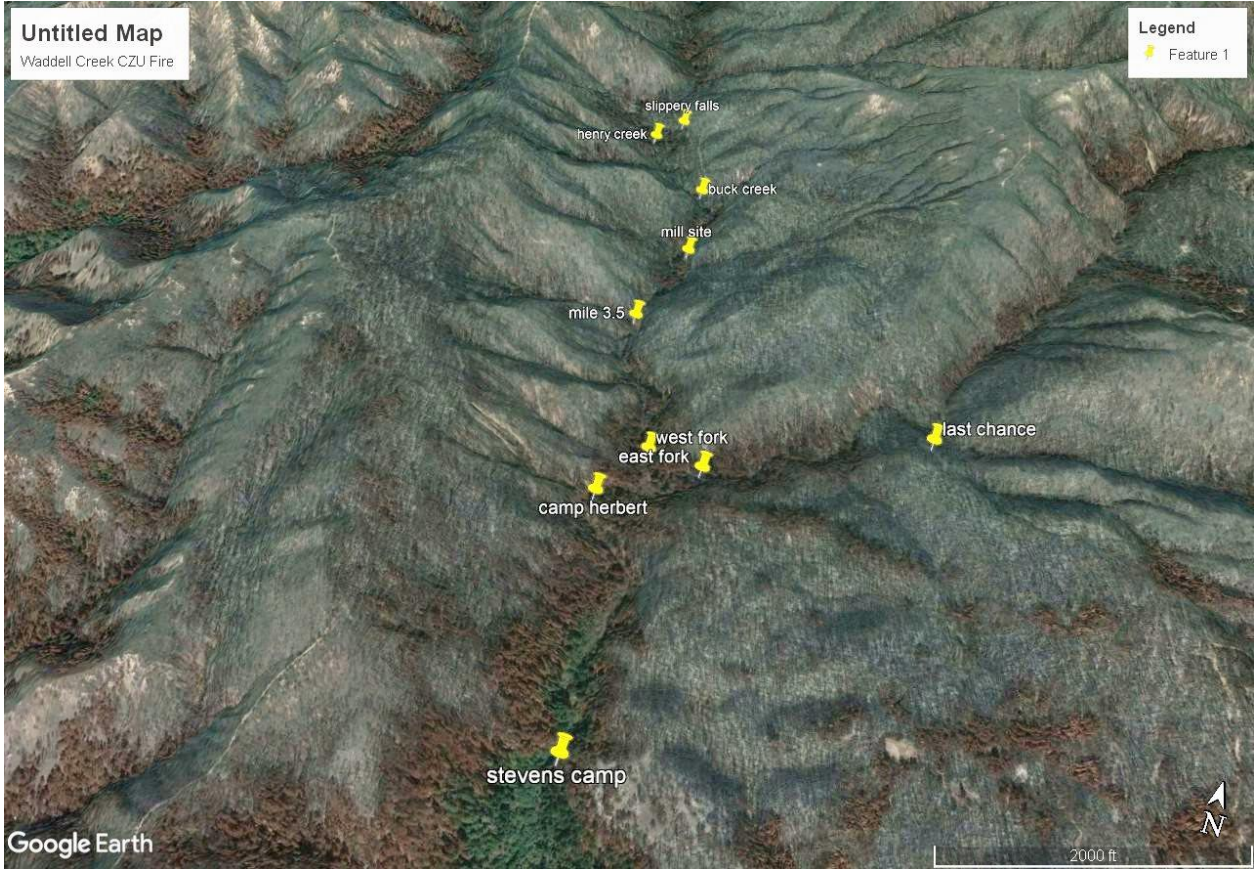
Figure 4. Google Earth aerial photo of Waddell Creek watershed from downstream of Stevens Camp (mile 2.55) to the upper watershed of the East and West forks (taken in fall 2020 after the CZU Fire). The green streamside is intact riparian and lower upslope forest. Orange is medium burned forest extending upstream to mile 3.6+ (Mill Site). Remainder of the watershed in gray is severely burned upland with standing or downed burned trees only. Yellow icons are historical fish sampling sites used since 1992.

burning, and the perennial pond to the southeast of the lagoon (the “Turtle Pond” near the Nature Center) had its perimeter trees and shrubs burned, and the emergent tules and the floating tule mat were partially burned. Upstream, from mile 1 to about mile 2.4, there was a patchy light to moderate burn on the lower slopes, occasionally reaching the road. There was a moderate to severe burn towards the ridge tops. However, the fires from northwest and southeast did not penetrate the relatively wide riparian corridor; fire impacts to the stream in this reach would come in 2022 from the more severe burn upstream and upslope of the left bank tributaries in the reach. At mile 2.5 (Stevens Camp) through mile 2.8 (Figure 4), burned and fallen trees were across the trail on the bank above the stream, with some trees reaching the channel. Upslope to the southeast the burn increased in severity, with all trees (mostly Douglas firs and tanbark oaks) on the uppermost slopes severely burned; tanoaks base sprouted, but most Douglas firs died. On the opposite slope the fire was mostly a light burn above the stream, but the upper slopes were moderately to severely burned. From mile 2.85 -3.1 (to the confluence of the East and West forks) the fires on both slopes reached, with light to moderate burn, to the edge of the stream; the redwoods along the stream were burned, but almost all survived (Smith 2020 and Figure 4). The West Fork to mile 3.6 was moderately burned on both banks, with severe burn farther up the slopes on both sides of the stream (Smith 2020 and Figure 4). The substantial log jam at mile 3.4, formed by fallen redwoods in 1998, has been an intermittent fish barrier in the past. It was substantially burned and is presently open to fish passage. Conditions substantially worsen even farther upstream (Figure 6), with nearly bare ash-covered slopes and a burned streamside. Similar moderate to severe burn conditions were present in the East Fork watershed (Figure 4).
