Waddell Creek CZU Post-fire Surveys 2020-2023

Jerry J. Smith, frogs_and_fish@yahoo.com

10 September 2023

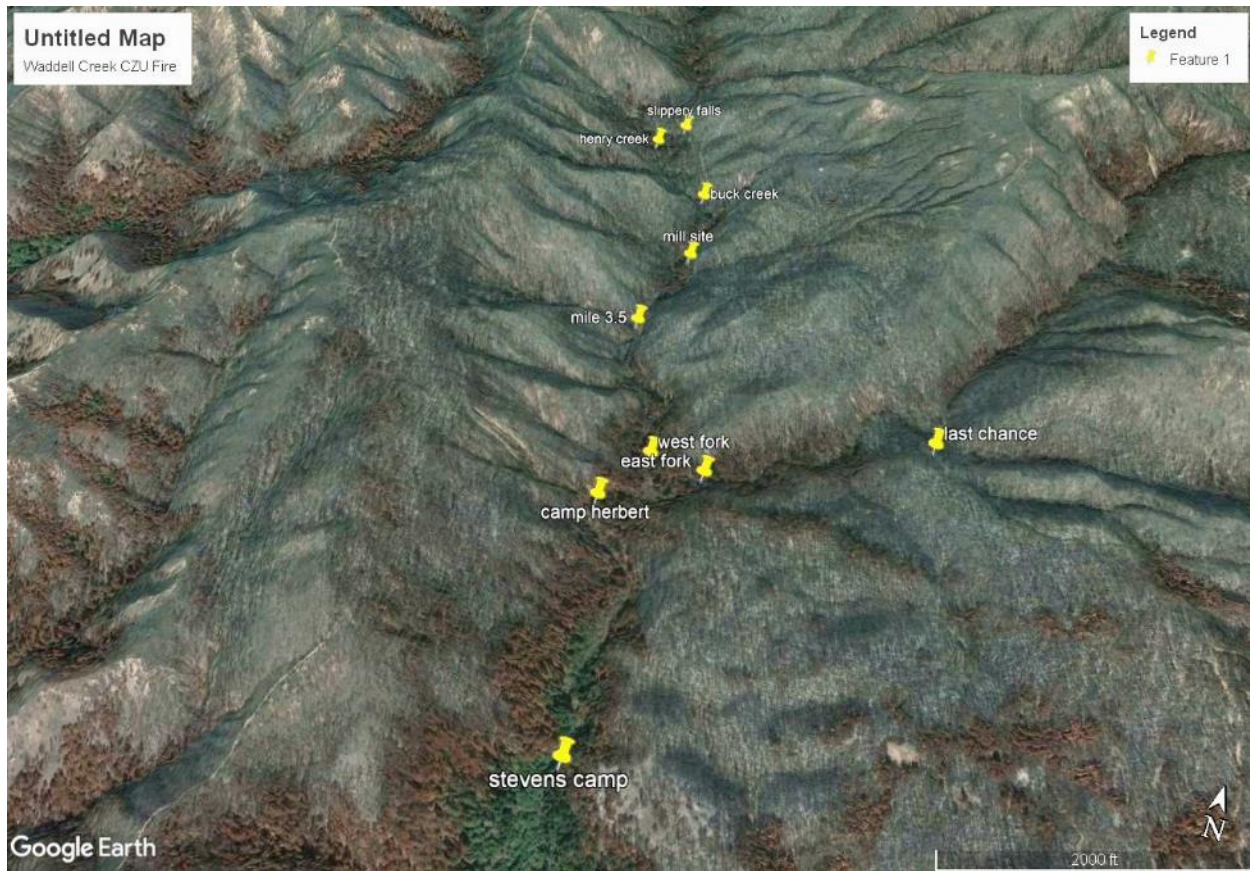
Figure 1. Google Earth aerial photo of Waddell Creek watershed from downstream of Stevens Camp (mile 2.55) to the upper watershed of the East and West forks (taken in fall 2020 after the CZU Fire). The green streamside is intact riparian and lower upslope forest. Orange is medium burned forest extending upstream to mile 3.6+ (Mill Site). Remainder of the watershed in gray is severely burned upland with mostly standing or downed burned trees only. Yellow icons are historical fish sampling sites used since 1992.

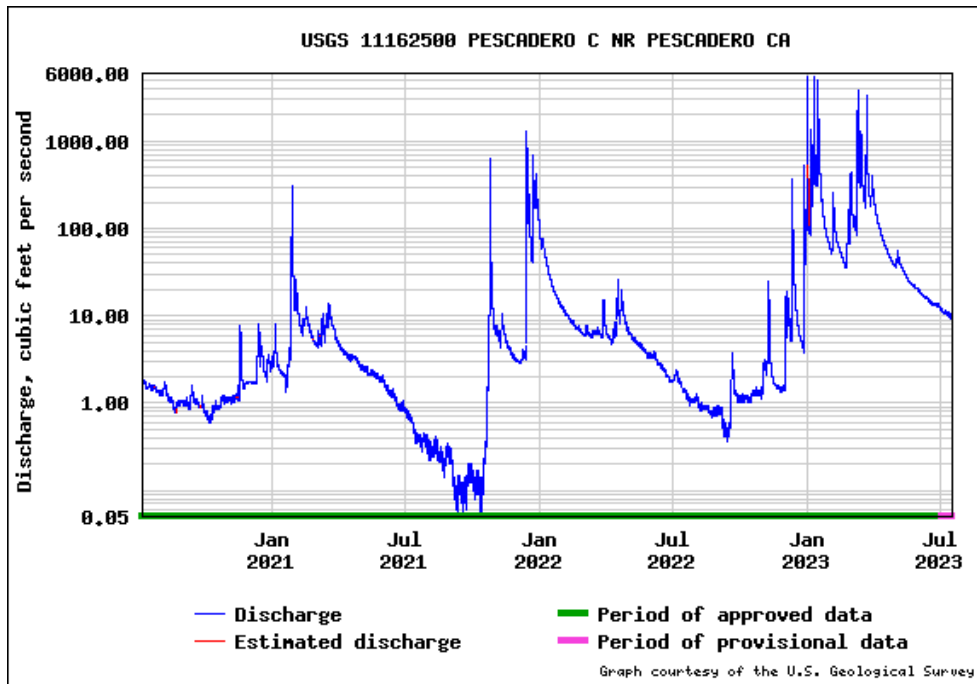
Figure 2. Logarithmic graph of runoff in Pescadero Creek in October 2020 – July 2023, as a pattern surrogate for ungaged Waddell Creek, showing a single modest rain/runoff event in January 2021 and much more intensive rain/runoff in October and December 2021, with drought by January 2022. From December 2022 through March 2023 repeatedly very intense storms produced more sediment inputs and substantial above-bank floods in Waddell Creek.

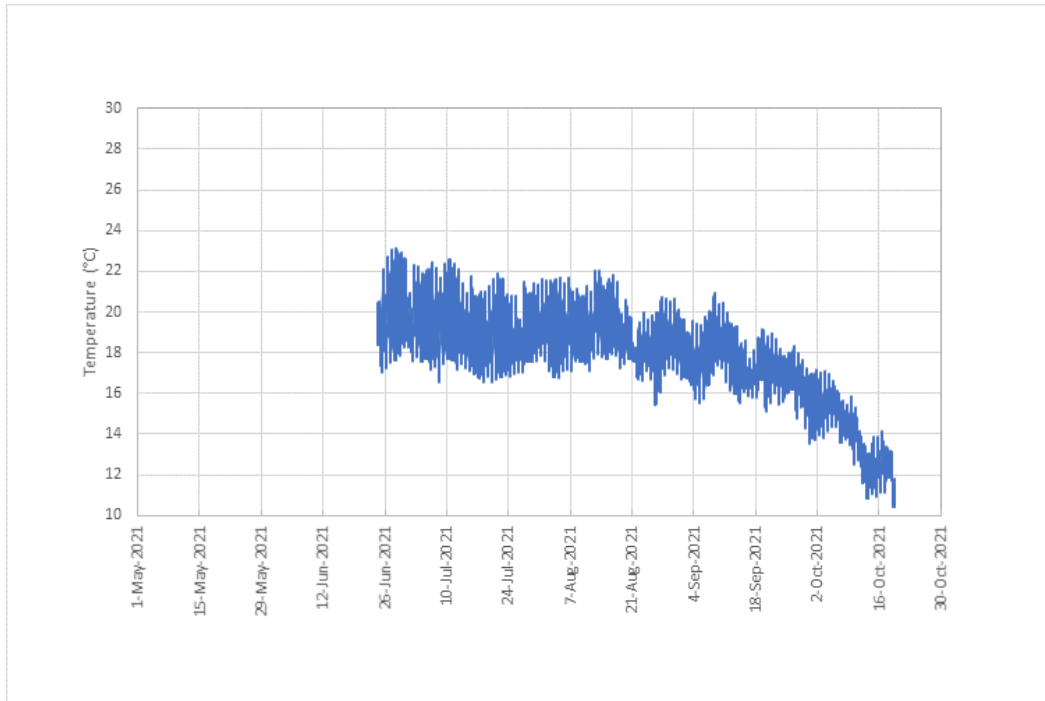
The extensive loss of canopy between mile 2.75 and 3.6+ resulted in increased algal growth and warmer stream conditions, with mean water temperature in late June–through late July 18-19°C, with daily ranges around 4°C (Figures 4-6 and Smith 2021b). Farther downstream where the canopy was not lost, at Twin Redwoods Camp, mean temperature in late June through July was 17-18°C, with daily range usually less than 3°C (Figure 7). 2022 results were similar. At Gazos Creek little shading was lost in the steelhead-accessible reach due to the fire, and mean water temperatures at three sites in mid-June through mid-August were 16°C, with daily ranges of 2-2.5°C. The warm water temperatures at Waddell Creek would have delayed potential fish sampling by electrofisher until at least mid-September, but salvage logging on the adjacent private property restricted access until mid-October anyway. A large October storm then eliminated potential sampling. However, juvenile steelhead (*Oncorhynchus mykiss*) were seen throughout the reaches surveyed for fire damage.

Figure 4. Water temperature in Waddell Creek at the Upper West Fork for 24 June through 19 October 2021.

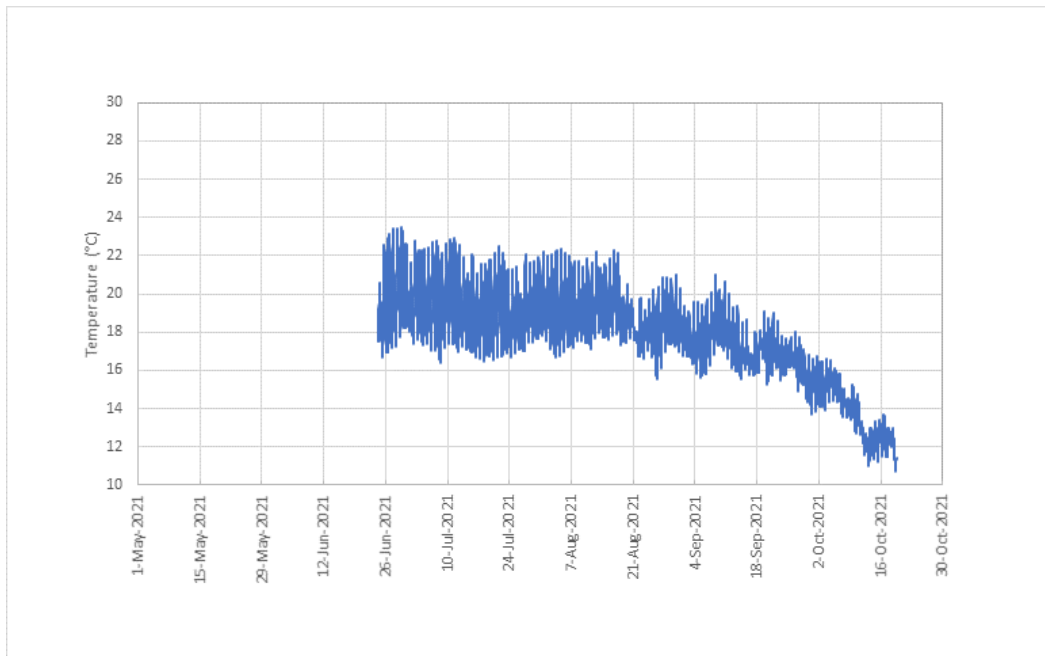
Figure 5. Water temperature in Waddell Creek at the Lower East Fork for 24 June through 19 October 2021.

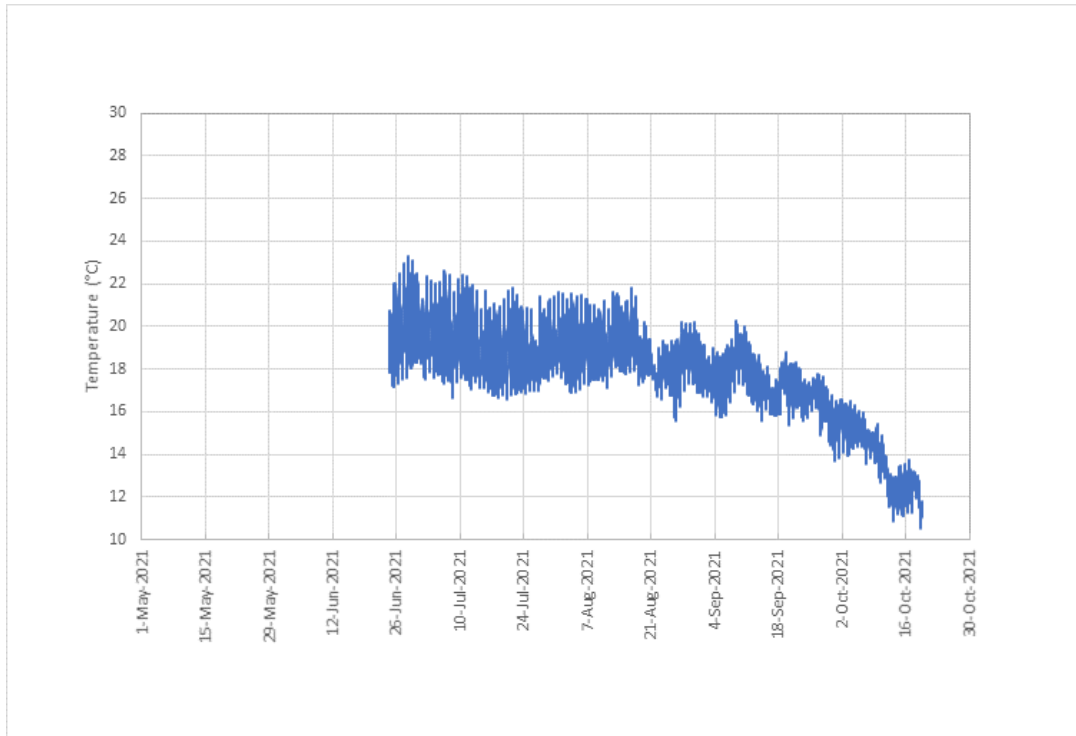
Figure 6. Water temperature in Waddell Creek at the Lower West Fork for 24 June through 19 October 2021.

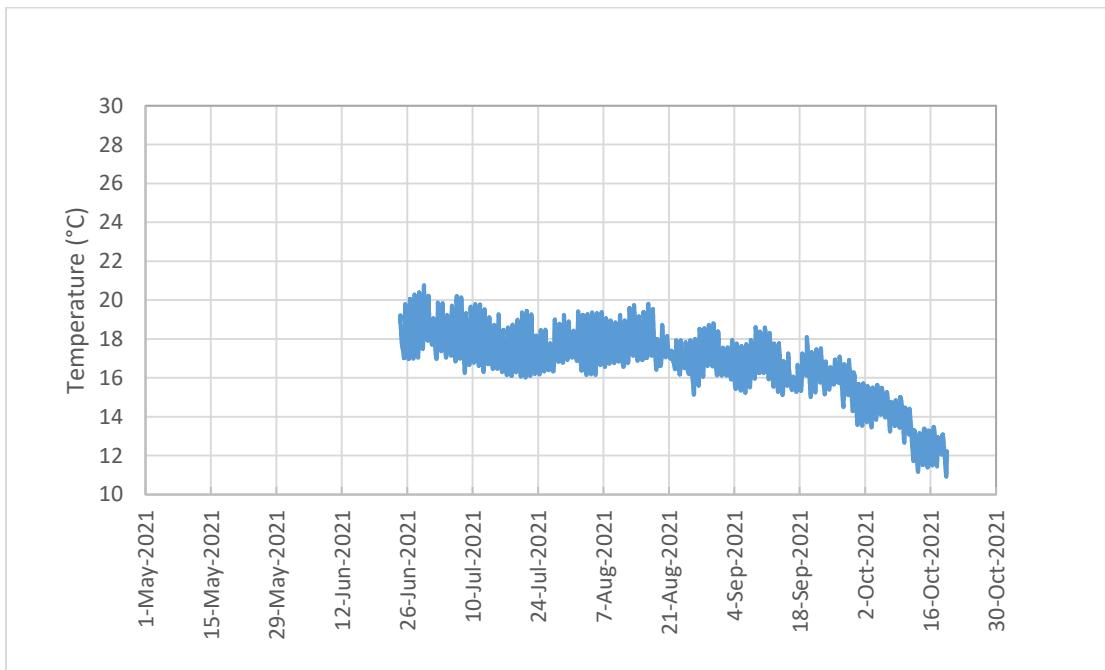
Figure 7. Water temperature in Waddell Creek at Twin Redwoods for 24 June through 19 October 2021.

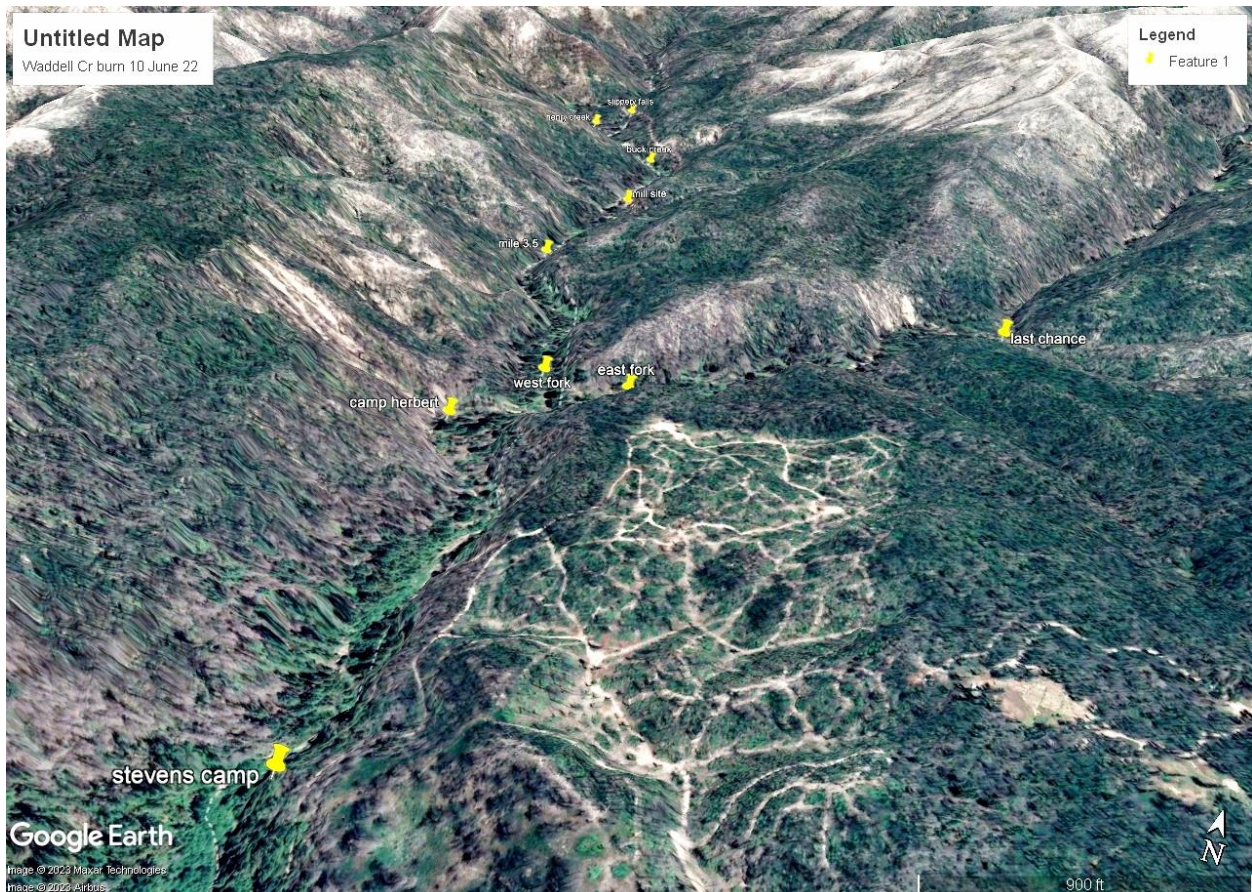
Figures 8. Google Earth aerial photo from 10 June 2022 from downstream of Stevens Camp (mile 2.55) upstream to the upper watershed of the East and West forks of Waddell Creek. The large debris scarp (ridge top to stream) on the west slope above Camp Herbert at the confluence of the forks deposited sediment in the stream more than half way (Mile 2.7) down to Stevens Camp in 2021. Erosion in 2022 from the west slope of the West Fork of Waddell deposited sediment, filling almost all pools between the confluence of the forks and mile 3.6+ (see also Figure 9).

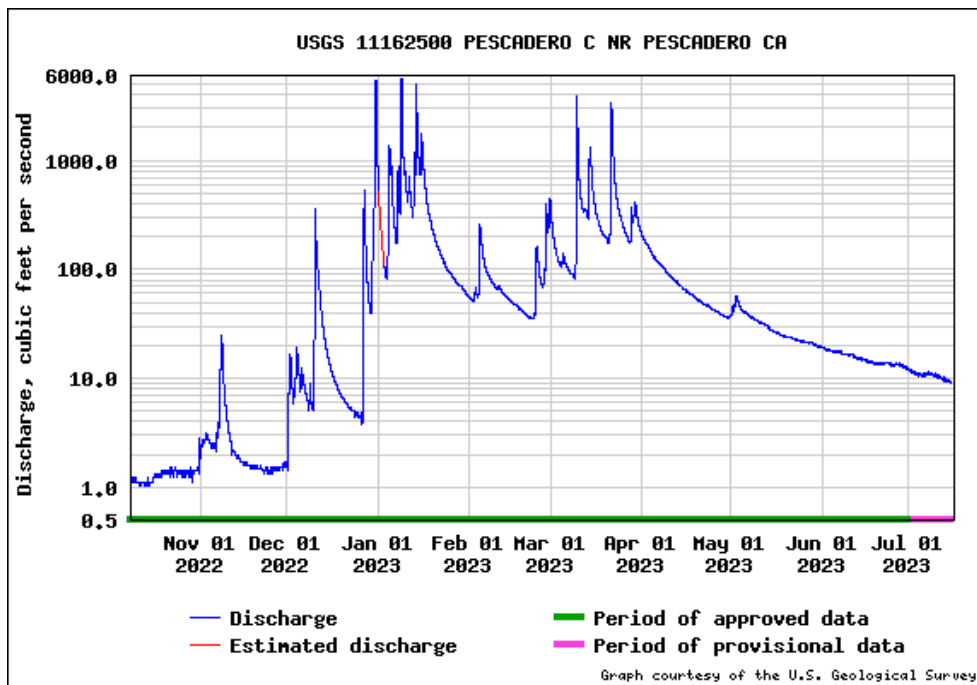
In January 2022 through March 2023 very heavy rains produced substantial flood flows (Figures 2 and 11), similar to those in the severe El Nino year of 1997-98, which caused erosion of stream banks and flood plain, toppling of streamside trees, and scouring, sedimentation, and filling of pools (Smith 1998).

Figure 11. Runoff in Pescadero Creek in October 2022 through July 2023, showing the intense December-January and March periods of repeated large floods.

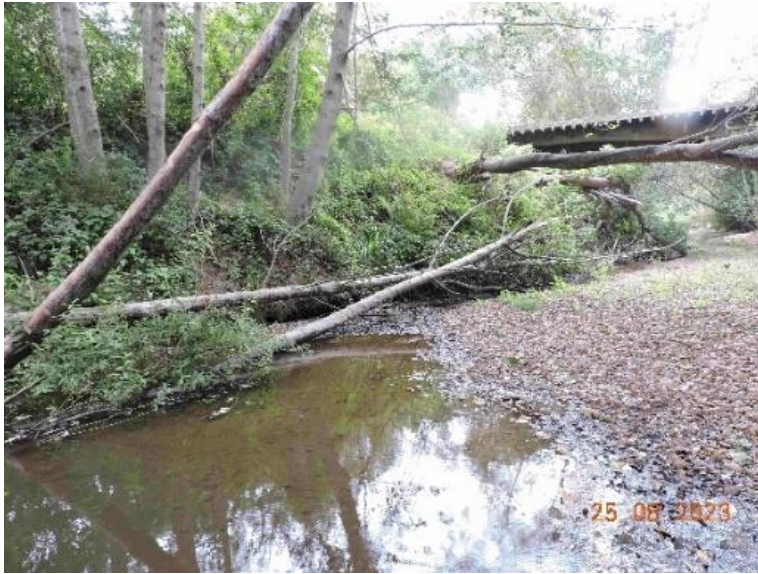
Photo 1. Mile 0.65 (from Highway 1). Looking downstream to the bridge above the lagoon. Winter 2023 flows reached to the bottom of bridge several times and flowed through the flood plain with wood to agricultural fields on the left bank. Streamside alders were toppled and the channel widened and flattened.

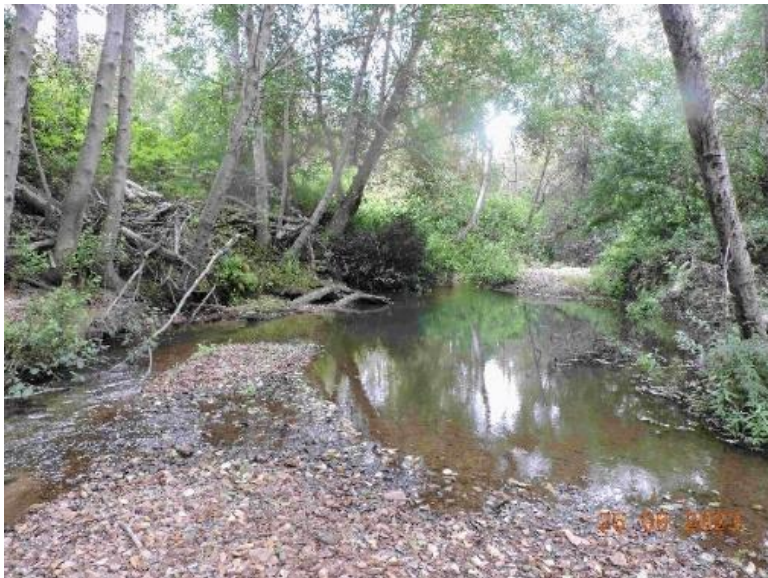
Photo 2. Mile 0.65, looking upstream. First pool upstream had been concentrated near the right bank, at a legacy log (left in photo), but the thalweg moved to the center of the channel and the sandy-bedded pool now extends bank to bank. Wood carried by the flood was caught in trees at the top (8+ ft) of the bank (left).

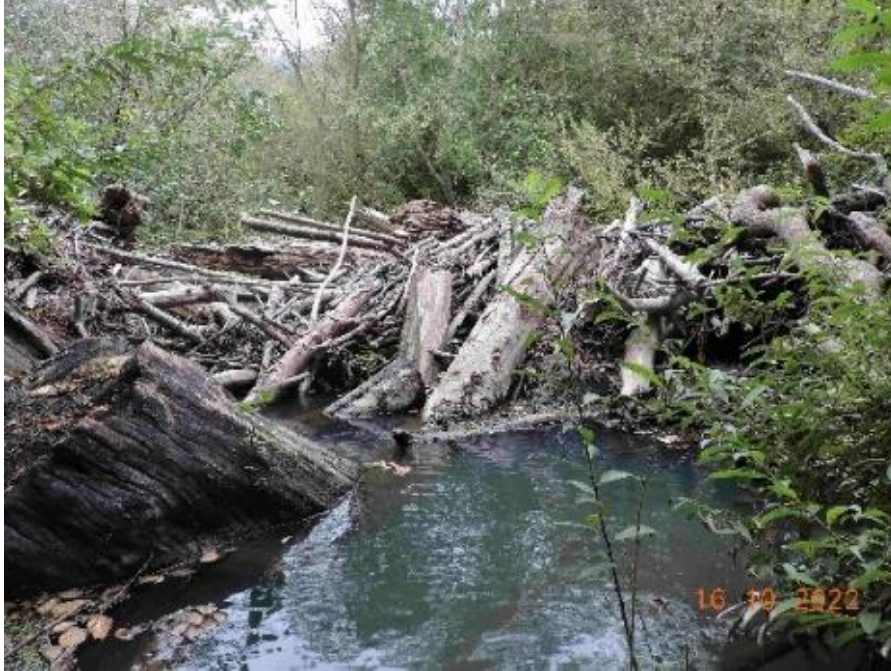
Photo 5. Mile 0.65, looking upstream. In 2022 a 10 ft high, tightly packed, bank to bank logjam was present at the upstream limit of the lagoon. It was judged to be a likely severe fish passage problem (16 October 2022 photo). December 2022 storms breached the jam along the left bank, eliminating any passage problem.

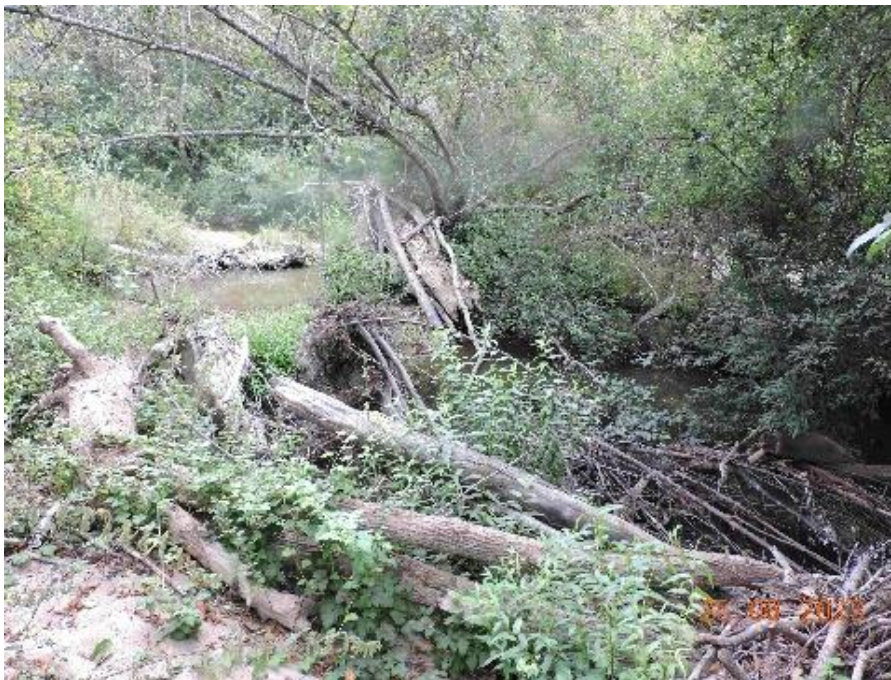
Photo 6. Mile 0.65, looking upstream. Winter storms in 2023 dismantled the jam, and most of the abundant wood of the jam was carried downstream or on to the floodplain.

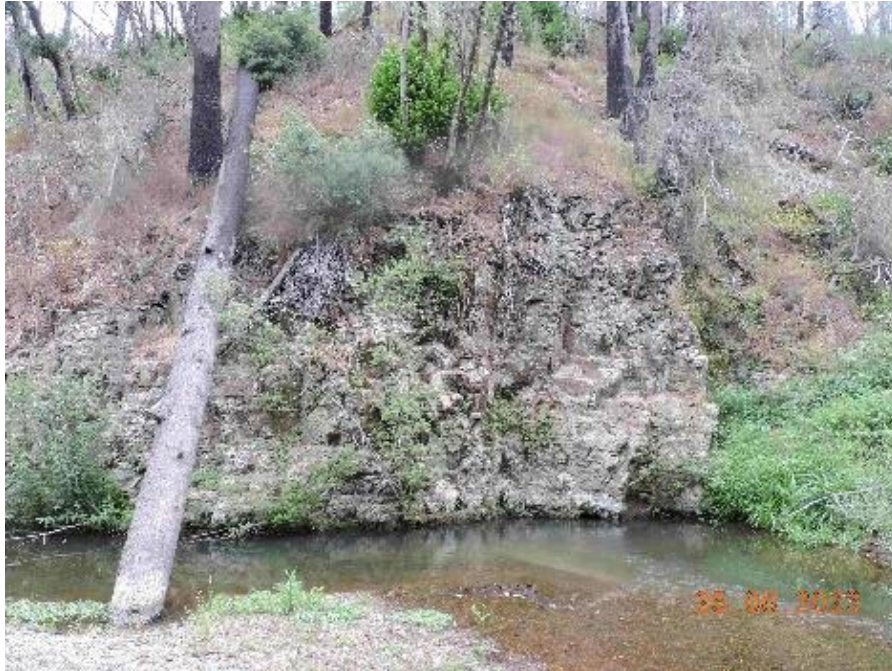
Photo 7. Mile 1.2, looking downstream. Prior to 2023, this corner pool at the cliff was more than 80 ft long and 6-10 ft deep. Sediment transported by the 2023 floods filled 80+ percent of the pool volume. Only 15 ft of the pool is now deep (4.5-5 ft).

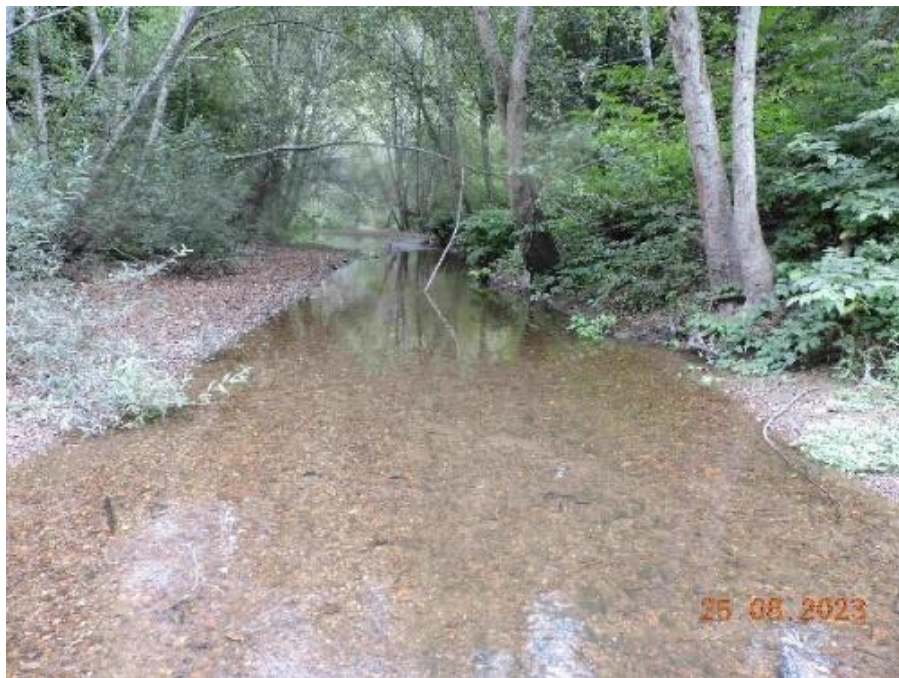
Photo 8. Mile 1.2, looking upstream from the cliff pool to the fish sampling site. The wide shallow, fine gravel and sand glide habitat lost depth and undercut banks along the left bank.

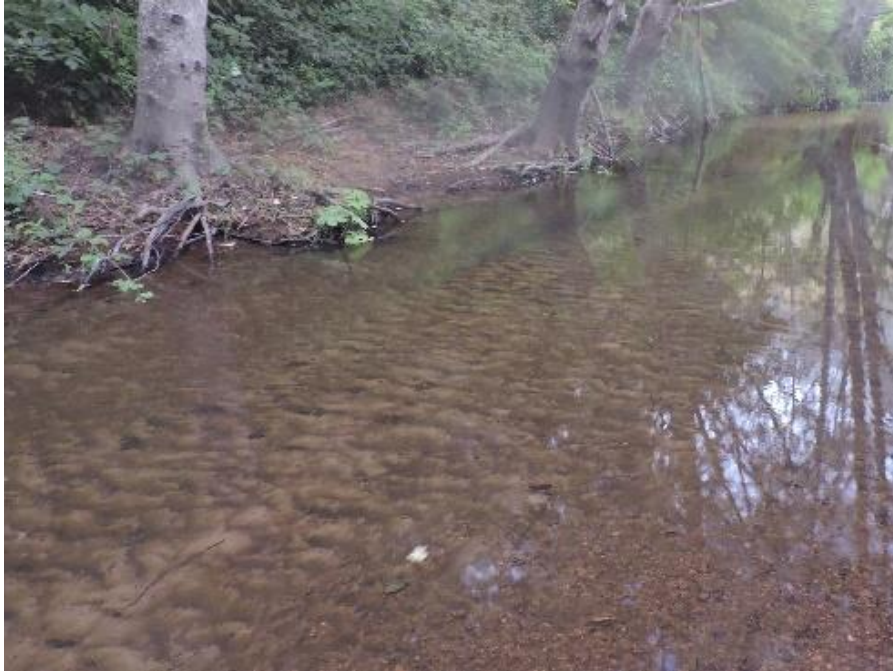
Photo 9. Mile 1.2, looking upstream. The second sampling habitat, is now a wide, shallow sandy-bedded glide. Bank scour and structure is gone.

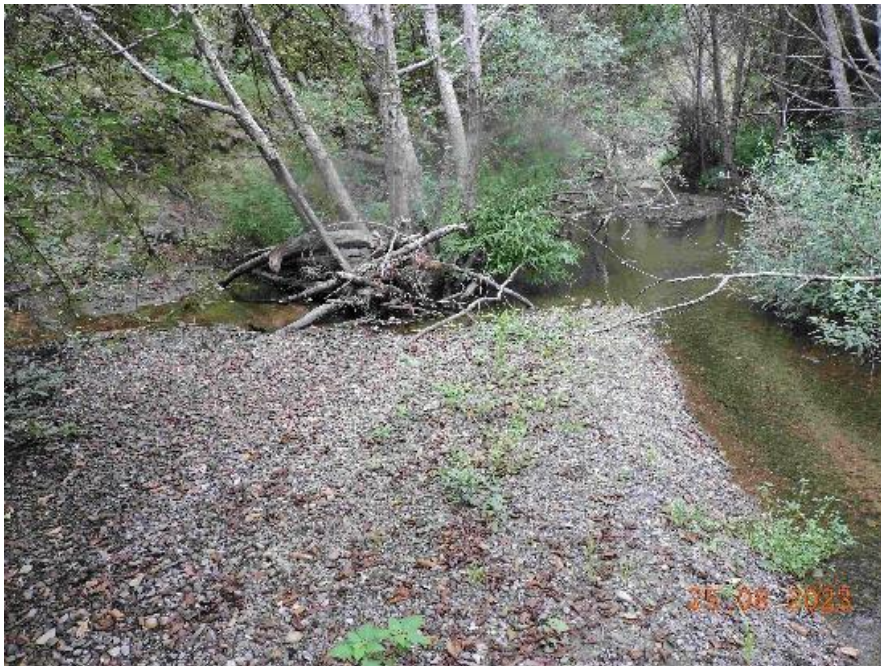
Photo 10. Mile 1.2, looking downstream. In 2002-2021 this was a deep pool with a left bank back-water alcove. The alcove was lost and the pool was half filled in 2022 and was almost completely filled in 2023.

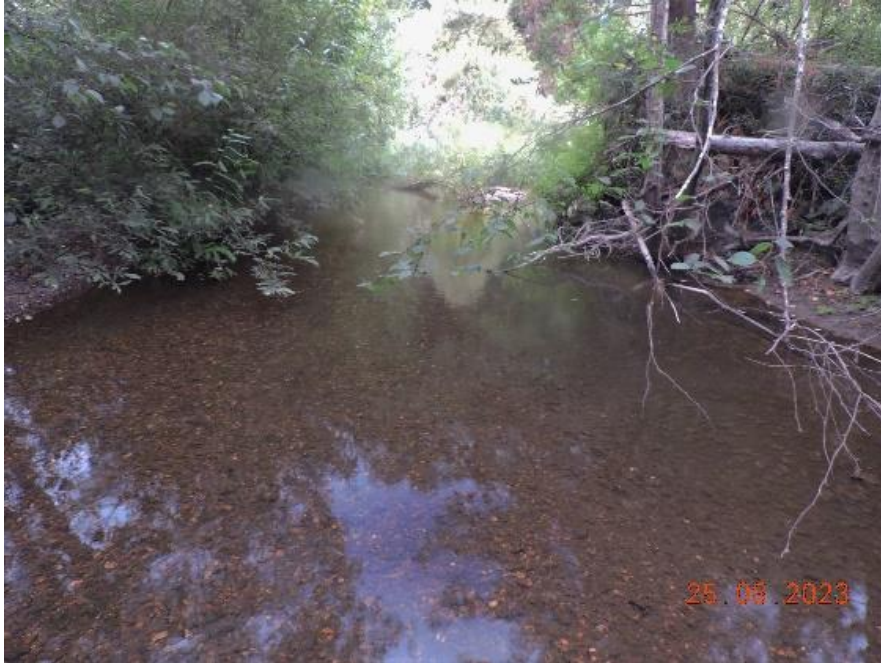
Photo 11. Mile 1.2, looking upstream. In 2021 this was a moderately deep pool (to 3 ft). In 2022 the pool was locally deep near and under a channel-spanning partial log jam. The jam was gone in 2023, and a shallow pool (< 2ft) pool remains.

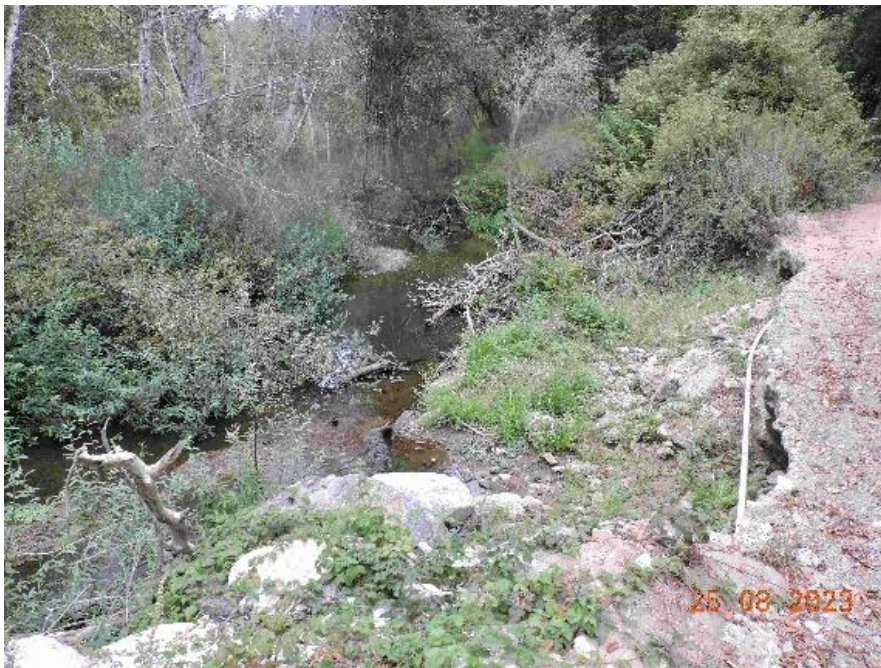
Photo 12. Mile 1.2, looking upstream from the edge of the eroded, reinforced road. Boulders to protect the road produce pool scour.

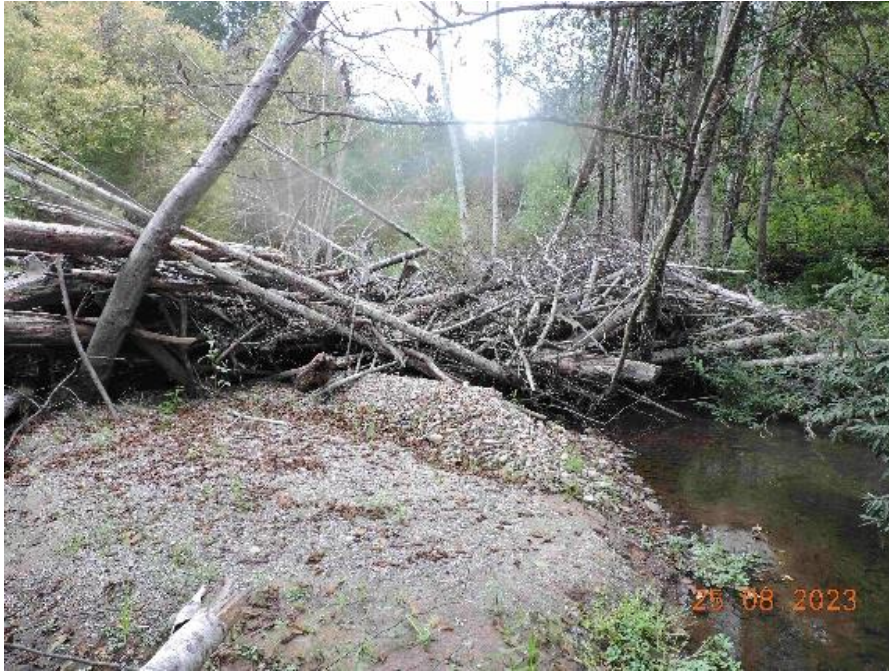
Photo 13. Mile 1.25, upstream of the sampling site, looking upstream. An 8+ ft high log jam, primarily of alders, spans almost all of the channel. At higher flows the jam could be bypassed along the right bank.

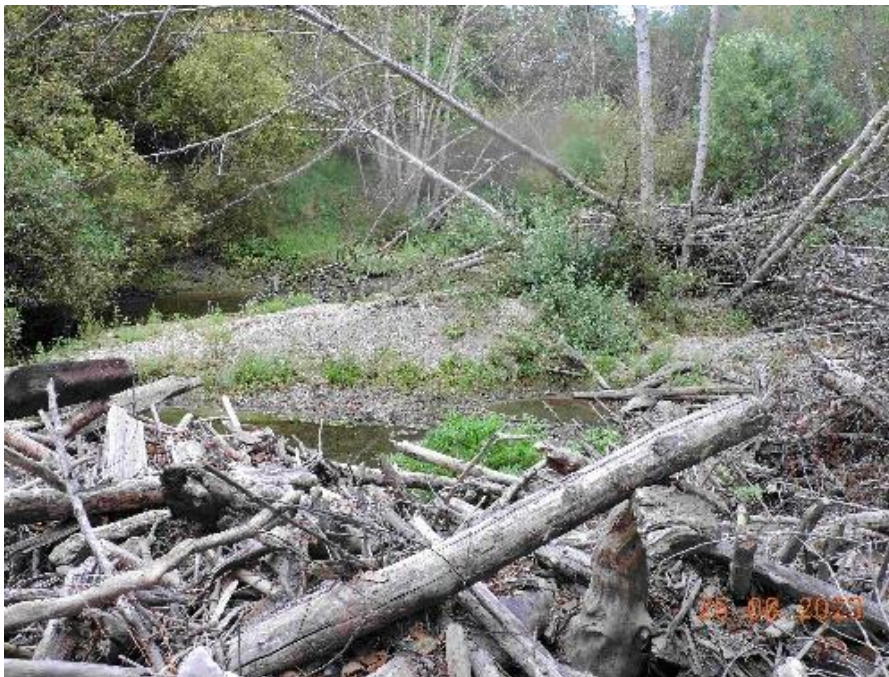
Photo 14. Mile 1.25, looking upstream from the jam in photo 13. Additional wood is trapped by mid-channel alders, now in the middle of a split channel.

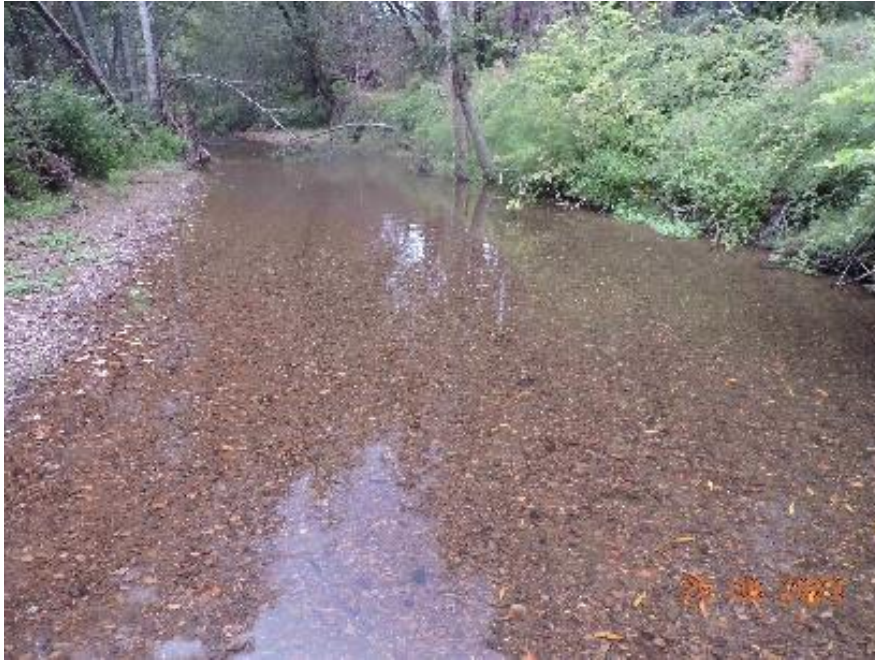
Photo 15. Mile 1.75+, looking upstream to the Twin Redwoods Camp sample site. The downstream portion of the former deep pool and glide was leveled and filled in 2022.

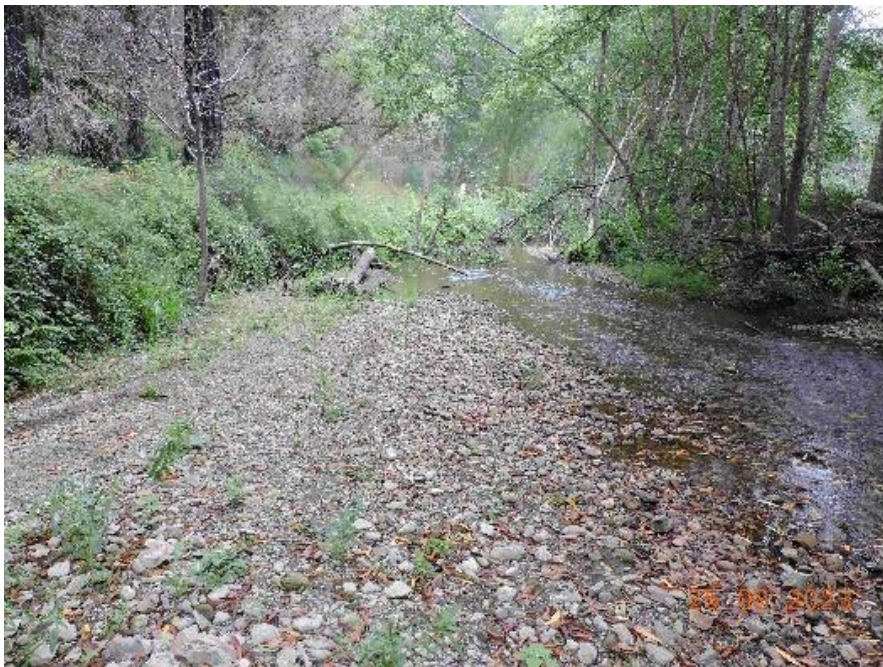
Photo 16. Mile 1.75+, former head of the first Twin Redwoods sample pool, looking downstream. The thalweg was shifted from left bank to right bank, eliminating the complex head of pool habitat. The deep remnant of the former pool, associated with large wood, was filled, leaving only a log sticking out of sediment near the left bank.

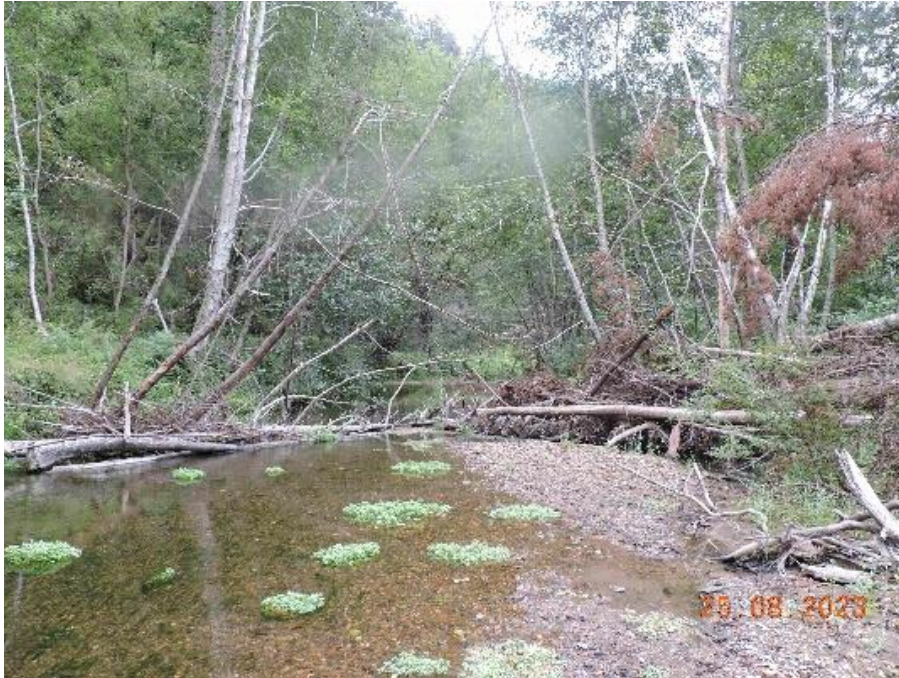
Photo 17. Mile 1.75+, looking downstream. Glide with scour and undercuts along both banks was aggraded with fines and mudstone gravels in 2022. In 2023 the channel was widened, toppling streamside alders. Very shallow except at channel-spanning fallen alders.

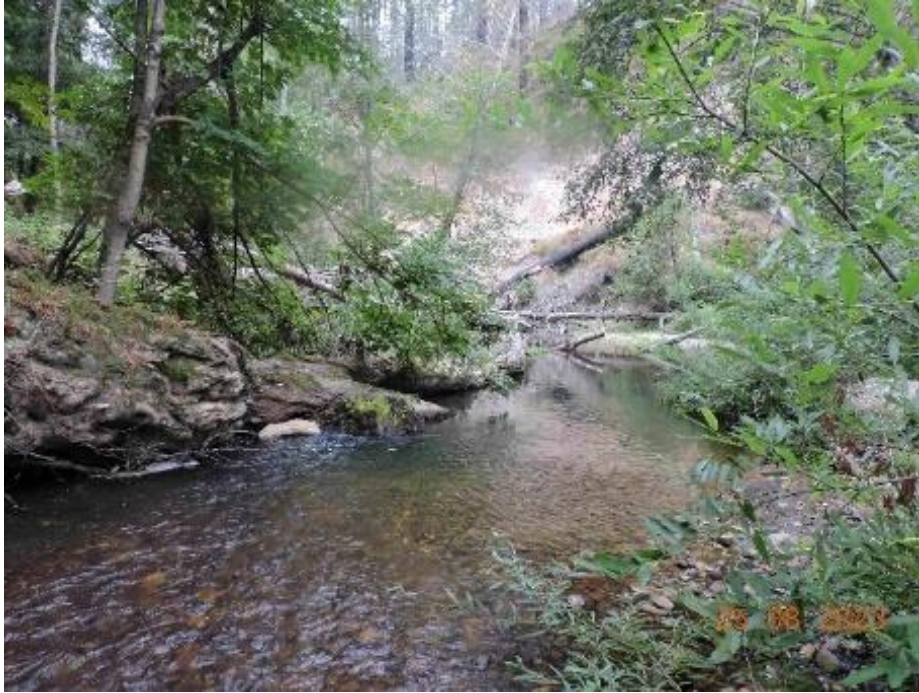
Photo 25. Mile 1.8, looking downstream at the pool in photo 24 and the bend and failed slope downstream.

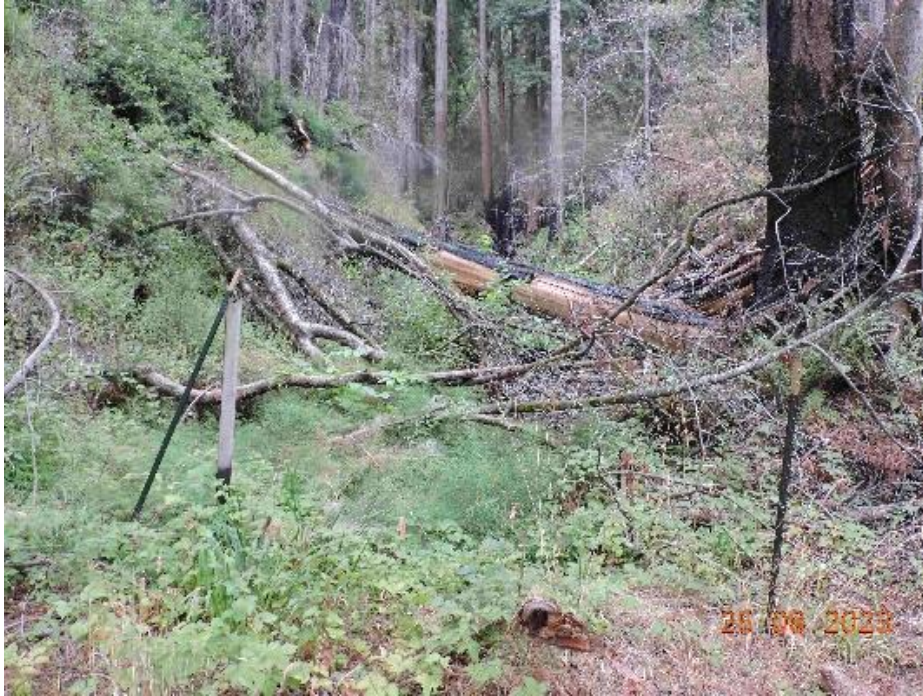
Photo 27. Mile 2.05. "Tramway Springs," a wet year perennial drainage upslope of the road.

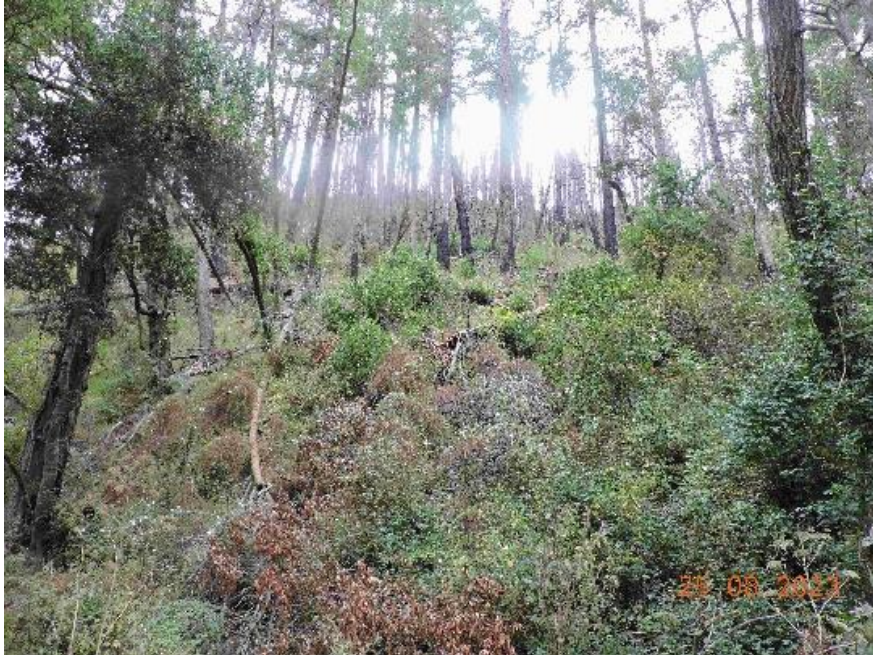
Photo 31. Mile 2.15+. The partially burned east slope above the road has fully reestablished ground cover, with trunk and basal sprouting by California bays and basal sprouting by tanbark oaks. Part of the upslope Douglas firs survived.

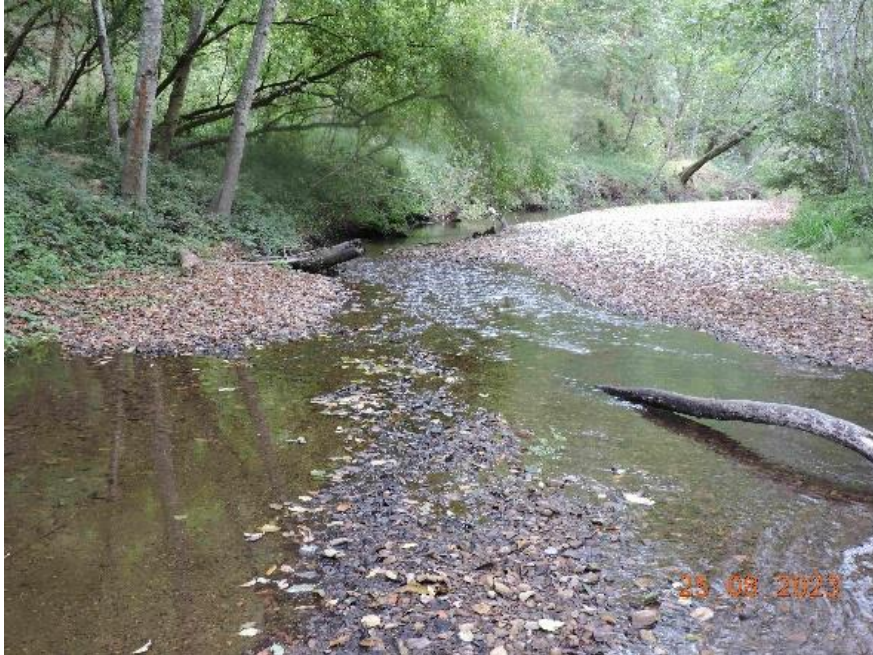
Photo 33. Mile 2.15+, looking downstream. In 2022 this was the upstream portion of the lower fish sampling pool. The pool had been mostly filled in 2022, except for a short (30 ft) section of scour around a cluster of left bank wood. In 2023 the entire pool was filled, leaving one buried log sticking out at the bottom of the left bank sand/gravel bar.

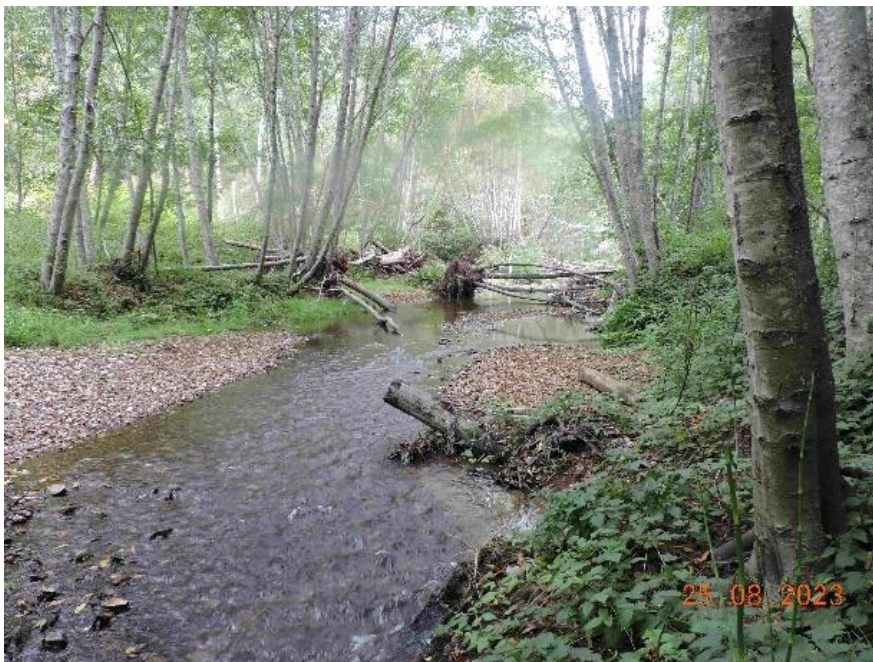
Photo 34. Mile 2.15+, looking upstream. The remnant wood in the pool in photo 33 is in the foreground. Farther upstream a fallen multi-trunked alder spans the shallow low flow channel.

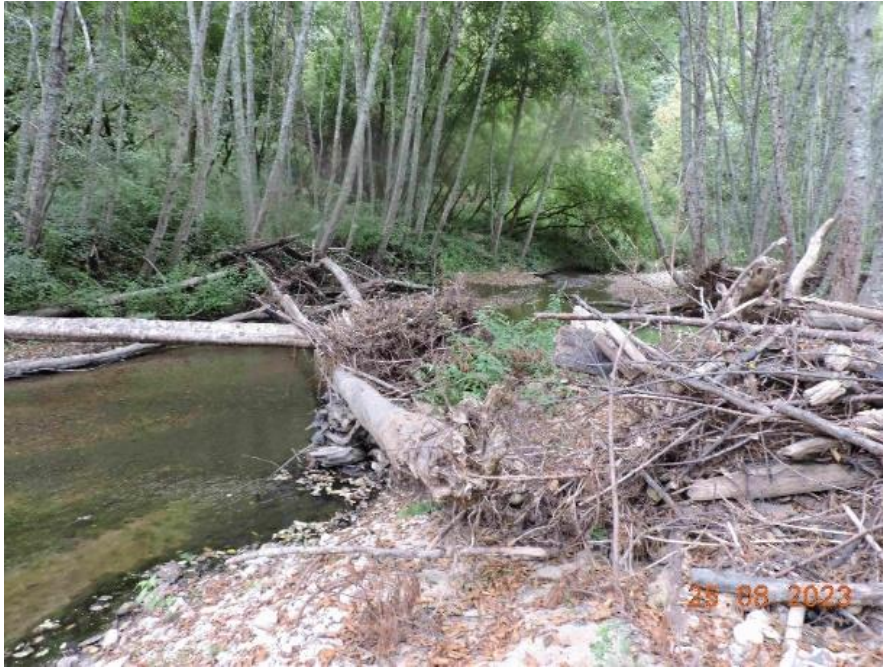
Photo 35. Mile 2.15+, looking downstream. Farther upstream from Photo 34, a wood jam on the right bank floodplain and several channel-spanning downed alders were present at the shallow channel.

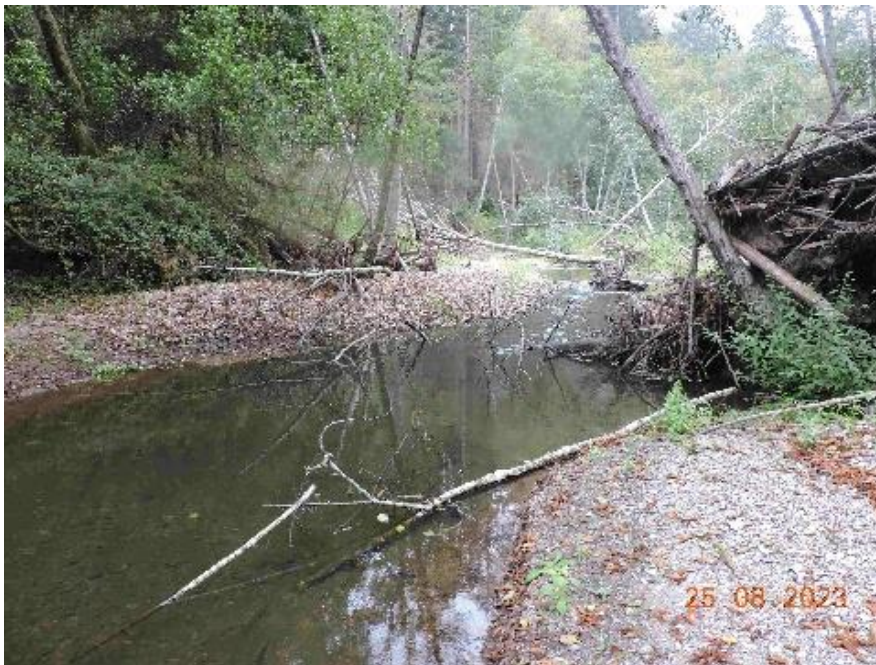
Photo 38. Mile 2.2, looking upstream. A cluster of pools around root wads and downed alders in 2021 was rearranged in 2022, and then the wood and complex pool habitat was mostly eliminated by the high stream flows in 2023.

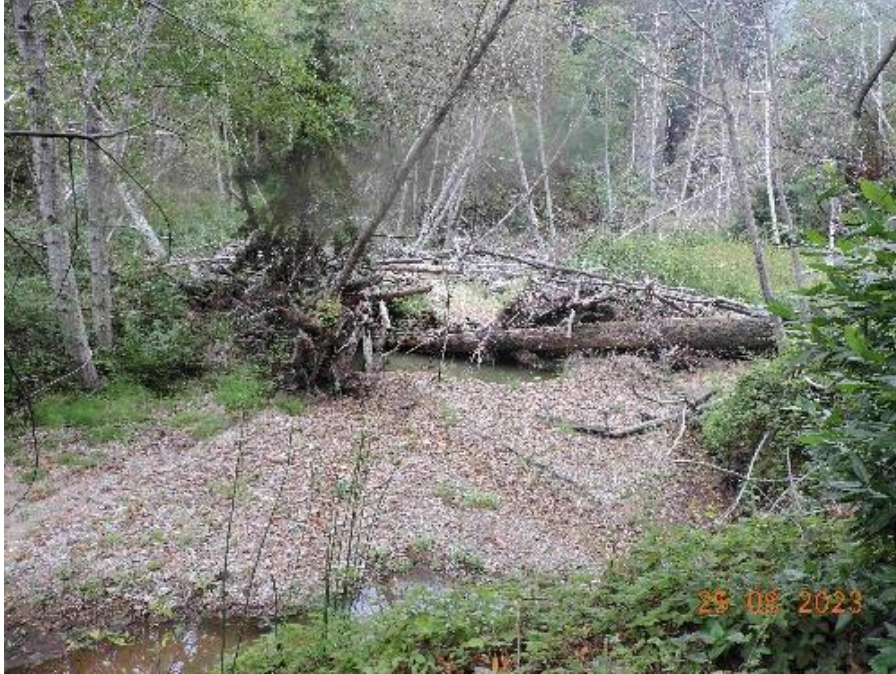
Photo 39. Mile 2.2, looking upstream. The original (2005-2019) upstream fish sampling pool was bypassed (to the channel in photo 38) due to a logjam in 2020, leaving an isolated low flow pool. High flows in 2023 filled the pool with sediment.

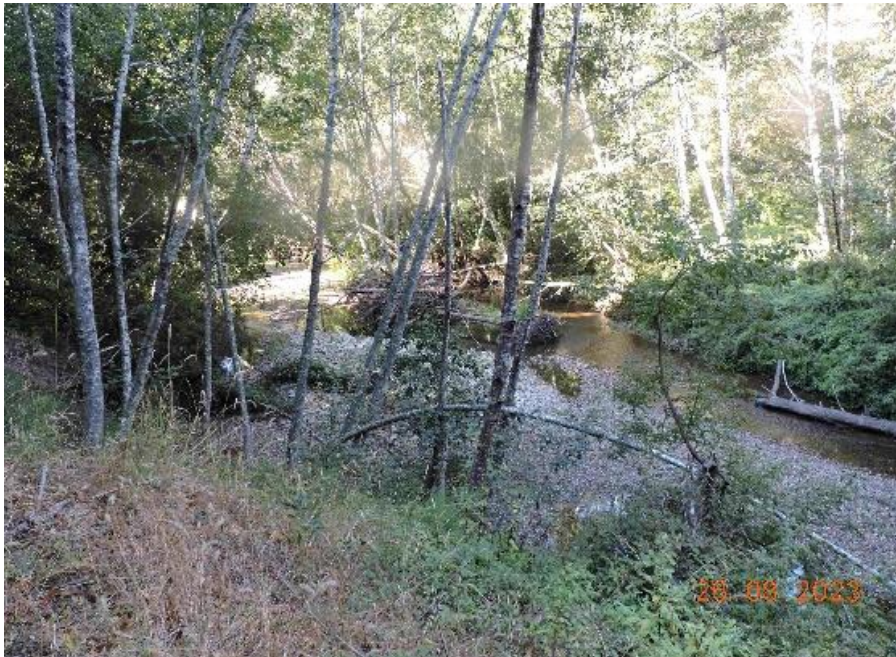
Photo 40. Mile 2.6+, looking downstream from the high left bank. The downstream portion of the formerly long, deep pool filled in 2022. The entire pool was substantially filled in 2023.
