Waddell Creek CZU Post-fire Surveys 2020-2023

Jerry J. Smith, frogs_and_fish@yahoo.com

10 September 2023

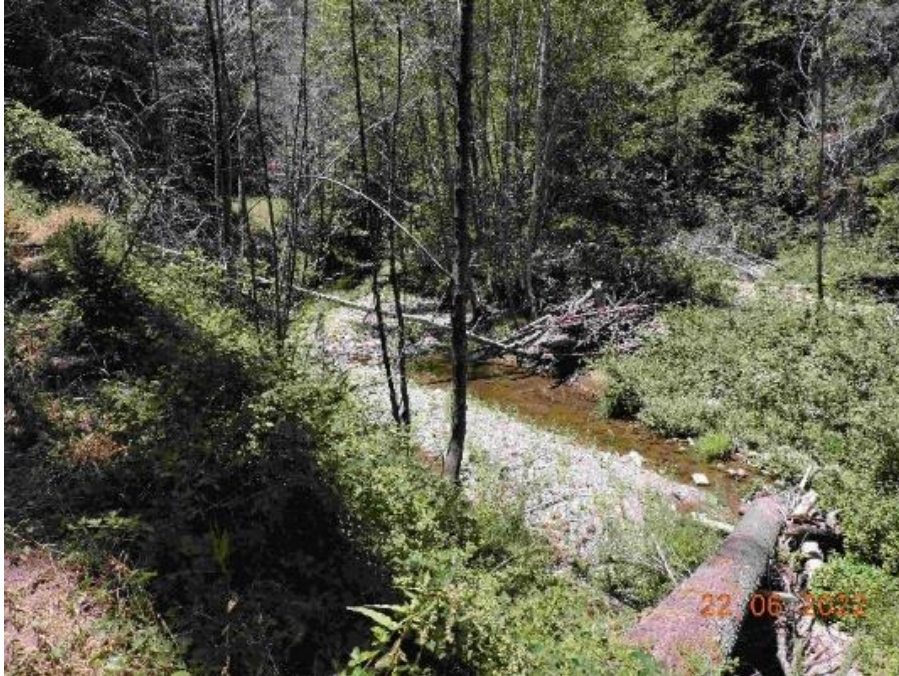
Photo 47. Mile 2.7, looking downstream (20 June 2022 photo). Dead and down alders and fallen Douglas fir from upslope. Narrow channel along the left bank, with remainder of channel vegetated.

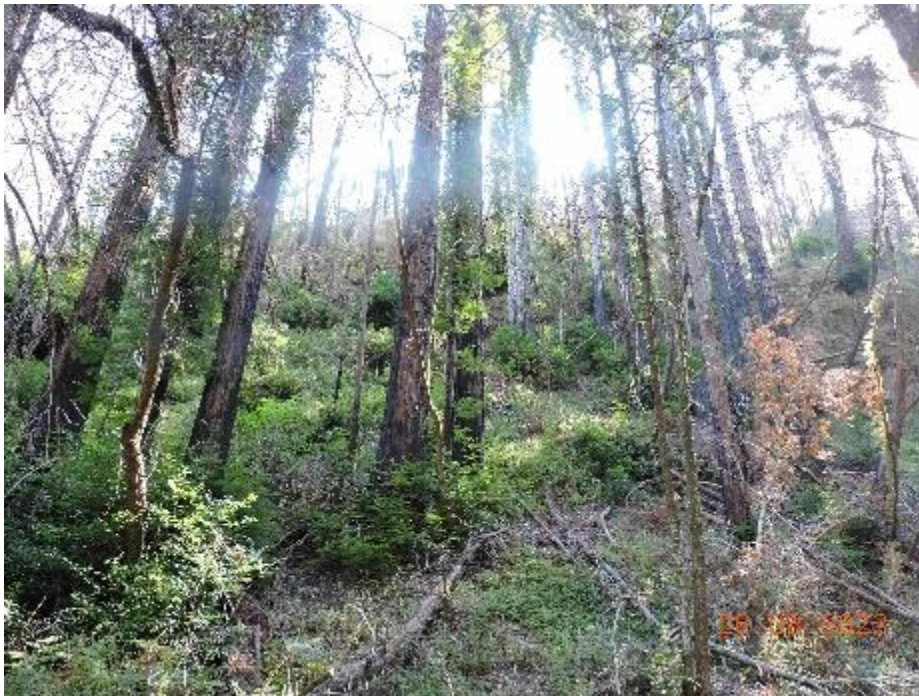
Photo 52. Mile 2.85+, looking at east slope. Redwoods with basal, trunk, and branch sprouts, and tanbark oaks with basal sprouts. Ground cover well established.

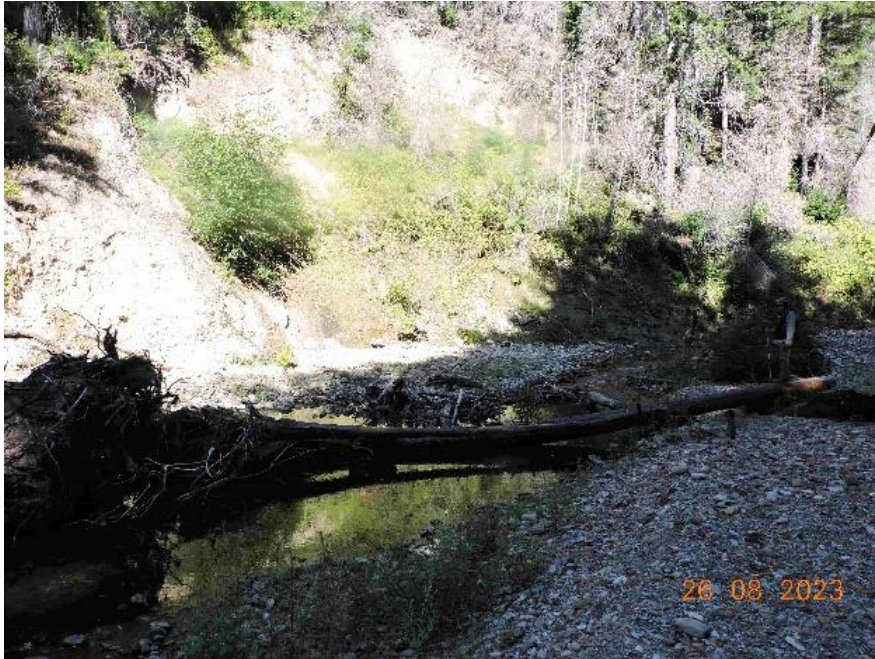
Photo 53. Mile 2.85+, looking upstream. Site of right bank debris flow in 2021 and large partial log jam formed from toppled trees in the debris flow. The jam was greatly enlarged with fallen alders from floodplain alder forest upstream in 2022. The jam and alders were gone in 2023, and are part of the large new jam downstream at mile 2.7.

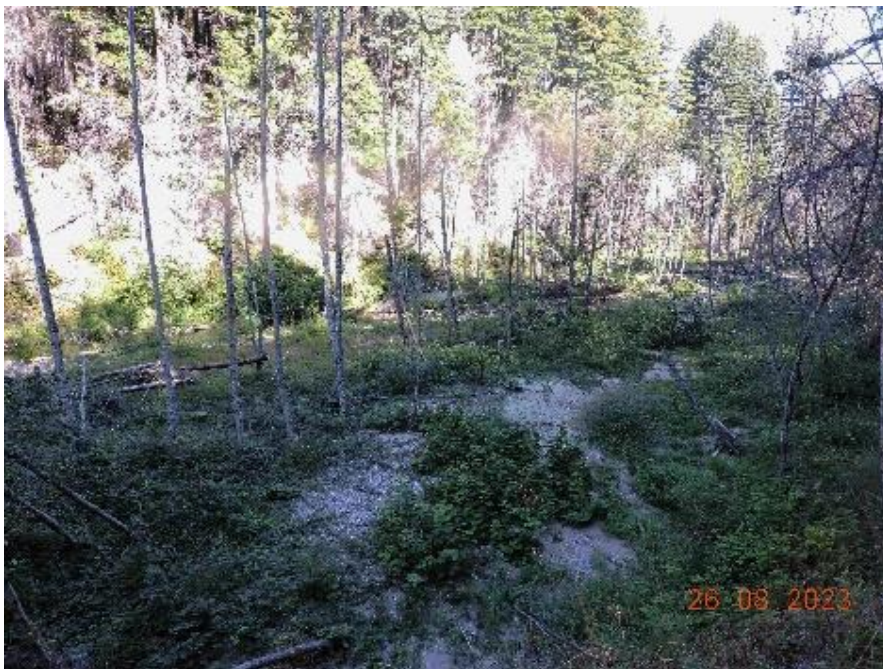
Photo 54. Mile 2.9-, looking upstream. Remnant of dense floodplain alder forest, mostly killed by fire, and added to logjam immediately downstream in 2022.

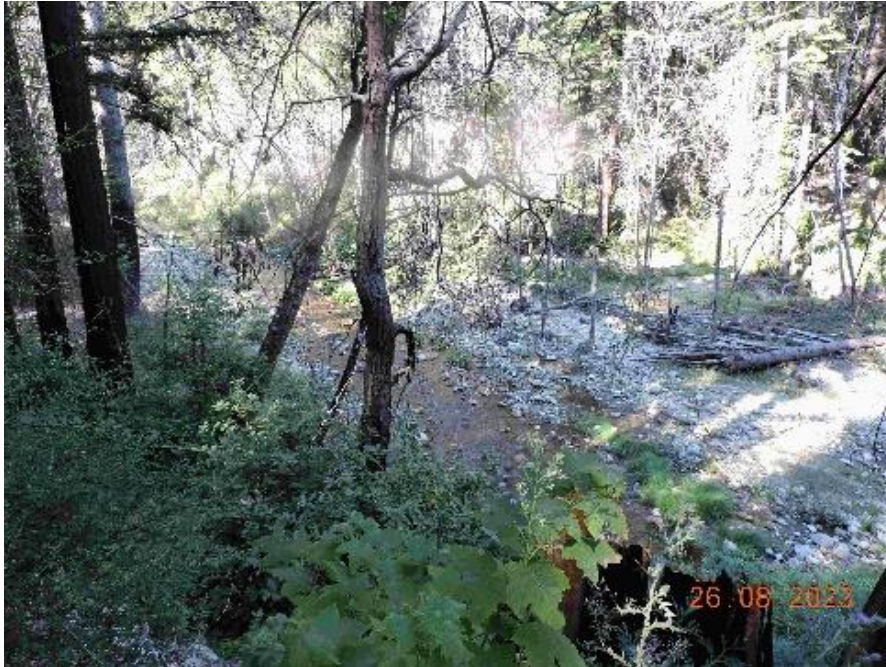
Photo 55. Mile 2.9, looking downstream from near the bottom of the bypass trail. Streamside alders dead and down.

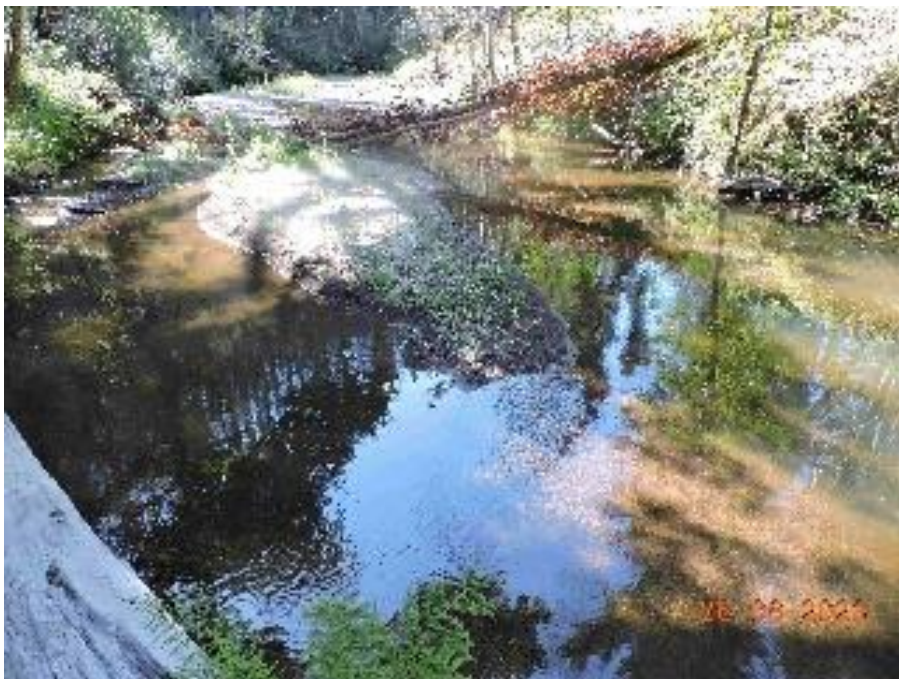
Photo 56. Mile 2.9+, looking downstream. By 2022 this large, deep pool was more than half-filled with small mudstone gravel. In 2023, the lower 2/3 of the pool was very shallow, and the pool was 90% filled with silt, sand, and gravel. Deep (3 ft) water was confined to the head of the pool at an old, large, carved redwood trunk near the left bank.

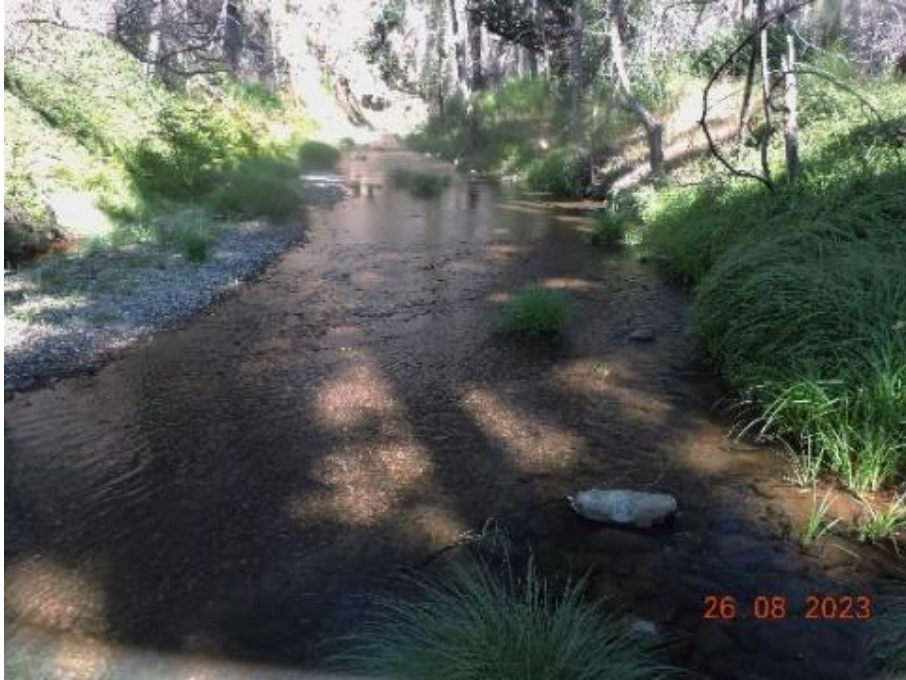
Photo 57. Mile 2.9+, looking upstream. As in 2022, the upstream habitat (to near the confluence of the forks) was an aggraded, filled channel. A west slope debris flow from rim to stream (visible at the right bank upstream) was the source of most sediment in 2021-2022.

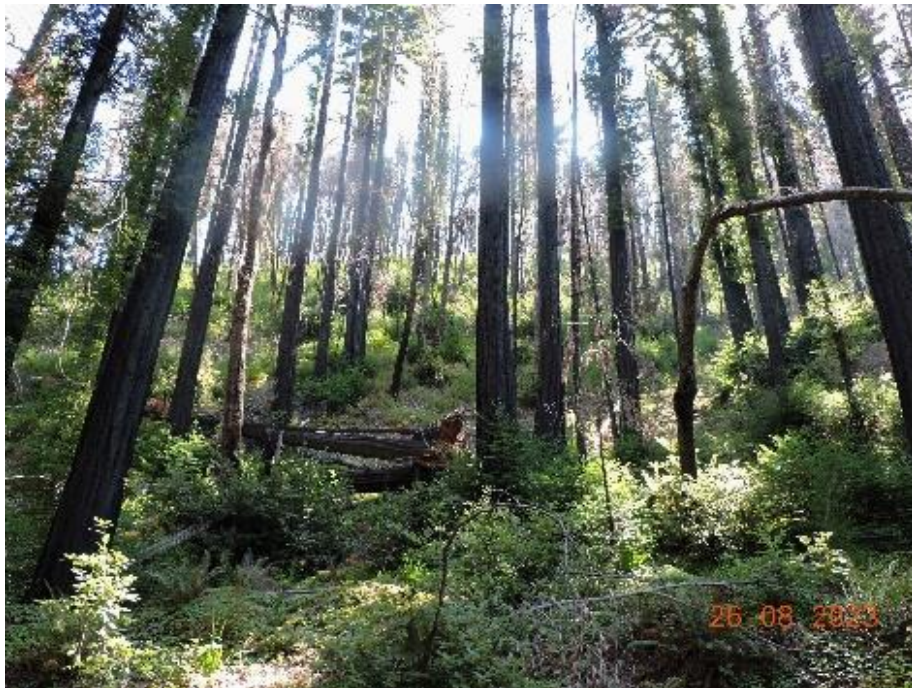
Photo 58. Mile 3.0, looking at East slope. Ground cover has fully recovered, and redwoods have basal sprouts and trunk epicormic sprouts; tanbark oaks with dead trunks have basal sprouts.

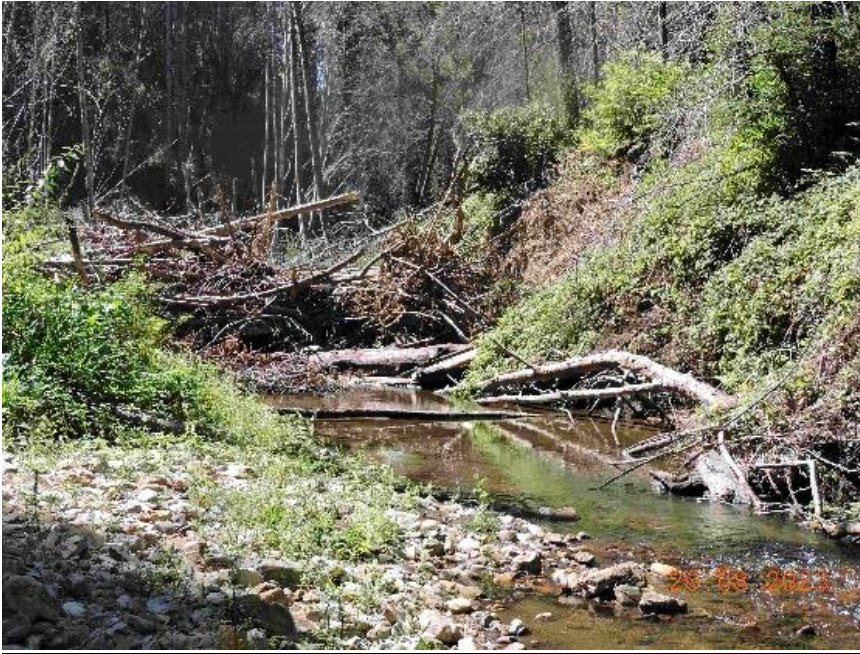
Photo 60. West Fork, mile 3.1+, looking downstream. Former long, deep, fish-sampling pool mostly filled in 2022, now with logjam in downstream portion.

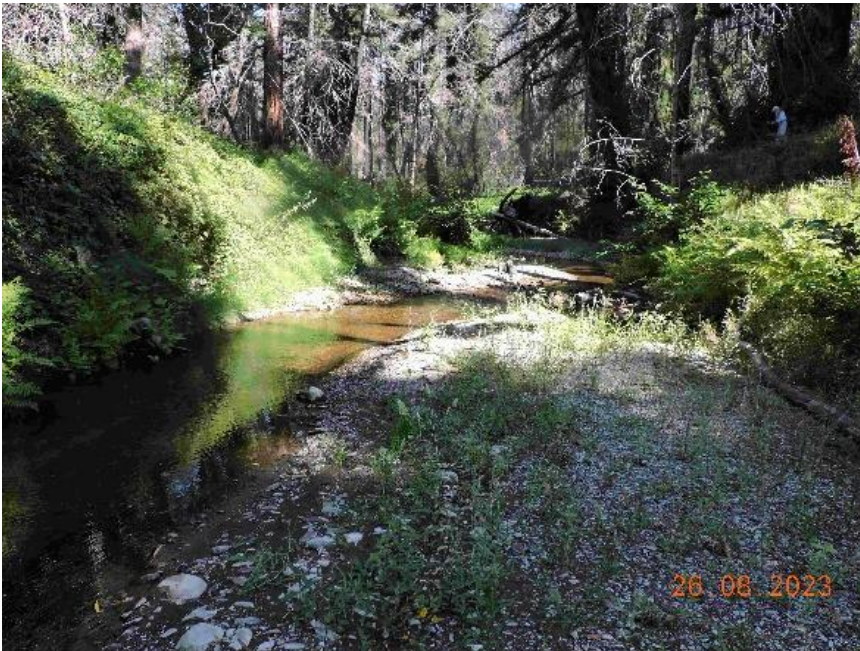
Photo 61. West Fork, mile 3.1+, looking upstream. Pool and glide habitat partially filled in 2022, now with aggraded channel mostly filled with fines and gravel.

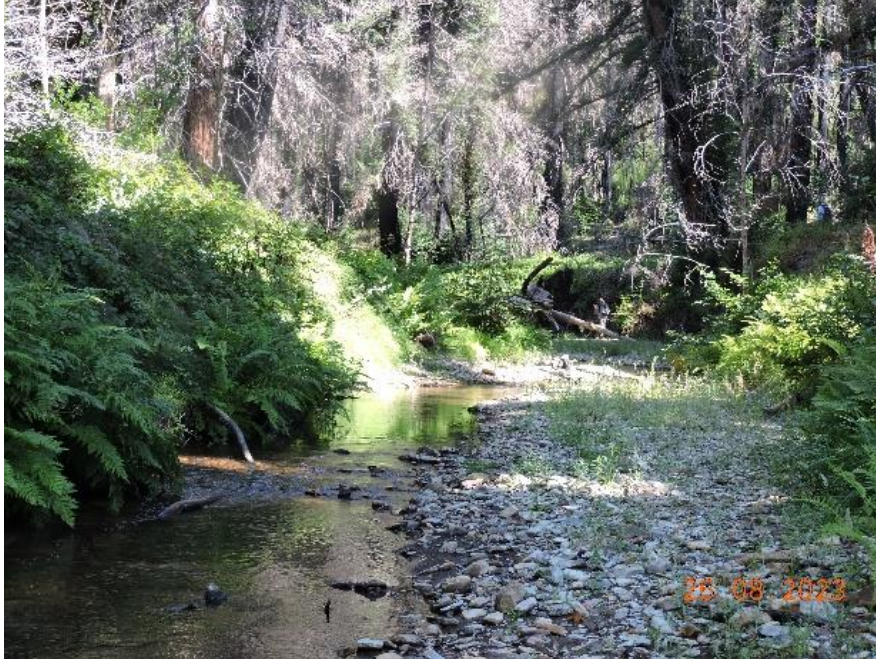
Photo 62. West Fork, mile 3.1+, looking upstream. Tail of large pool upstream was filled as narrow run habitat in 2022.

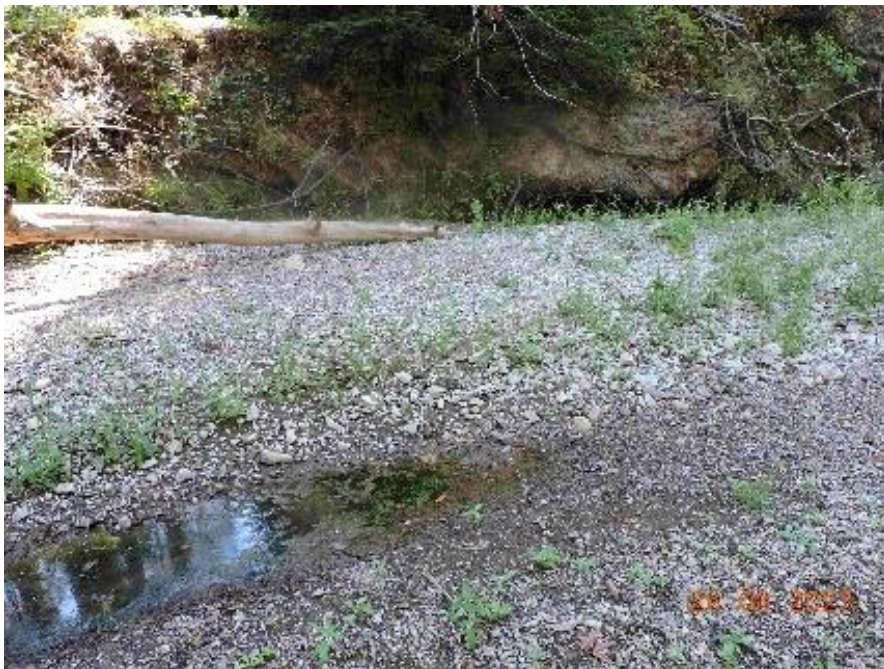
Photo 63. West Fork, mile 3.15, looking downstream to old redwood (nurse) log supporting a 3 ft diameter redwood. Site of 3-4+ ft deep pool (and undercut log) from 1992-2021 (often too deep to sample). The pool was mostly filled and shortened in 2022, and was completely filled with fines and gravel in 2023.

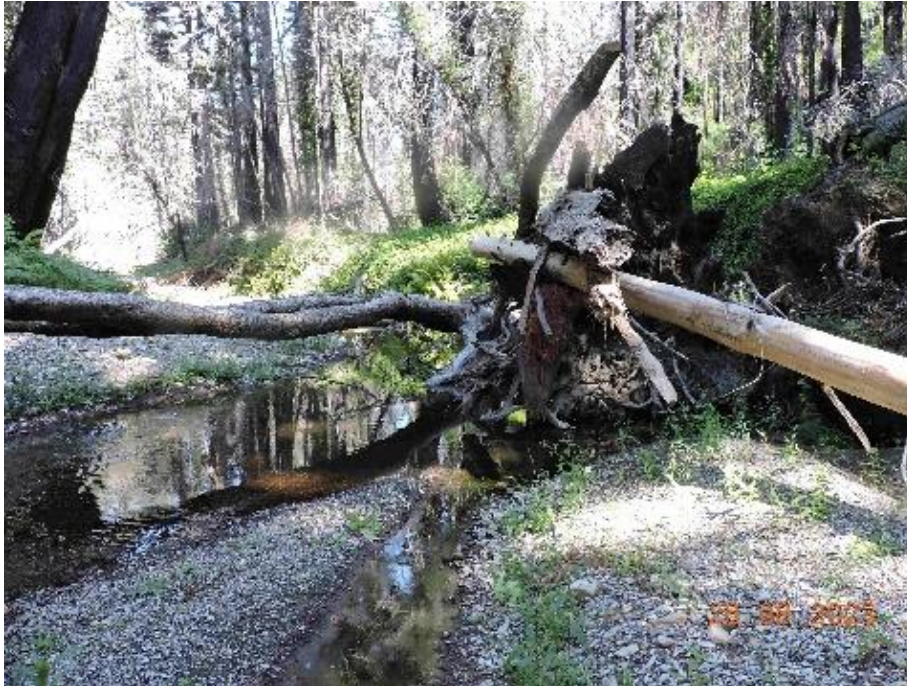
Photo 64. West Fork, mile 3.15, looking upstream immediately above the filled pool in photo 63. A transported root wad and other wood has produced a small, deep pool.

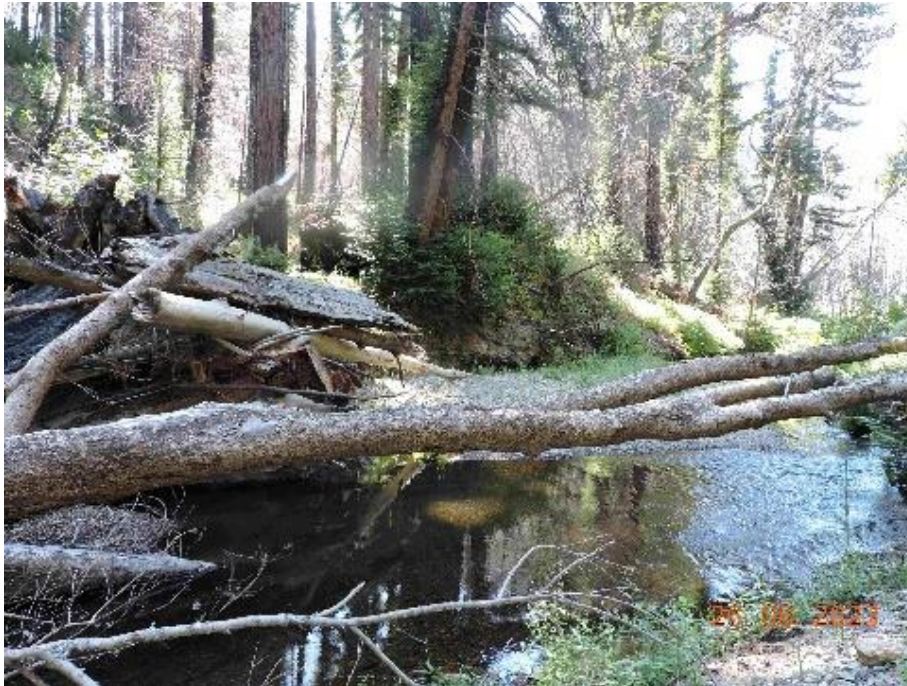
Photo 65. West Fork, mile 3.15, looking downstream past pool in photo 64 to the location of former pool in photo 63.

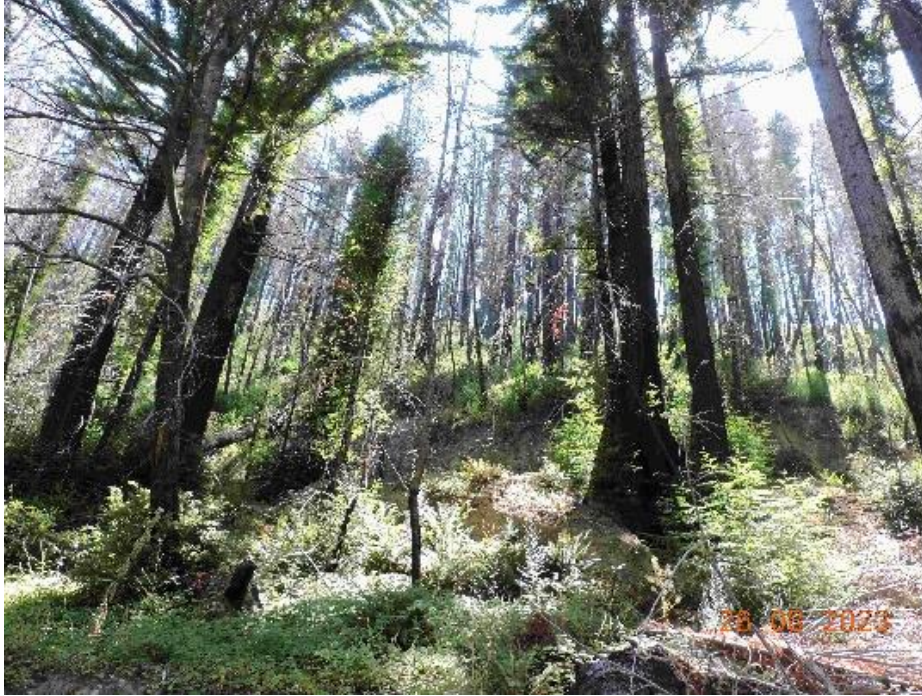
Photo 68. West Fork, mile 3.2, East Slope. Well-developed ground cover on moderate slope. Redwoods with epicormic sprouting on trunk and branches and standing tanbark oaks with basal sprouts.

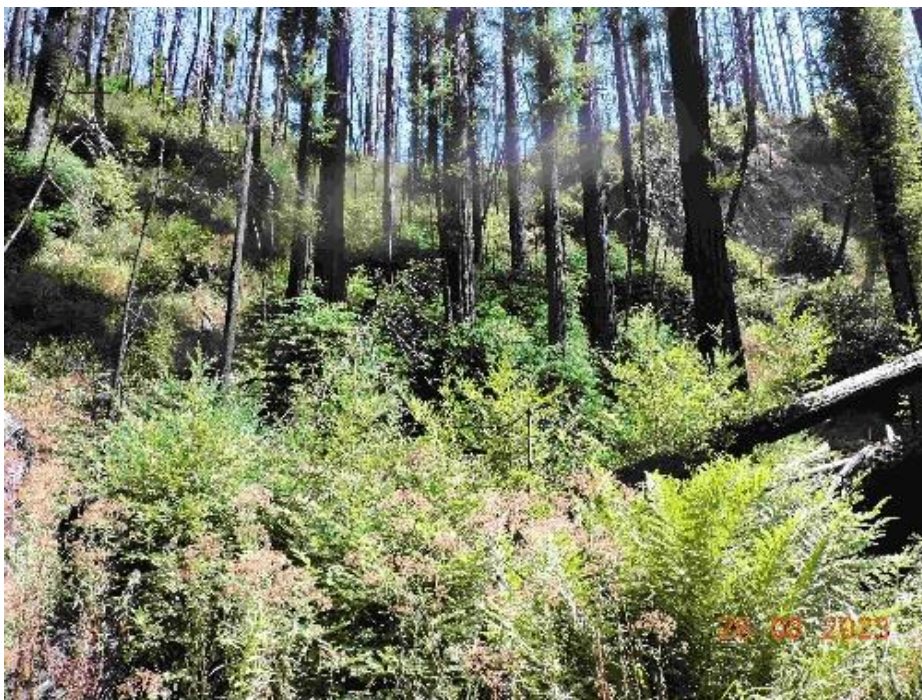
Photo 71. West Fork, mile 3.5. The east slope has dense ground cover and redwoods with basal and trunk sprouts. Douglas firs were killed by the fire.

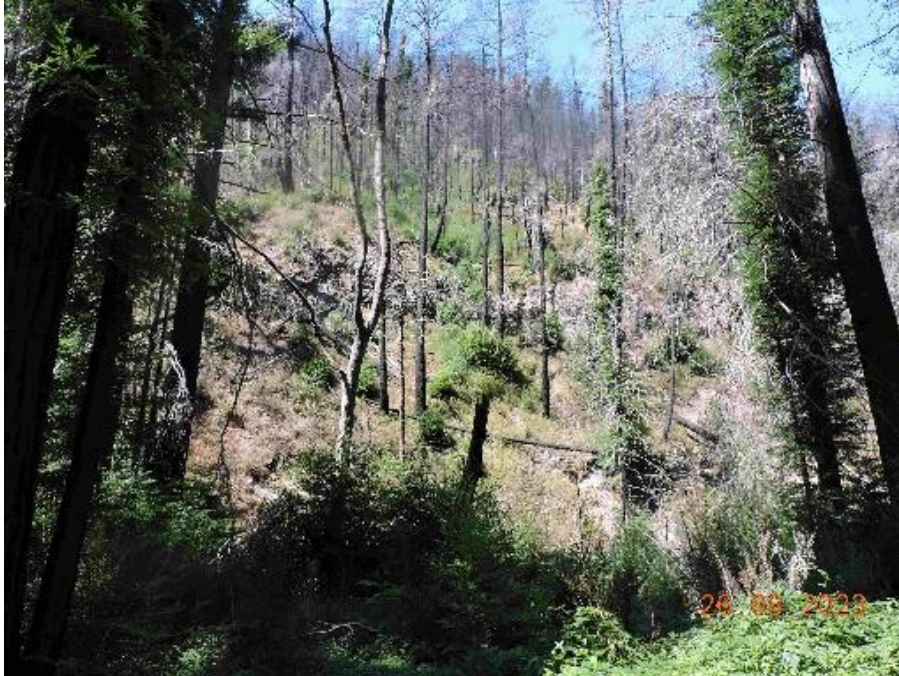
Photo 72. West Fork, mile 3.5. Fire survival was poor on the west slope except near the stream; most Douglas firs and many redwoods were killed. Most of the slope is still lacking ground cover, which has somewhat increased compared to 2021-2022.

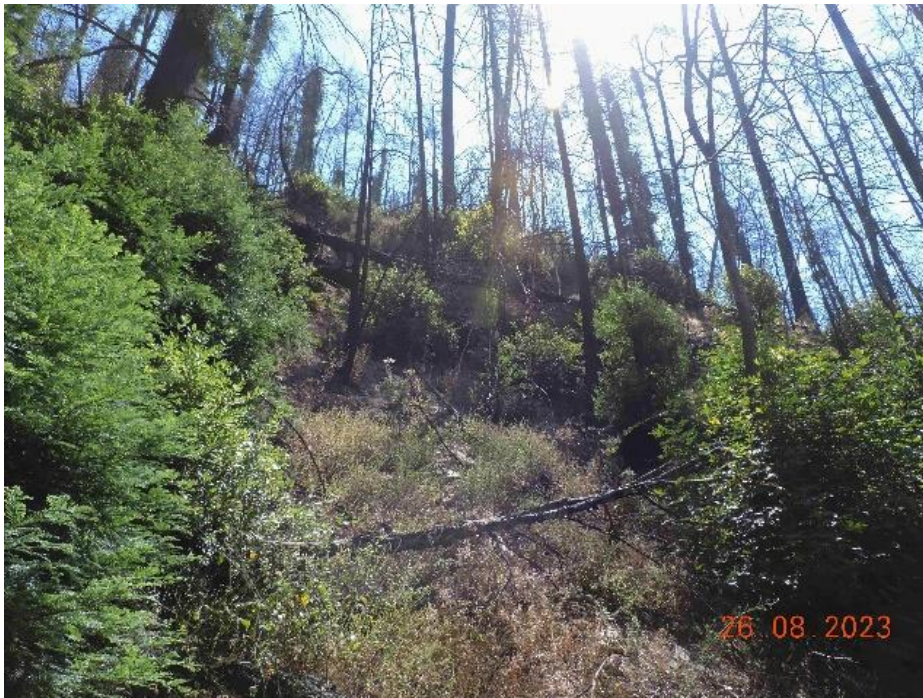
Photo 77. West Fork, mile 3.55+. East slope with dead Douglas firs, but redwoods and maples with basal sprouts, and redwoods with trunk sprouts. Slope well-protected by ground cover and trees.

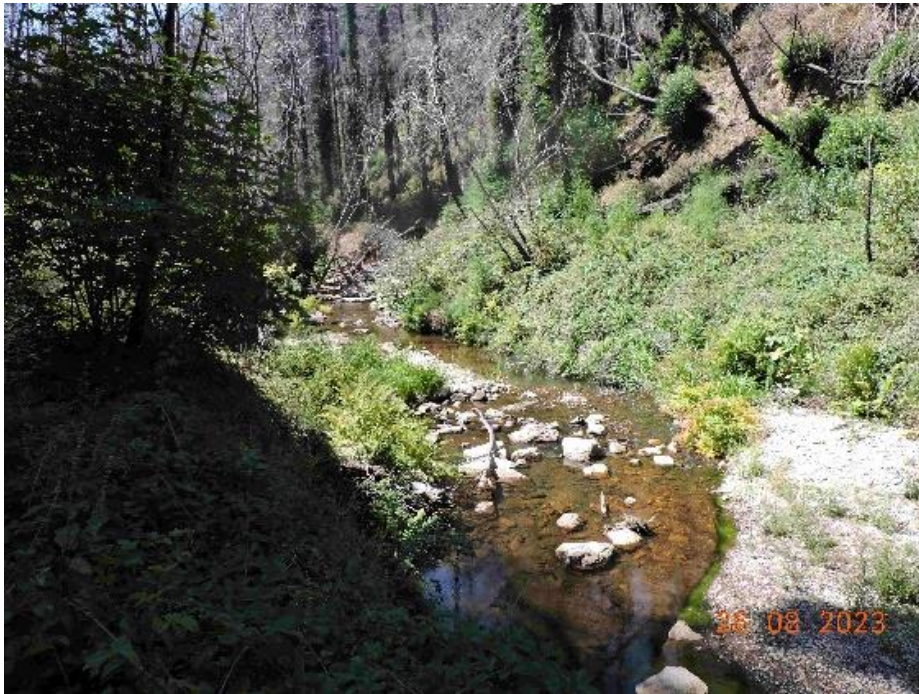
Photo 79. West Fork, mile 3.6+, looking downstream. Sprouted maples and ground cover near stream. Gravel and bedrock channel.

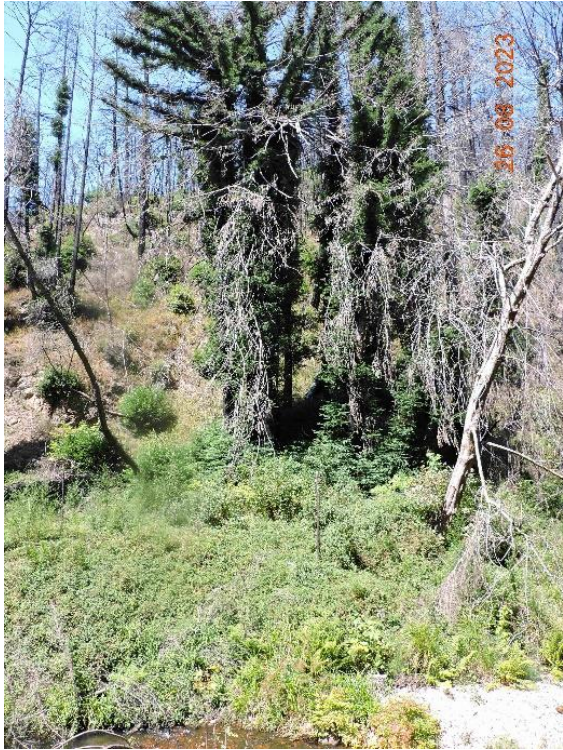
Photo 80. West Fork, mile 3.6+. West slope with trees and ground cover near stream and mostly dead trees and sparse ground cover upslope.

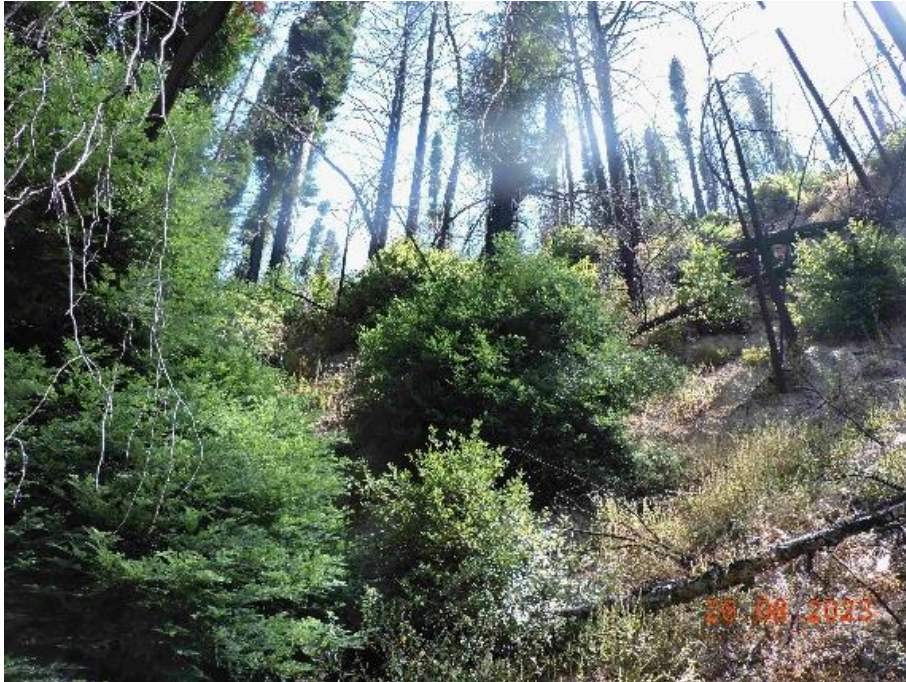
Photo 82. West Fork, mile 3.6+. Redwoods on the east slope, which is less steep than the west slope, are slowly recovering, but Douglas firs are dead.

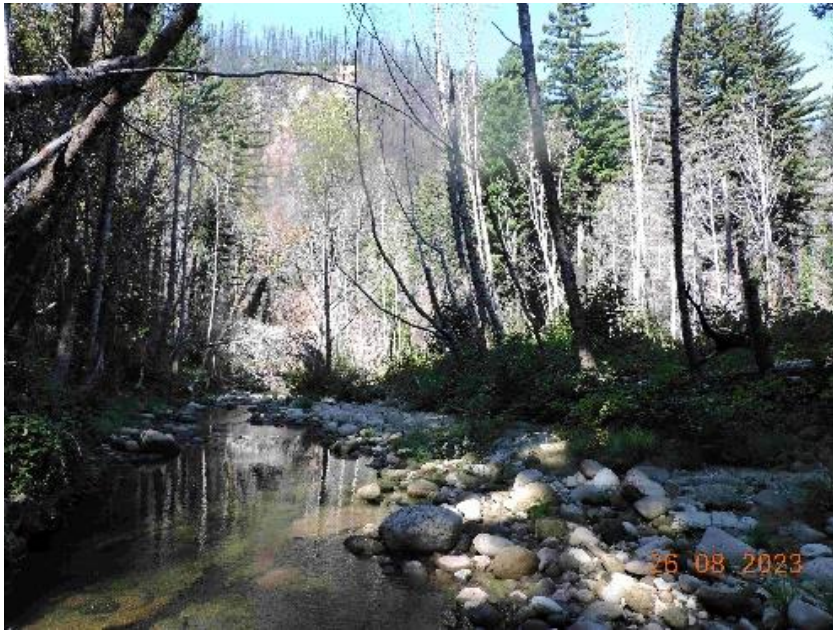
Photo 87. East Fork, mile 0.05, looking downstream to the confluence from the trail ford. Almost all alders along the stream and on in the terrace on the right bank at the confluence were killed by fire. The rim to stream bare slope from the 2021 debris flow on the west slope at the confluence is visible in the background.

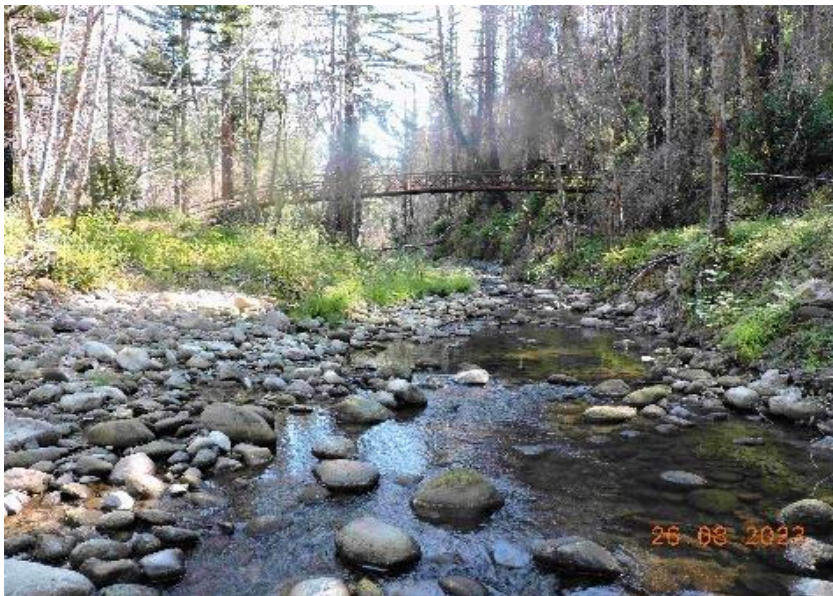
Photo 88. East Fork, mile 0.05, looking upstream from the trail ford. Alders and Douglas firs were killed. Tanbark oaks with basal sprouts on dead trunks, and redwoods recovering with epicormic sprouts. Channel with additional Butano sandstone and mudstone cobbles and boulders carried downstream in 2023 winter floods. A 2 ft diameter mudstone boulder adjacent to a rebar stake (for temperature logger attachment) was carried away by the high flows.

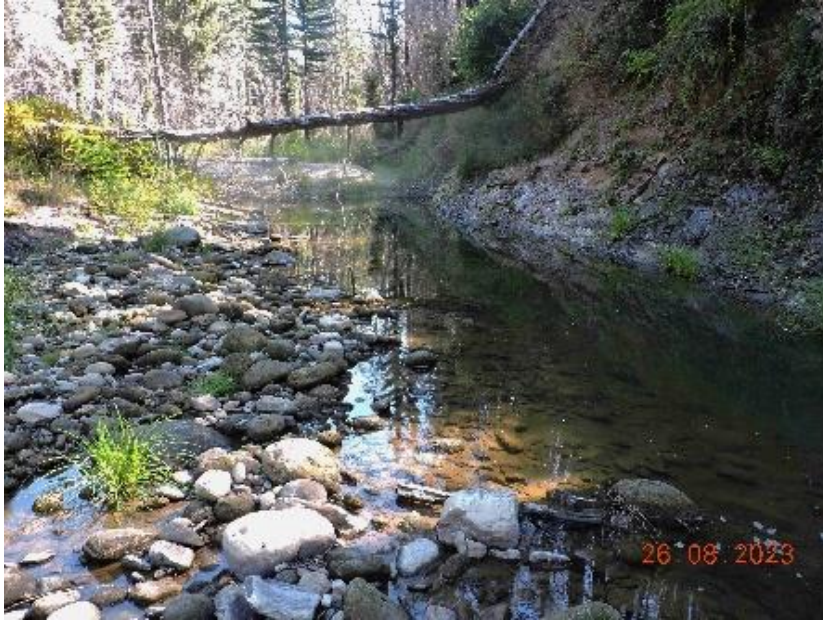
Photo 89. East Fork, mile 0.1, looking upstream. Bedrock pool upstream of footbridge. Some silt on bottom, but no pool filling. The head of the pool was cut off by cobbles and boulders from the channel realignment in the upstream bend to the left by high flows in December 2021. However, the bend was completely rearranged in 2023. A secondary flood channel directly upstream in 2023 removed the materials deposited in the head of the pool in 2022.

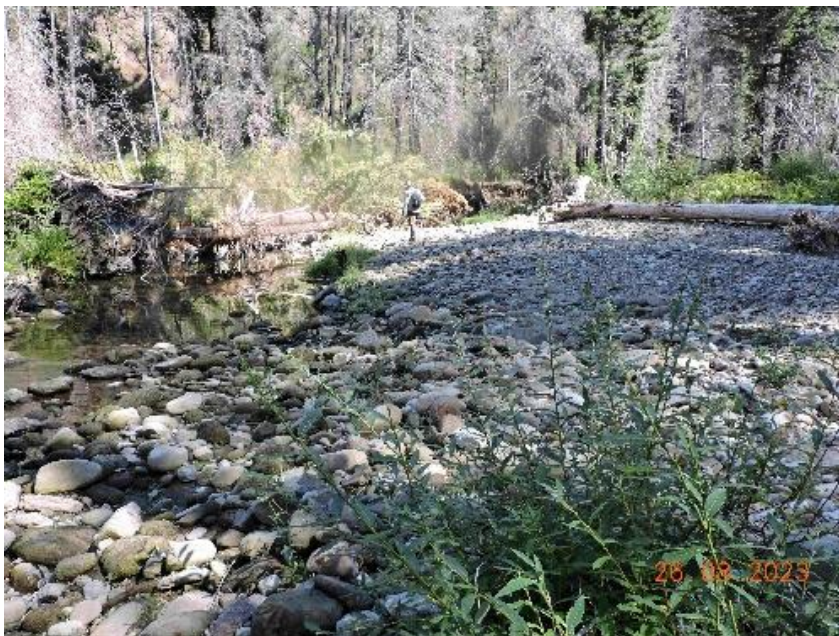
Photo 90. East Fork, mile 0.1+, looking upstream from near the pool in photo 89. The 1998-2021 channel was to the left (right bank) in the photo. The 2022 channel was pushed to the right by fallen and transported trees in the upstream bend (filling the head of the pool in photo 89). In 2023 the floods removed the wood, and the channel returned to the 1998-2021 position.

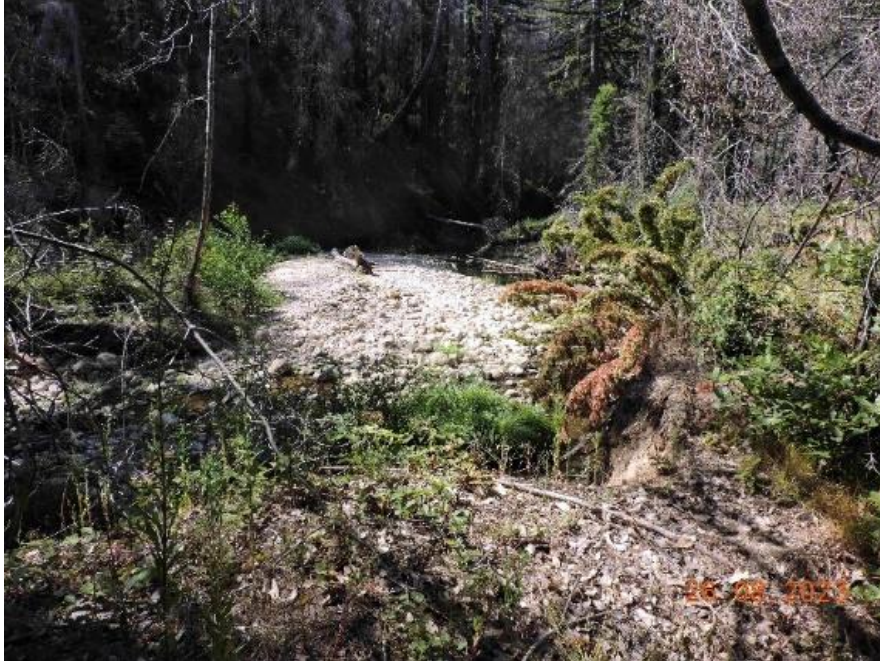
Photo 91. East Fork, mile 0.1+, looking downstream at the cobble bar shown in photo 90. Bank alders still present in 2022 are now gone.

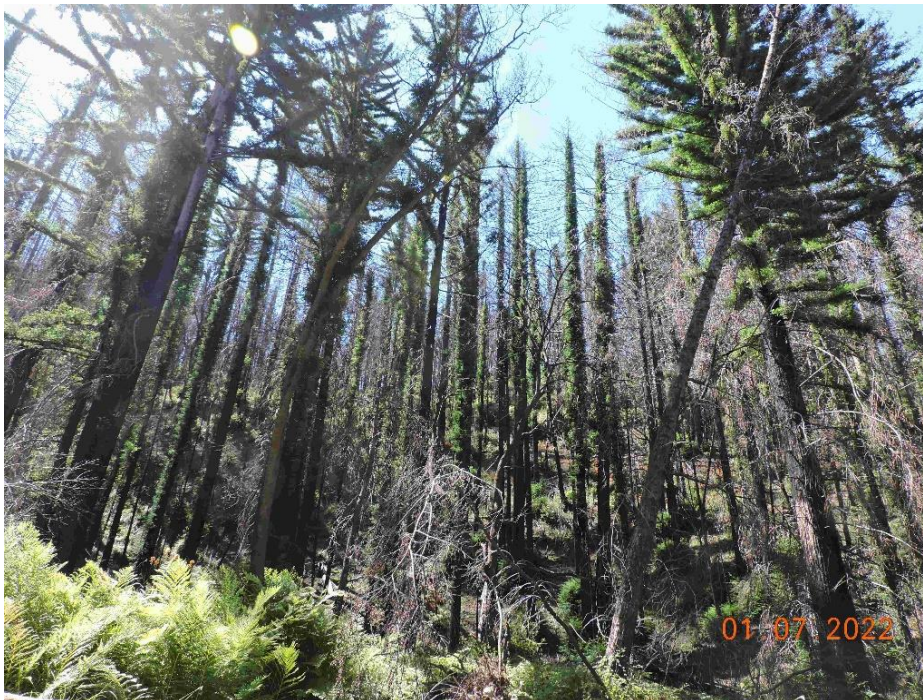
Photo 96. East Fork, mile 0.2 (July 2022 photo). South slope with burned, but recovering, redwoods. Few tanbark oaks, with dead trunk, but basal sprouts. The few Douglas firs are dead.

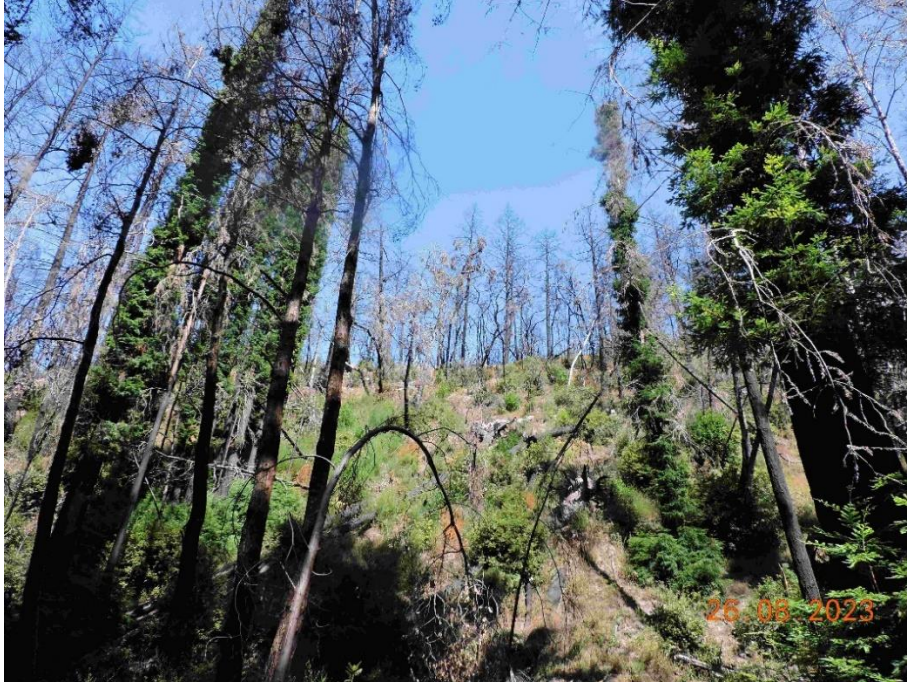
Photo 97. East Fork, mile 0.2. The north (south-facing) slope above the stream, has sparse surviving redwoods at the base of the slope. Dead trees upslope (mostly Douglas firs). Most tanbark oaks also dead, but some with basal sprouts.

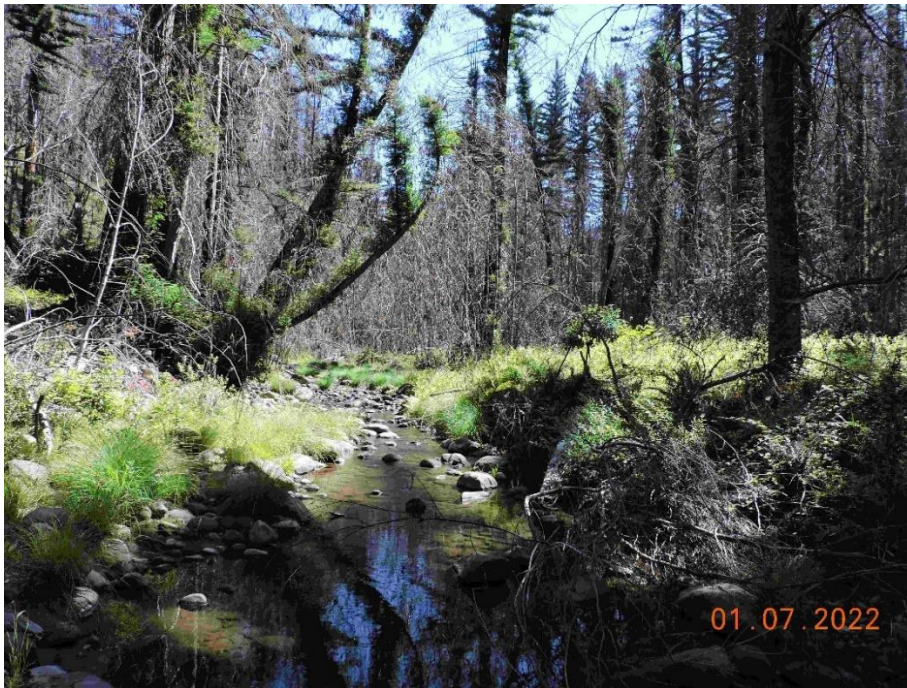
Photo 98. East Fork mile 0.2+ (July 2022 photo). Dead streamside alders, but recovering redwoods with epicormic sprouts on the terrace above the stream.
